THE FRACTURE CHARACTERISTICS OF GLASS FIBER POST AND CORE ON USING DIFFERENT TYPES OF CORE RESIN MATERIALS

Purpose. This in vitro study was to evaluate the most suitable type of resin core for the glass fiber post through surveying the fracture modes and the maximum load that fractures the tooth.

Material and methods. 50 sound maxillary premolars restored with glass fiber posts(ParaPost[®] Fiber White) and different types of resin cores(ParaCore, Z100[™], Rebuilda[®] and Admira[®]) were prepared and loaded to failure in a universal test machine.

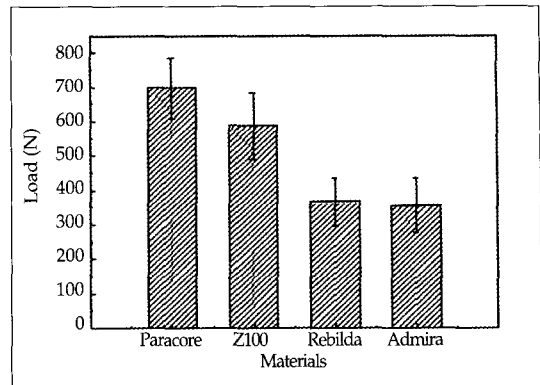
Fig. 3. The means and standard deviations of maximum fracture load in the tooth specimens.

Maximum fracture load of the tooth specimens according to the Wilcoxon rank sum test, there was a significant difference between the maximum fracture loads of the tooth specimens. Among ParaCore, Z100[™], Rebilda[®] and Admira[®], ParaCore showed the highest mean maximum fracture Load followed by Z100[™]. Both the cast metal post and core specimen did not fracture till the load of 1000N. According to the Turkey test, there was significant difference between ParaCore and

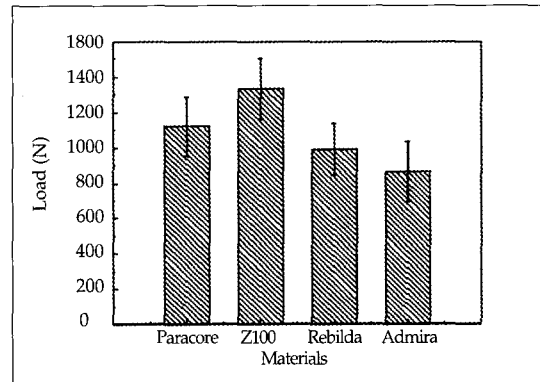
Fig. 4. The means and standard deviations of compressive fracture load in the resin specimens.

According to the Wilcoxon rank and sum test, there was significant difference among compressive fracture load of the resin specimens. Among ParaCore, Z100[™], Rebilda[®] and Admira[®], Z100[™] showed the highest mean value followed by ParaCore. According to Turkey test,

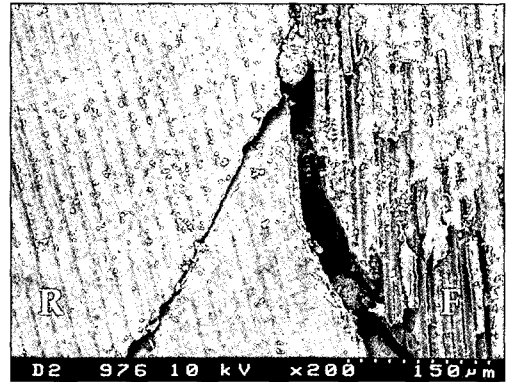
Fig. 8. The interface of glass fiber post and resin core in type D fracture(×200)
(F : Glass fiber post, R : Resin core)

that the bond between the glass fiber post and resin core at the site of fracture (Fig. 7, 8). And the broken bond between glass fiber post and resin core is to be seen at the region containing fracture lines. And although the tooth that was restored by metal cast post and core did not fracture under high load, there was a root fracture in the cross section of the samples (Fig. 10).
