# GPS·GIS 기법을 활용한 태풍 후 해운대 해변지형의 3차원 변화 탐지 및 분석

## Detection and Analysis of Post-Typhoon, Nabi Three-Dimensional Changes in Haeundae Sand Beach Topography using GPS and GIS Technology

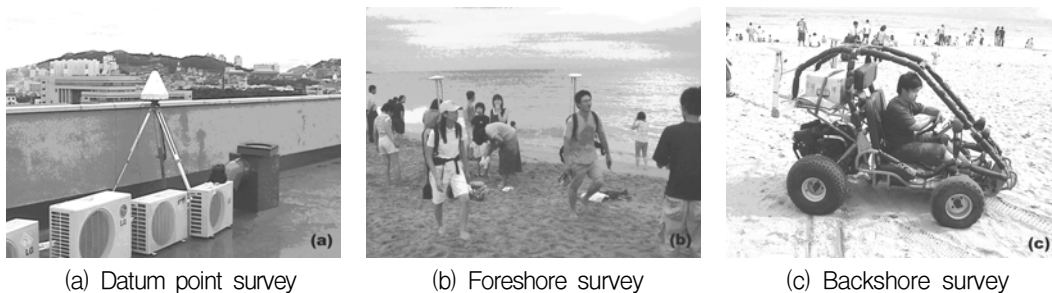
FIGURE 1.

Affair and Fisheries, the second survey was conducted on 19–20 September 2005 conforming to the first spring tide after Typhoon Nabi had passed. We selected Pukyong university in Busan as the temporary base point. We surveyed the foreshore by directly walking at 1.5m intervals from the coastline, as shown in Fig.1 (b), and surveyed the backshore by driving an off-road vehicle loaded with two GPS antennas as shown in Fig.1 (c).

We could improve the operation efficiency applying an off-road vehicle to the sand beach survey. As a result of comparing an efficiency of the walking survey with one of the vehicle survey, we could survey the distance equivalent to 3 km by 1 point per 90 min. But a vehicle could survey the distance equivalent to 9 km by 2 points per

90 min. As it words, the survey efficiency of using an off-road car was 6 times higher than one of using a pedestrian.

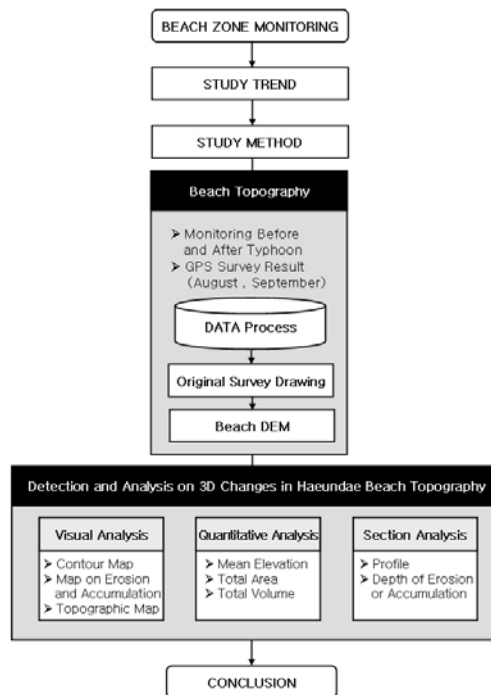
FIGURE 3. Flow chart of study methods

We set up survey results at predicted time to occur the low tide by Ministry of Maritime Affairs and Fisheries as the sea level and we extracted the coastline and the sand beach topography of Haeundae from sand beach survey drawings. As grid data is more useful than vector data for the connection with RS data, the overlay analysis of layers and the simulation, we extracted digital elevation models (DEMs) composed of grids from GPS survey results using Intergraph MTA & InRoads. And then we accomplished the visual analysis, the static analysis and the sectional analysis of DEMs, using GIS software such as Modular GIS Environment and Arcview GIS 3.3, and detected three dimensional changes in the sand beach. (Fig. 3)

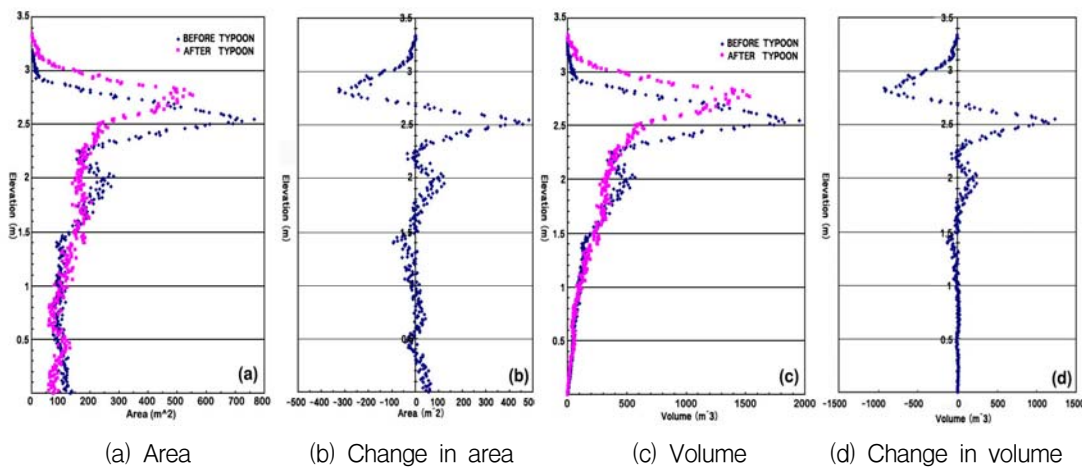
**FIGURE 6.** Sand beach topographic change graphs by elevations

as computing and analyzing the mean elevation, the area and the volume. To improve the accuracy of histogram, we set up the interval of the histogram as 1 cm and extracted histograms of pixels composing sand beach DEMs. From histograms of sand beach DEMs, We derived computed mean elevations, areas and volumes. We then created charts of areas and volumes by elevations, as shown in Table 1 and Fig. 6.

Sand beach elevation categories increased or decreased after Typhoon Nabi as follows: decrease at 0 - 0.4 m, increase at 0.4 - 0.6 m, decrease at 0.6 - 1.0 m, increase at 1.0 - 1.5 m, decrease at 1.5 - 2.7 m, and increase above 2.7 m. Post-typhoon volumes by elevations changed very little at 0 - 1 m, accumulated at 1 - 1.5 m, decreased at 1.5 - 2.7 m, and accumulated above 2.7 m. The elevation exhibiting the maximum erosion in area and volume was 2.5m. These findings indicate that waves moved onto the sand

beach to an elevation of 2.5 m; the receding waves carried away large quantities of sand from areas above and below 2.5 m in elevation. If the area and the volume conforming this elevation that tourists take place are eroded continuously, the value of Haeundae sand beach as a tourist resort would be dropped.

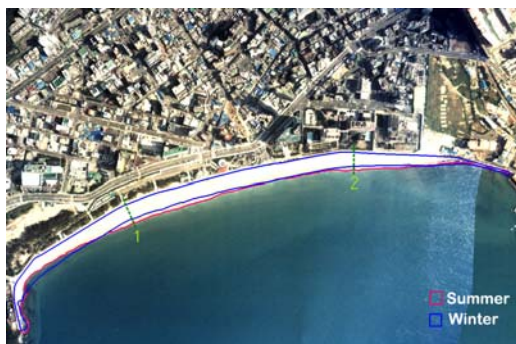
FIGURE 8. Change in sand beach shape by seasons (2004)

We demonstrated this phenomenon by scanning and ortho-rectifying aerial photos and digitizing the sand beach. We set up sectors ranging from Chosun Beach Hotel indicated in Fig. 7 to Mipo port. As a result of measuring areas confirming to each sectors, the area of the west sand beach was decreased and one of the east sand beach, increased in summer because movement of minute sand affected by monsoon (Fig 8). However, the west sand beach was accumulated and the east sand beach, eroded in winter. Therefore, it is estimated that the typhoon eases the erosion on the west sand beach in summer.

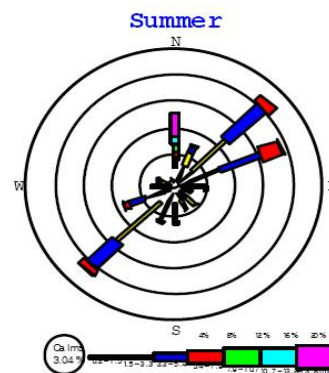
FIGURE 9. Summer wind rose

12.5 m/s in a north-northeast direction, generated surges exceeding 3 m. North-northeast surge reached the sand beach and washed away sand, particularly at the central and the east sand beaches. However, a natural spur, Dongbaek Island, blocked surges from directly reaching the west sand beach. Therefore, it is estimated that sand beach erosion was not generated at the west sand beach by Dongbaek Island.
