# Diagnosis of Cryogenic Pump-Motor Systems Using Vibration and Current Signature Analysis

**Key Words :** Vibration Diagnosis, High Pressure Cryogenic Pump-motor, Current Analysis, Pole Pass Frequency, Rotor Bar Pass Frequency (RBPF)

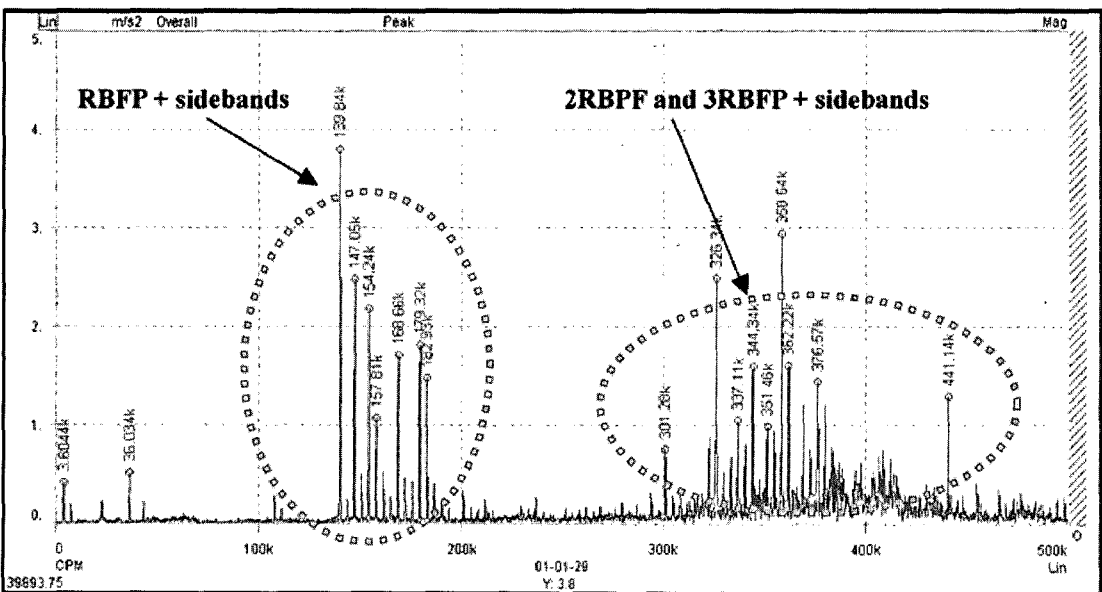
Fig. 5 Vibration spectrum of high frequency band

In this paper, the number of motor rotor bar is 41. So RBPF is  $41 \times 59.75 \text{ Hz} = 2,450 \text{ Hz}$ . The spectrum data of high frequency band has been

taken by connecting between on-line monitoring sensor and portable equipment as shown in Fig. 5. In Fig. 5, RBPF component and sidebands of 7,200 rpm interval were generated with high level peaks to compare with 1X, and two and three

times RBPF component and side bands interval were also generated with high level amplitude in high frequency band exceptionally.

Through the result of vibration analysis, motor rotor bar or end rings problem is suspected. But it

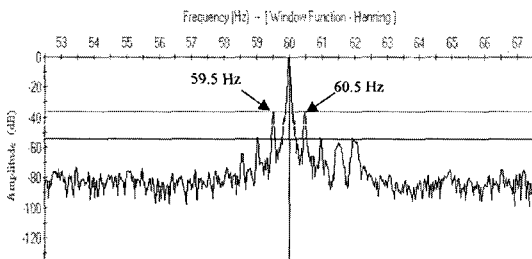
Fig. 8 High resolution spectrum of current signal

The result of current signature analysis was shown in the Fig. 8. In Fig. 8, it could be confirmed that the amplitudes gap of between sidebands (59.5 Hz and 60.5 Hz) and line frequency (60 Hz) was from 36 dB to 39 dB in current spectrum. Generally this amplitude gap indicates that one or two rotor bars were cracked or broken according to the rotor bar damage severity level chart as shown in Table 4. (Bonnet and Soukup, 1992 ; Berry. and James, 1999 ; Finley et al., 2000 ; Thomson and Fenger, 2001, 2003)

With the above result of current analysis, motor rotor bar problem was confirmed again, therefore, motor was removed from service and repaired for the modification of abnormal vibration cause.

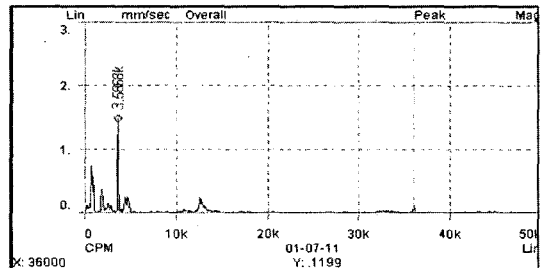
Fig. 13 Vibration spectrum of low frequency band after repairing

In Fig. 13, the overall vibration values are reduced after repairing. And it could be verified the amplitude peak of rotating frequency component (1X) was significantly reduced with about 1.5 mm/s, e.g., approximately 80% level of vibration than before repairing.
