An Experimental Study of Valve Seat Material Galling Characteristics in Waterworks

KEYWORDS : Galling, Material transfer, Seizure, Threshold galling stress, Hardness, Surface roughness

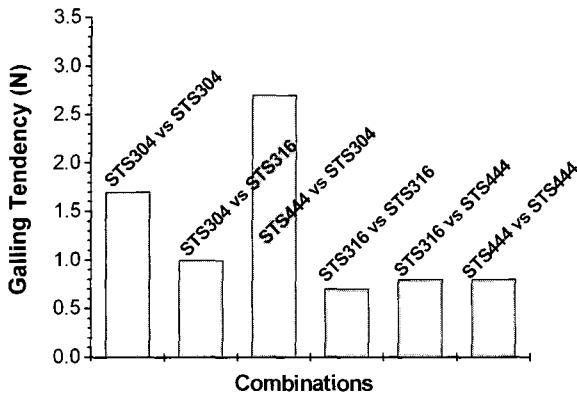
The galling tendencies are shown in Fig. 4. Each result is the average of three measured data points. Combinations that included STS304, which was the softest material, had a very high galling tendency because its surface had the most cold welding or plastic deformation. Chemical attraction also had an influence when STS304 was used. An optical microscope was used to observe this phenomenon more precisely. The surface of STS 304 magnified 500

Fig. 4 Galling tendency for different material combinations

The combination of STS316 and STS316 had no galling or chemical attraction, although the mating materials were the same. This result indicates that hardness has a greater effect on galling than chemical attraction. In other words, if the hardness of the material is high, galling does not occur because the effects of cold welding and plastic deformation are small.

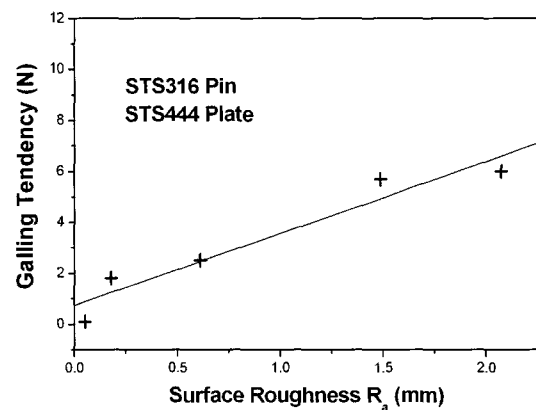
The galling tendency for different surface roughness values is shown in Fig. 7. As the friction force between the surfaces increased, so did the amount of surface galling.

Since the contact area increased, partial melting occurred over a larger area so that the galling tendency had a proportional relationship to the surface roughness.

Fig. 7 Galling tendency with surface roughness

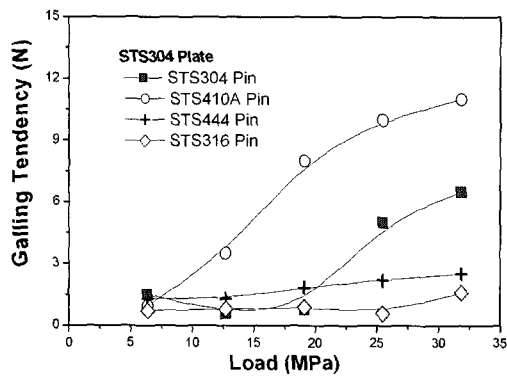
Fig. 8 shows the galling tendency of various loads for combinations of STS304 plate and various pin materials. The STS304 pin and plate combination showed little galling up to 19 MPa, followed by a sharp increase in galling between 19 and 26 MPa. The STS410A pin combined with the STS304 plate exhibited a very strong tendency to generate galling.

This tendency increased sharply between 6 and 19 MPa and then increased more slowly between 19 and 26 MPa, so the surface was expected to change during the later range. To verify this result, the surface at 16 MPa, shown in Fig. 9, was analyzed under the SEM. An irregular deposit of material that differed from the original material was observed. Because Si, P, Cr, and Mn are common between the two materials, while Mo only exists in STS410A, whether a transition between the two materials occurred can be verified by analyzing the Mo content on the STS304 plate.

Fig. 8 Test results for the STS304 plate

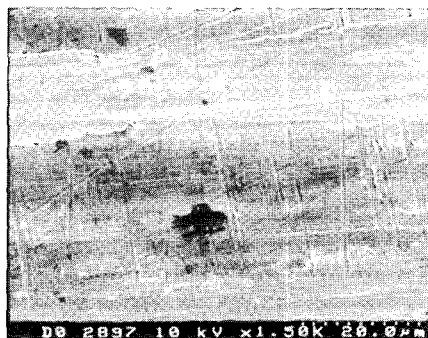
Fig. 9 SEM image of the STS304 surface at 19 MPa

An EDS analysis of the plate surface is given in Table 2, which indicates that a combination of STS410A and STS304 will produce fatal damage at about 19 MPa.

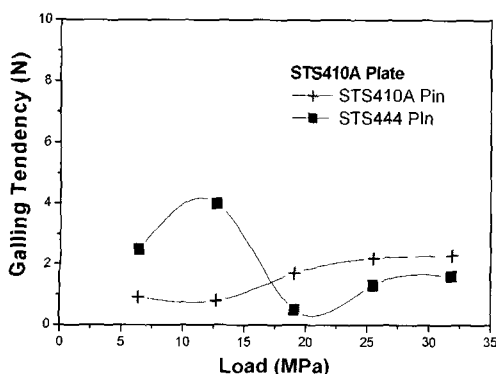
The test results for STS410A plate are shown in Fig. 10. The galling tendency was low at 19 MPa for all combinations because the melting material caused by the high partial pressure reduced the static friction force by providing a melting lubricant effect.

Fig. 10 Test results for the STS410A plate

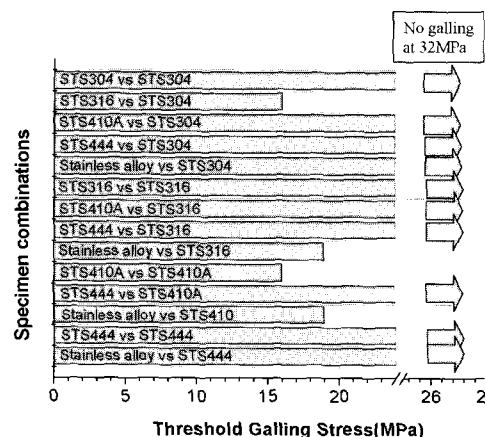
The threshold galling stress for various combinations of material is shown in Fig. 12. If the galling tendency was high, the surface of the test sample showed similar changes.

Fig. 12 Threshold galling stress

Thus galling, as defined in this study and the galling tendency were related to each other.

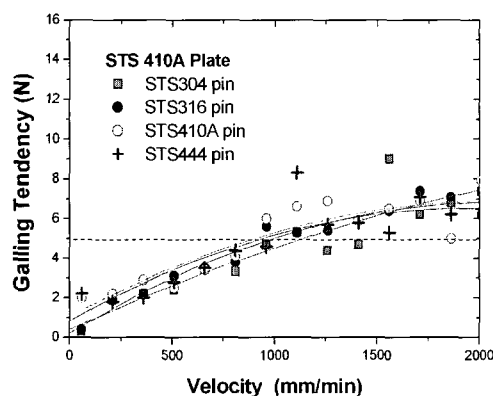
The tests were performed using 6 test samples and 18 combinations. The effect of the sliding speed on galling for the STS304 plate is shown in Fig. 13, while that for the STS410A plate, which contains a coating material, is shown in Fig. 14. The galling tendency for the STS304 plate combinations increased and then decreased with the sliding speed. However, for the STS410A plate, some combinations exhibited a continuously increasing galling tendency with sliding speed.

Fig. 14 Velocity effect on galling for the STS410A plate
