A Study on the Fluoro-polymer Composite Coatings for Protecting the Corrosion of Fossil-fuel Power Plants

Keywords : FGD, fluoro composite Coatings, sulfuric acid resistance, corrosion protective coatings

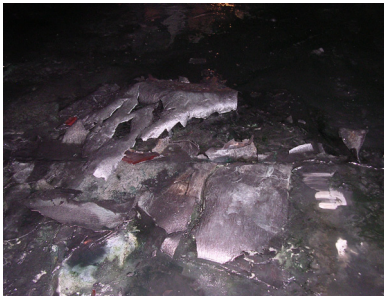
Flake unsaturated polyester coatings	Carbonation and crack

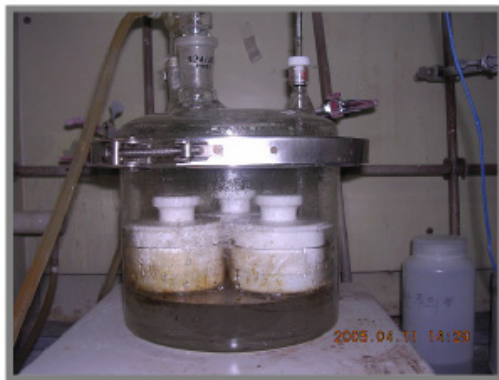
Prior to the application of the paint of fluoro-polymer composite, the verification was first performed to compare with the existent paint. Fig. 3 indicates the test method of the resistance to sulfuric acid, which is the corrosion

95% H₂SO₄, 40°C → 90°C

Fig. 3. Soaking test on acid resistance (sulfuric acid)

test by sulfuric fluid occurring in the region of drainage in the FGD facility, by soaking each coated specimen into 95% sulfuric solution as shown in Fig. 3.

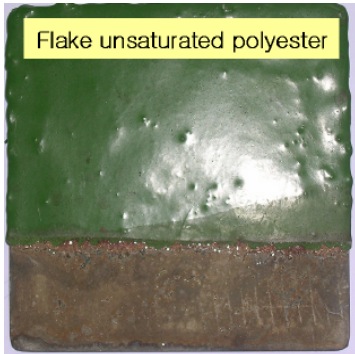
Fig. 4 shows the result of the soaking test in sulfuric solution of high concentration. Seeing a coating of cross-cut specimen we recognized the effect of low corrosion spread of fluoro-polymer composite paint showing no erosion on coating even at the high temperature of 90 °C, whereas in the case of the paint of novolac epoxy or flake-like unsaturated polyester coating was damaged at the temperature as low as 40 °C.

Fig. 4. Result of soaking test on acid resistance (sulfuric acid)

(2) Prior to field test on the FGD facility, performing the comparative test of acid resistance between the paint of novolac epoxy or flake-like unsaturated polyester used widely in the facility of fossil fuel power plant and the paint of fluoro-polymer composite, the former showed carbonation and crack of coating but the latter did excellent acid resistance.
