A CONTROLLED CYCLIC LOADING ON THE SURFACE TREATED AND BONDED CERAMIC: STAIRCASE METHOD

Yang-Jin Yi*, DDS, MSD, PhD

Associate Professor, Department of Prosthodontics, Section of Dentistry, Seoul National University
Bundang Hospital, Seongnam, Korea

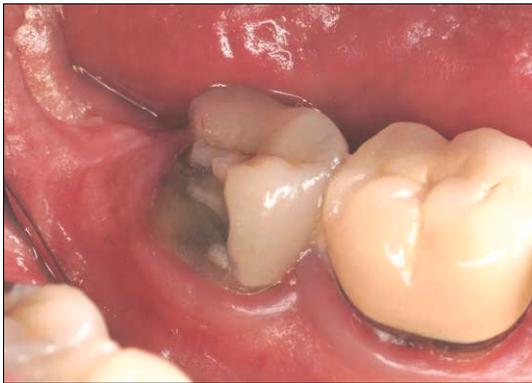
Fig. 1. Clinically failed all ceramic crown.

The differences between the clinically failed ceramic crown and fractured ceramic crown in the lab test are well known (Fig. 1). *Hertzian cone crack*, characterized by the formation of a ring crack just outside the contact area that eventually grows into a sub-surface cone crack is common characteristics of usual lab test but is not seen in the clinically failed crown.¹⁸ Moreover, because traditional laboratory tests require high loads to failure, compared with low occlusal force measured during mastication, they are not clinically relevant.

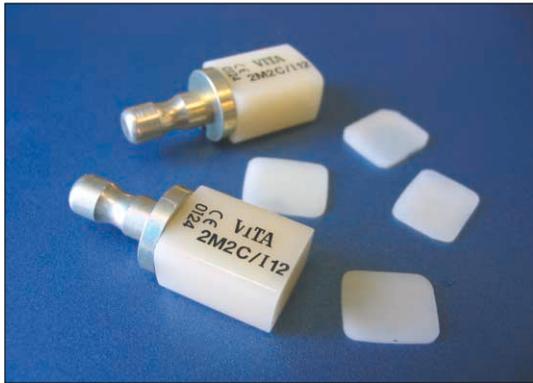
Fig. 2. Specimens were sectioned from Mark II blocks.

Cerec Vitablocs mark II (Vita Zahnfabrik, Germany) blocks were cut into 1.1-1.2 mm thickness with a diamond saw (Isomet 1000, Buehler Ltd., IL, USA) and 60

specimens were prepared. Specimens were divided into 3 groups randomly and groups were polished (control), sandblasted, and etched group. Specimens of each group were gradually polished manually to # 600 roughnesses under water circulation, and this status, polished specimens were used as a control group. Specimens of sandblasted group were air blasted with 50 μm aluminum oxide particle at a 2 cm distance, under 2.7 bar pressure for 5 seconds. Sandblasted group had 20 μm more thickness for compensation of the volume loss from the blast procedure. This amount was set from the preliminary test. Specimens of etched group were treated with 9 % buffered hydrofluoric acid (Porcelain Etch, Ultradent Products Inc., Koln, Germany) for a minute. All specimens were cleaned in the ultrasonic cleaner and dried thoroughly before bonding. The final thickness of polished and etched group for bonded test were 1.0 ± 0.0 mm and 1.0 ± 0.02 mm for sandblasted group.

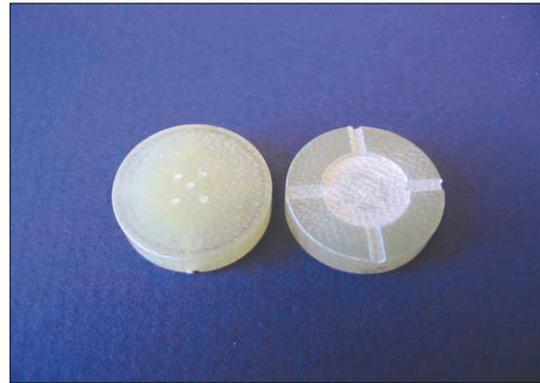
Fig. 3. Micro-channels, lateral channels and central well were prepared for water pumping effect.

Support bases were made from a dentin-analog material having contact stress-strain behavior similar to hydrated dentin (woven glass fiber-filled epoxy; NEMA G10, International Paper, Hampton, SC, USA). Bases were 20 mm in diameter and 5 mm thick and modified by creating small channels and a well to allow water to access the cementation surface, simulating dentinal tubules (Fig. 3). The micro-channels were filled with accessory gutta-percha points so that they remained open following cementation.

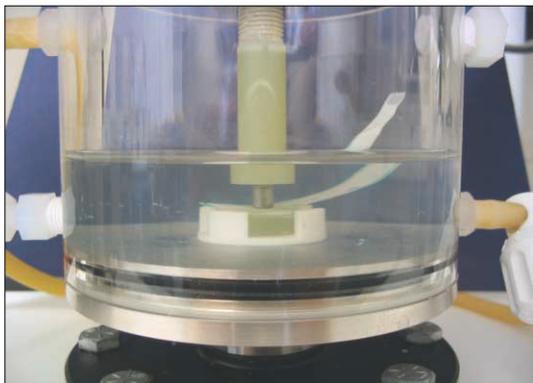
Fig. 4. Specimens were cyclically loaded in the wet environment.

Specimens were set in the water chamber and pre-loaded 10N compressive stress by Chewing simulator (Elf 3300, EnduraTEC Systems Co., MN, USA). Cyclic loadings were then delivered at a frequency of 15Hz using a haversine wave form (Fig. 4). Indenter was also made of G10 to avoid surface cracking with flat end, 3 mm diameter. The indenter but end of 1 mm, was reinforced by metal ring to prevent spreading out during cyclic loading. To avoid cone cracking by piston edge-loading, a 125 μm thick plastic tape was placed between the indenter and the ceramic surface. After

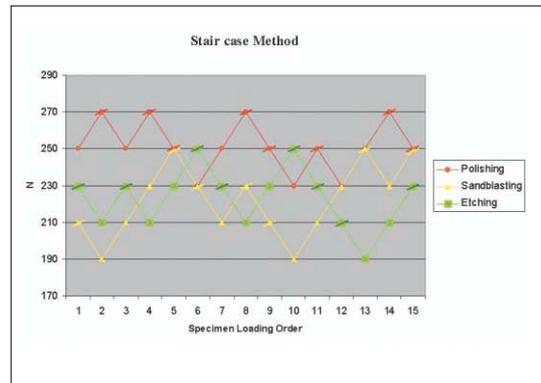
Fig. 5. Diagram illustrating the results of three groups. Fractured specimens are indicated by an oblique line. Indications without line are run-out ones.

Subsequent failure or run-out of specimens of three groups were shown in Fig. 5. Cracks were all radial crack at the bonded interface and there was no Hertzian cone crack.

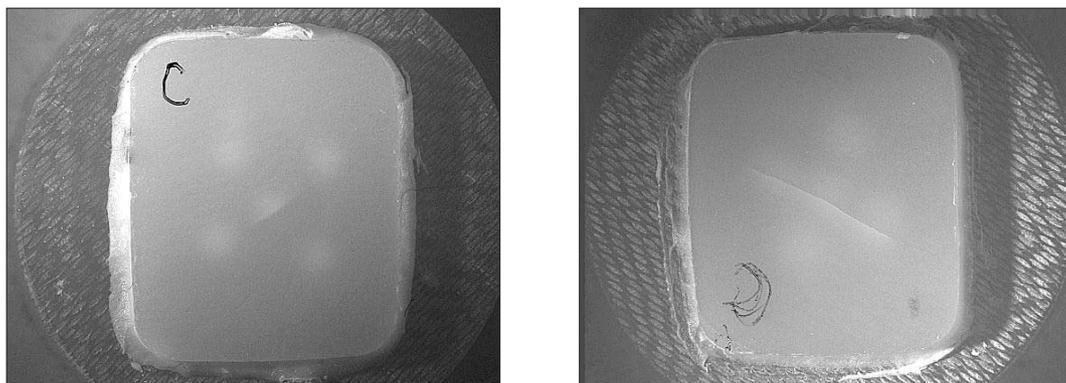
Fig. 6. Difference of crack length was demonstrated.

Of cracked specimens followed by cyclic loading, there were differences in the crack propagation after 24 hours. In contrast 7 of 8 for etched cracked specimens and 5 of 7 for sandblasted showed long crack, only 1 of 8 cracked specimens in the polished group showed long crack and rest of them was confined to the diameter of central micro-channel (Fig. 6).
