A Case Study on Engineering Failure Analysis of Link Chain

Objectives: The objective of this study was to investigate the effect of chain installation condition on stress distribution that could eventually cause disastrous failure from sudden deformation and geometric rupture.

Methods: Fractographic method used for the failed chain indicates that over-stress was considered as the root cause of failure. 3D modeling and finite element analysis for the chain, used in a crane hook, were performed with a three-dimensional interactive application program, CATIA, commercial finite element analysis and computational fluid dynamic software, ANSYS.

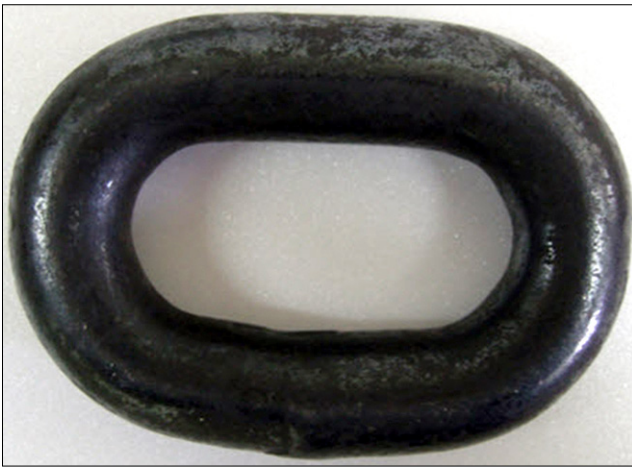
Fig. 1. Chain specimen of original crane chain.

In this study, 3-dimensional (3D) modeling and FE analysis were performed to identify the correct and incorrect installation procedures of link chain, and identify factors which could lead to disastrous failures from the incorrect installation. A chain (Fig. 1), consisting of consecutively connected metal rings, is usually used to crane heavy weight materials and hot parts in industry, due to its rigidity and strong resistance to heat and corrosion [3]. The results show that a method to reduce the rate of disasters could be identified by quantifying the effect of the worker's incorrect handling of the chain link procedure.

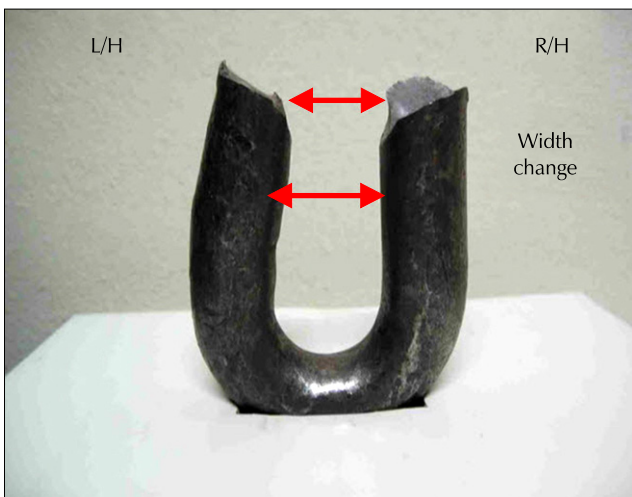
Fig. 2. Failed crane chain.

After failure of the crane chain occurred, a fractured chain was sent to a metallurgical laboratory to identify the failure mechanism and its root cause. As shown in Fig. 2, the width of the ruptured chain ring was shrunk by deformation when the chain failed, without retaining its original shape. The fracture surface which was formed at an angle of 30-45° to the primary load direction, clearly shows the shear fracture. In a macroscopic view, both fracture surfaces of the crane chain show a shear fracture (Fig. 3 L/H) and the cup and cone shape (Fig. 3 R/H), of which phenomena are considered as evidence of catastrophic failure due to improper overload. Especially, Fig. 3 L/H shows a shear fracture with crushed damage formed by the compressive load on the side of the chain. To analyze the fracture surfaces, each part was viewed with a scanning electron microscope. As shown in Fig. 4, the fracture surface having the shape of cup and cone as an enlarged area of Fig. 3 R/H shows the equiaxed dimples in the flat surface and the elongated dimples in the inclined region. Elongated or equiaxed dimples are observed inside the fracture surface. Fig. 4B and 5C show the step-like topographies indicating the fracture due to bending moment rather than uniaxial tension. Also, as shown in Fig. 4D, cleavage fracture surface is usually formed under high strain rate loading condition. Therefore, it is considered that the fracture of the crane chain was occurred under high strain rate bending moment rather than uniaxial tension instantaneously.

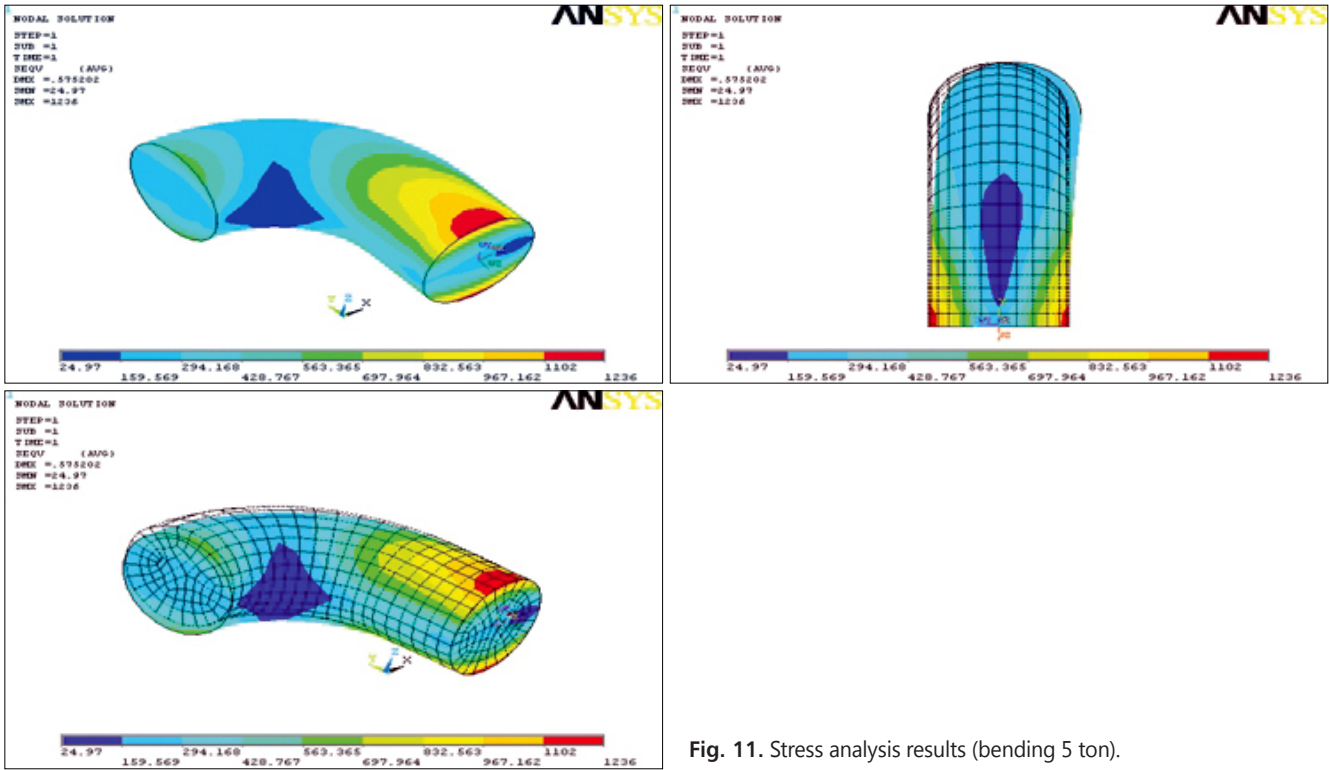
Fig. 11 shows the results of the ANSYS analysis when a bending load is applied. From the numerical analysis, the results show that the maximum Von-Mises stress is 455 MPa from ANSYS under axial tension. When the bending moment is applied, the stress is 1,236 MPa. Considering the case of

five tons of tensile load, the analysis result computed from FE analysis is approximately 460 MPa, which is lower than that of the yield strength of the material. On the contrary, when five tons of bending load is applied, the result amounts to approximately 1,180 MPa, nearly reaching the ultimate strength (1,204 MPa). Also the result shows that the stress magnitude occurred by a bending force is 2.5 times greater than that of a plain tensile load. From the results, we are sure that the magnitude of stress is heavily dependent on the stress state acting on the fracture surface.

Fig. 11. Stress analysis results (bending 5 ton).

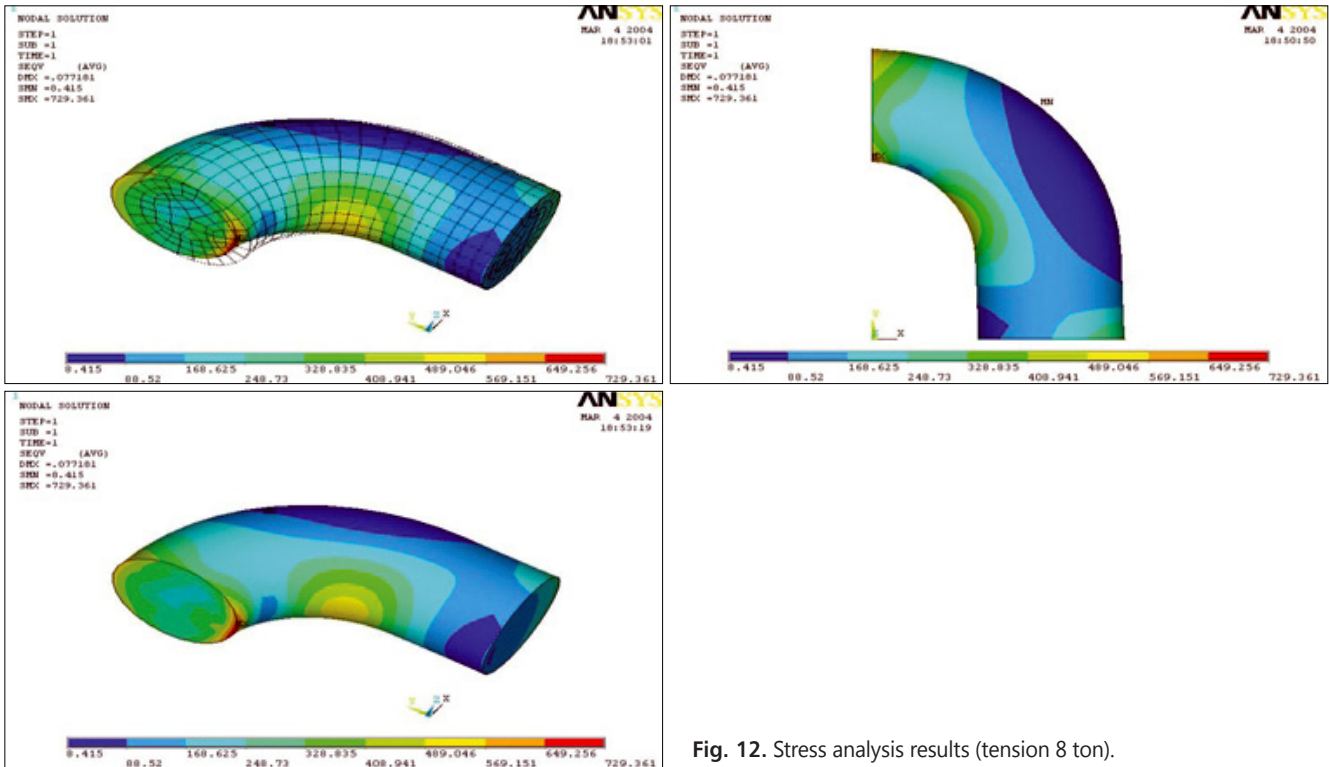
Fig. 12. Stress analysis results (tension 8 ton).

From the experimental simulations conducted with respect to various load cases, it was found that the chain can hold an ultimate load of about 8 tons when the tensile load acts on it as shown in Fig. 12. In this case, the maximum Von-Mises stress amounts to 729 MPa in ANSYS, which is slightly lower than that of the yield strength (805 MPa) of the material, AISI 8622 steel.
