실내 시공시 손상시험에 의한 HDPE 지오멤브레인의 기계적 특성 및 응력균열거동 해석

Analysis of Mechanical Properties and Stress Crack Behavior of HDPE Geomembranes by Laboratory Installation Damage Test

초록: 표면이 매끄럽고 돌기가 있는 2가지 HDPE 지오멤브레인 dumbbell 형 시료에 두께 10% 간격으로 10~90% 깊이의 노치를 가하여 시험에 사용하였다. ISO 10722에 의거하여 부가하중 횟수를 변화시켜 시공시 손상의 실내 모사시험을 HDPE 지오멤브레인에 실시하였으며, 부가하중 횟수가 시공시 손상에 미치는 영향을 비교하였다. 항복응력과 변형률은 노치 깊이가 커짐에 따라 감소하였다. 손상된 그리고 노치를 가한 지오멤브레인을 응력균열시험에 사용하였으며, 50±1 °C에서 pH 4와 12 용액에 침지시켜 항복응력 변화에 따른 응력균열저항성을 NCTL 시험을 통하여 고찰하였다. 인장 강도의 35% 이상에서 지오멤브레인은 응력균열에 취약함을 나타냈으며, 손상을 받은 그리고 노치를 가한 지오멤브레인 모두 같은 경향을 나타내었다. 특별히 노치를 가한 지오멤브레인의 경우 각각의 응력균열 시험조건에서 시공에 의해 손상된 지오멤브레인보다 낮은 강도를 나타내었다.

Abstract: Two smooth and textured surfaced HDPE geomembranes (GMs) were cut into dumbbell shape and notched where depth of the notch produced a ligament thickness of 10% to 90% of the nominal thickness with the specimen at 10% interval. A series of laboratory simulation test for installation damage were carried out at different loading cycles on HDPE GMs in accordance with ISO 10722 test method and the effect of number of loading cycle on installation damage was compared. It was found that yield stress and elongation at yield point de

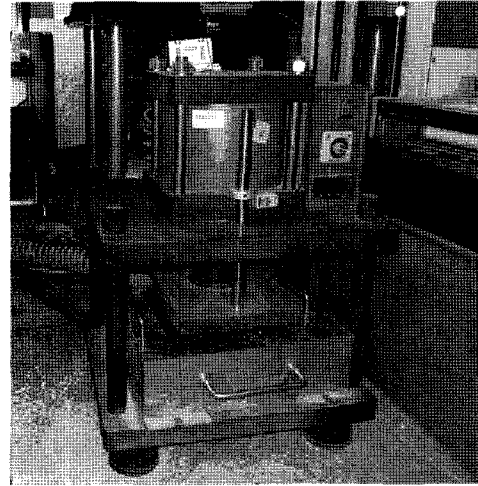
Figure 1. Laboratory installation damage test equipment.

Installation Damage. A hydraulic cyclic loading system with a maximum capacity of 80 kN and a maximum loading rate of 2.5 Hz was used in the present study (Figure 1). ISO

10722-1 was used as a guide. One steel rigid box of 350 mm long, 350 mm wide and 100 mm high was used to contain the fill material (soil) and GMs for the test.¹³ A steel loading plate of 300 mm long, 200 mm wide and 30 mm thick was placed at the center of the rigid box. Loading cycles were 200, 400, 600 and 800 with a loading frequency of 0.5 Hz.

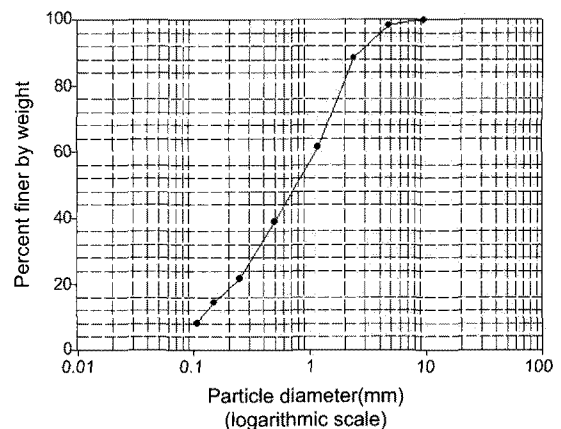
Figure 2. Grain size distribution.

Soil Particle Distribution. Figure 2 explains the soil particle distribution curve of soil used as fill material for installation damage of GMs.

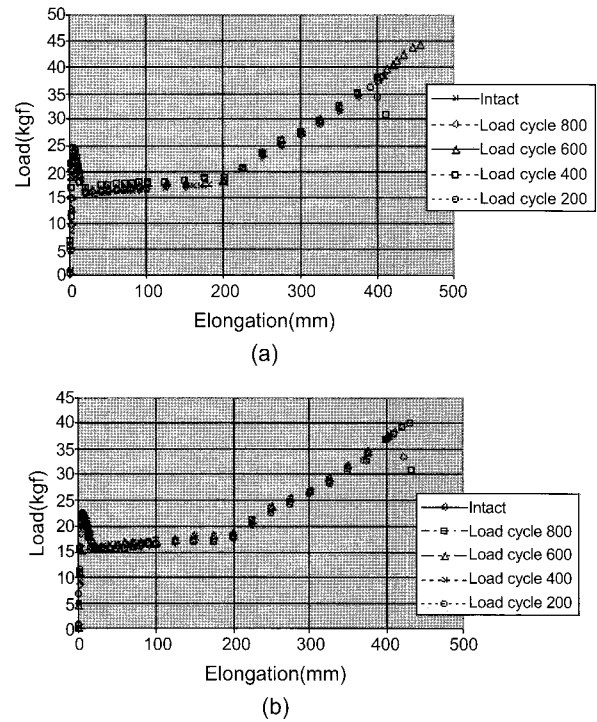
Figure 3. Tensile behavior of HDPE smooth GMs after installation at different loading cycle: (a) Machine direction (MD); (b) Cross machine direction (CMD).

Tensile Behavior: Figures 3 and 4 show the tensile behavior of HDPE GMs (smooth and textured) at both directions (MD and CMD) due to laboratory installation damage at different loading cycle (intact, 200, 400, 600, 800). The stress initially increases proportionally to elongation according to Hook's law before passing through a maximum known as the yield point. It provides to be extensively ductile up to the elongation of 11%. The samples failed at approximately 700% of strain. In Figure 4, some changes in tensile behavior of HDPE textured GMs are observed. However, significant changes are not observed for HDPE smooth surfaced GMs (Figure 3) which implies that either executed laboratory installation damage is unsuitable to investigate strength reduction damage for the GMs due to installation or error occurred during testing period. Various comparisons and

Yield strength and breaking strength of HDPE (smooth)

GMs increase significantly in machine direction and remain unchanged in cross machine direction with little fluctuations where breaking strength decreases. The reasons behind this attitude are unknown that suggests rechecking the process with intensive research. Contraction of plastic sheet due to load can be the reason for such increase. The same cause is applicable for other samples too. Yield strength and breaking strength of HDPE (textured) GMs declines in both directions with some fluctuations which implies that load causes reduction in tensile strength.

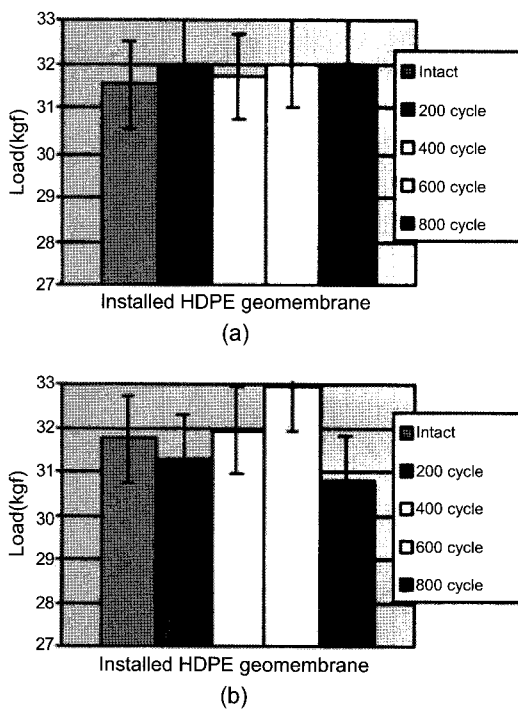
Figure 5. Comparison of tear resistance of HDPE smooth GMs at different loading cycles: (a) Machine direction (MD); (b) Cross machine direction (CMD).

Tear Resistance: HDPE smooth and textured GMs do not present any significant change in tear behavior. Figures 5 and 6 illustrate the comparison of tear resistance of HDPE smooth and textured GMs respectively using bar graphs. Tear resistance of HDPE (smooth) GMs remains almost same after installation damage in machine direction where it fluctuates in cross-machine direction. Tear resistance of HDPE (textured) GMs goes up more in machine direction than that of cross-machine direction at 800 cycle: MD: 6.6%; CMD: 0.5%.

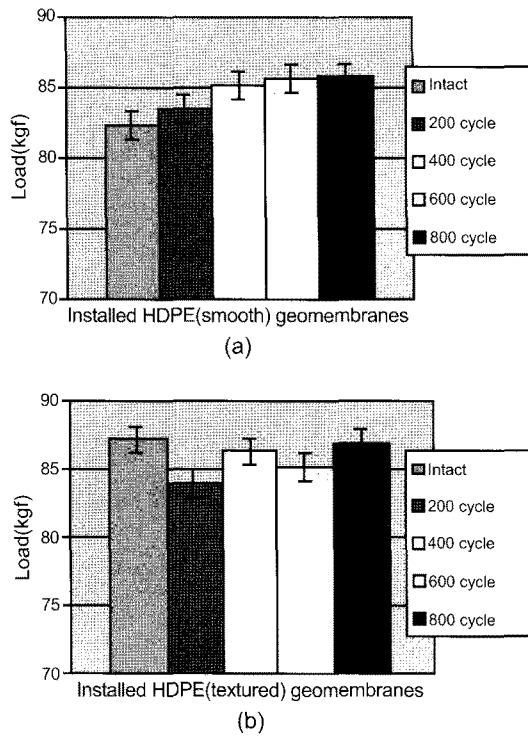
Figure 7. Comparison of puncture resistance of GMs at different loading cycles: (a) HDPE smooth GMs; (b) HDPE textured GMs.

tation of design loads, and required service lifetime.¹⁸ Figure 7 shows the puncture resistance of GMs at different loading cycle. Puncture resistance of HDPE (smooth) GMs gradually rise to 6.7% at 800 cycles where HDPE (textured) GMs show fluctuations in values rather than gradual upward or downward trend. However, due to laboratory installation damage puncture resistance has not decreased because of the type of soil used i.e. angularity of particles. On the other hand, in most cases, puncture resistance has increased because of compaction by load applied. Further investigation is required to elucidate the phenomenon. However, as an angularity of soil or installation medium is greatly important for the damage, highly angular sintered aluminum dioxide should have been used in this study. It is also important to keep in mind that GMs are viscoelastic in nature. This suggests that the failure pressure of these materials is a function of time. In this study, only pressure has been evaluated. The effect of time on the failure of GMs in the puncture mode has not been investigated. So, it is important to consider a creep related design for puncture resistance.

From this review, we cannot find the constant trend with compaction cycle for installation damage even though 10 samples were used for each SCR test. To explain this, it is only supposed that this fluctuation is uneven change in GM surface by compaction and more uneven surface change will be occurred by compaction increasing. Besides this, an-

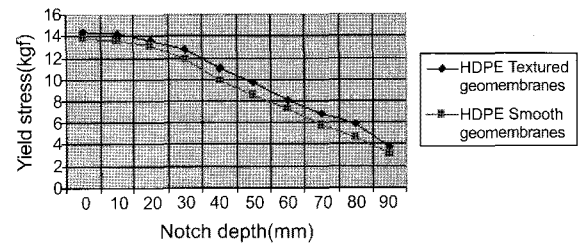
Figure 8. Yield strength of HDPE GMs at different notch depths.

Yield Stress and Yield Elongation at Different Notch Depth. Due to notch GMs lose strength like other materials. Yield stress and elongation at yield point decreased gradually as the notch depth was increased. Figure 8 states the notch percentage at 10% interval across the thickness of GMs and their yield stresses. It implies that yield stress depends on the thickness of materials if the width is constant. It doesn't show any major exceptions along the figure. It can be concluded that yield stress is proportional to the thickness of material at constant width without any significant difference. Rate of decrease in yield stress is almost constant after 20% depth of notch. Figure 9 shows the elongation at yield point of different thickness of GMs at constant width. Here, elongation at yield point of GMs is proportional to their thickness without substantial change at constant width.

tensile strength at different depth of notch, it can be concluded that yield stress is proportional to the thickness of material at constant width without any significant difference. In the stress cracking observation, it is understood that residual strength decreases as applied load increases. After data analysis, it seems that at 25% and 30% tensile load GMs can withstand more than one thousand hours without any significant damage whereas over 35% tensile load GMs become vulnerable to stress cracking where both damaged and

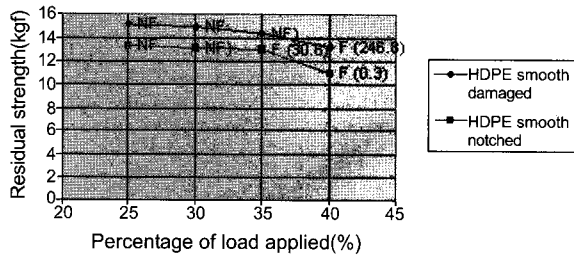
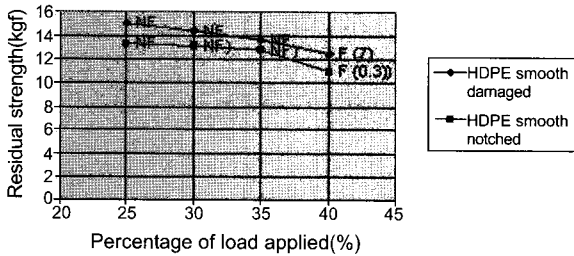
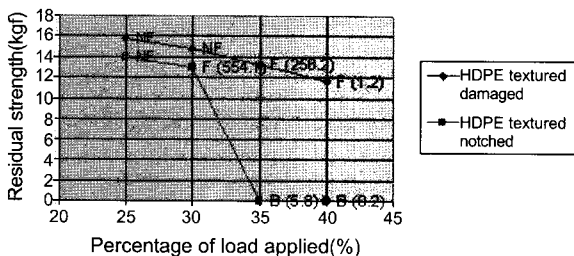
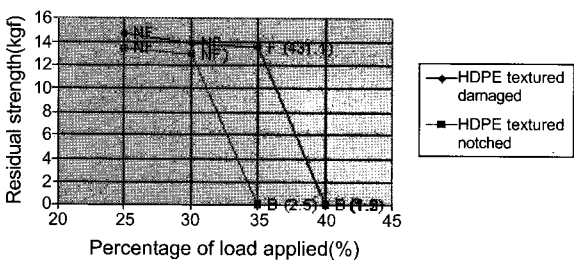
Stress Cracking Resistance (SCR). SCR of HDPE smooth and textured GMs were measured at pH 4 and pH 12 where ASTM D 5397-07 was used as a guide, respectively. Here, notched GM means intact samples with 20% notch of its thickness and damaged sample means laboratory installation damaged sample after 800 loading cycles without any further notch. In this SCR test, some samples failed and some of them didn't fail even after one thousand hours. However, from the obtained date, it seems that residual strength decreases

as applied load increases. After data analysis, it shows that at 25% and 30% tensile load GMs can withstand more than one thousand hours whereas over 35% tensile load GMs become vulnerable to SCR where both damaged and notched GMs follow the same trend. It is also observed that notched GMs possess less strength than installation damaged GMs at every stage. It clarifies that 20% notch is an overestimate to understand SCR due to installation damage of GMs. So, further intensive investigation considering all relevant factors is required. Figures 10, 11, 12 and 13 show the residual strength after stress cracking observation. Some symbols should be interpreted as NF=not failed after one thousand hours, $F(t)$ = failed (at time in hour) and $B(t)$ = broken (at time in hour).

Figure 10. Residual strength of HDPE smooth GMs(notched and damaged) after stress cracking observation at pH 4.

Figure 11. Residual strength of HDPE smooth GMs(notched and damaged) after stress cracking observation at pH 12.

Figure 12. Residual strength of HDPE textured GMs(notched and damaged) after stress cracking observation at pH 4.

Figure 13. Residual strength of HDPE textured GMs(notched and damaged) after stress cracking observation at pH 12.

notched GMs follow the same trend. It is also observed that notched GMs possess less strength than installation damaged GMs at every stage. It clarifies that 20% notch is an overestimate to understand SCR due to installation damage of GMs that requires further intensive investigation considering all relevant factors. Through more intensive research is needed to find out acceptable correlation between changes in mechanical properties and laboratory installation damage along with the field installation. Finally, it is suggested that 20% notch is an overestimate to understand SCR due to installation damage of GMs.
