Cone beam computed tomography findings of ectopic mandibular third molar in the mandibular condyle: report of a case

ABSTRACT

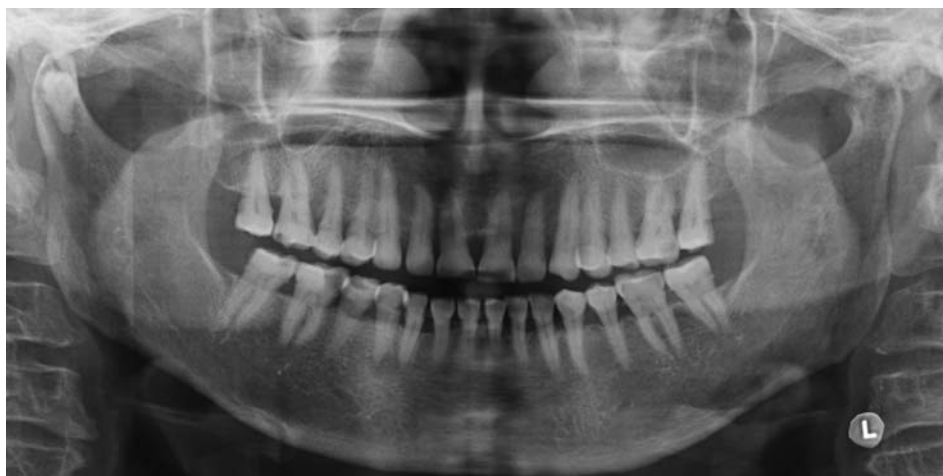
Fig. 1. Panoramic radiograph shows the impacted tooth in the right mandibular condylar head.

A 70-years-old woman visited the department with a complaint of discomfort on the left preauricular area during mastication and mouth opening, which had occurred 3 or 4 months before. On the clinical examination there was tenderness on the left preauricular area without any specific findings. Panoramic radiograph showed generalized alveolar bone destruction and calculus deposition. All the teeth showed moderate attrition. Additionally, a well-formed, impacted tooth was found in the right condylar head of the mandible. The tooth crown seemed to direct into the head of the condyle (Fig. 1).

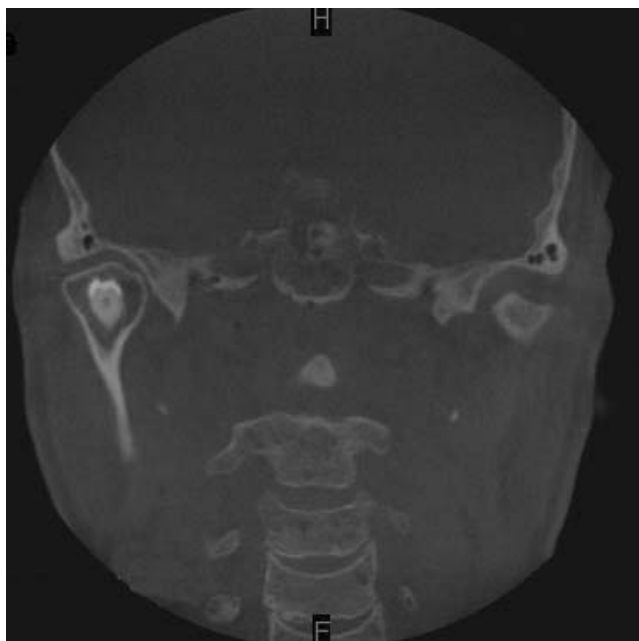
Fig. 2. Coronal CBCT image shows the upward crown position of the impacted tooth. There is no cystic change around impacted tooth.

Cone beam CT scans were performed to evaluate the position and direction of the impacted tooth in the mandibular condyle. Coronal image showed the upward crown position of the impacted tooth (Fig. 2). There was no pathologic sign such as cystic change around the impacted tooth. On the axial image, an impacted tooth was found in close proximity to the front cortical bone and in the middle portion of the mandibular condyle (Fig. 3). Sagittal image

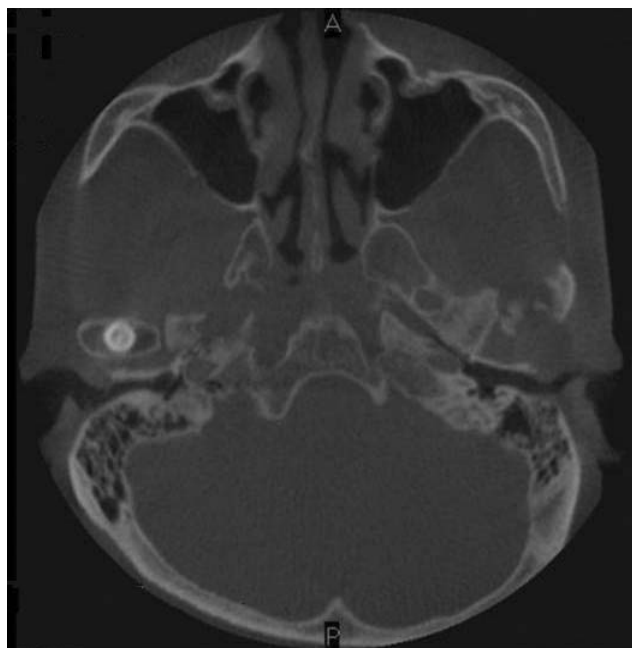
Fig. 3. Axial CBCT image shows the impacted tooth with the proximity to the front cortical bone and middle portion of the mandibular condyle.

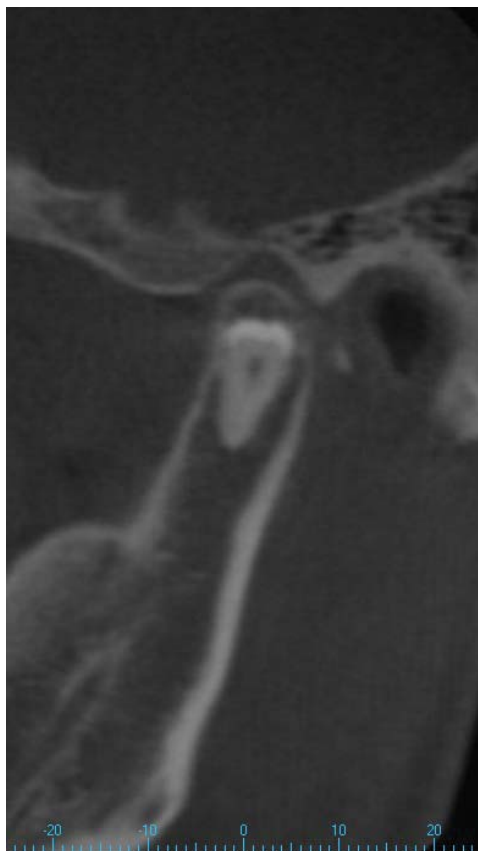
Fig. 4. Sagittal CBCT image shows the fully developed impacted tooth with the proximity to the outer cortical bone of the mandible.

showed a well developed impacted tooth with proximity to the outer cortical bone of the mandibular condyle (Fig. 4). The follicular space and lamina dura of the tooth were not distinguished. On the frontal view of 3D volumetric image, the crown of the impacted tooth was partially covered with bone (Fig. 5).

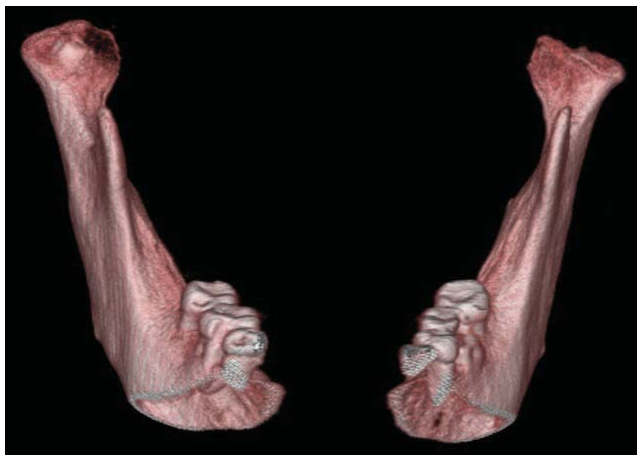
Fig. 5. Frontal view of 3-dimensional volumetric CBCT image shows the crown of the impacted tooth partially covered with bone.
