Analysis Report of the Elapse for Costa Concordia's Disaster

코스타 콘코디아 재난 경과 분석 보고서

Abstract : On January 13th 2012 Italian flag Costa Concordia was partly sunk. The ship was carrying 4,252 passengers and crew; in the next few days the bodies of 30 people were found. Two are still missing. Two South Korean passengers and an Italian crew member was rescued from the ship on January 15th, more than 24 hours after the accident. As of June 18th 2012 (The date of presentation) around 32 people had not been accounted for. In this paper, it is viewed and pointed out the cause, problem, and implication for the future. As a result, intelligent innovative evacuation system for the VLPS (Very Large Passenger Ship) should be set up in terms of international maritime safety.

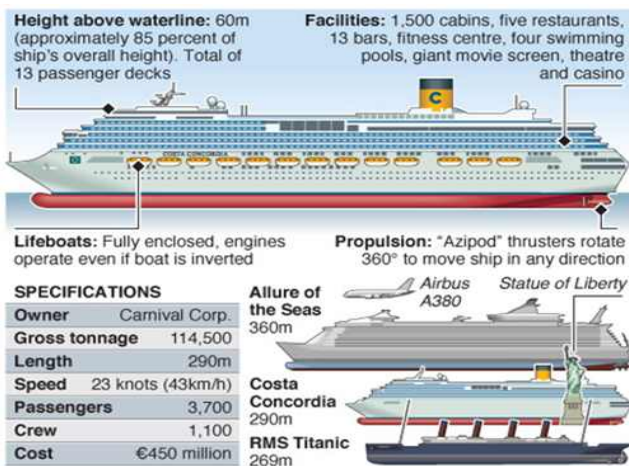
Fig. 1. Characteristics of Costa Concordia(BBC News, 2012b).

The largest Italian cruise ship ever conceived, Costa Concordia was ordered on 19 January 2004 by Carnival Corporation in Fincantieri and built in the Sestri Ponente yard in Genoa, as yard number 6122. At the vessel's launch at Sestri Ponente on September 2nd 2005, the champagne bottle, released by model Eva Herzigová failed to break, within an inauspicious omen in maritime superstition. The ship was delivered to Costa on June 30th 2006. She cost US\$570 million to build(BBC news, 2012b). Costa Concordia is 290.20 metres long, with a beam of 35.50 metres and a draught of 8.20 metres. She is equipped with a diesel-electric propulsion with six 12-cylinder Wärtsilä 12V46C four-stroke medium-speed diesel generating sets with a combined output of 75.6 megawatts (101,400 hp) and two 21 megawatt electric motors connected to fixed-pitch propellers. Her service speed is 19.6 knots(Trade Winds, 2012), but during sea trials she achieved a speed of 23 knots. In Fig. 1, vital statistics of the ship included as Gross Tonnage 114,500 tonnes, Length: 290.2m, Beam: 35.5m, Draught: 8.2m, Decks: 17, Speed: max 23knots, Capacity 3780 passengers, Crew: 1,100. The Costa Concordia was the flagship of Costa Cruises. Costa Cruises is an Italian cruise line based in Genoa in Italy(Pianigiani, 2012).

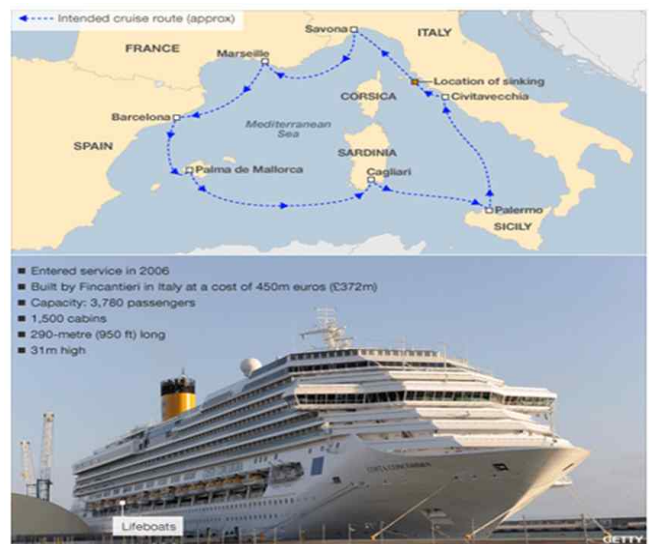
Fig. 2. Track and Service of the cruise(Lloyd's List, 2012).

The name Concordia was intended to express the wish for "continuing harmony, unity, and peace between European nations." She was launched at Sestri Ponente on September 2nd 2005 and at the time of her construction was the largest Italian cruise ship ever built. In Fig. 2, she was delivered to Costa on June 30th 2006.

Costa Concordia did a weekly cruise in the Western Mediterranean visiting Civitavecchia, Savona, Marseille, Barcelona, Palma, Tunis, and Palermo.

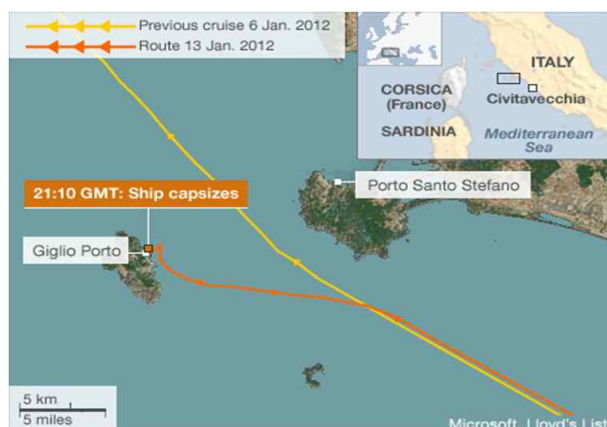
In Fig. 3, there are two courses that the cruise vessel sailed on January 6th 2012 in Yellow (or Forward Track) and January 13th 2012 in Red (or Left side).

Fig. 3. Comparative Course between Normal(Yellow) and Accident(Red)(Lloyd's List, 2012).

On her weekly cruise the Costa Concordia normally passed between the small island of Giglio and the mainland (sailing closer to the mainland shore) at midway up the west coast of Italy - a channel that is 7.5 miles wide. Just less than 2 hours into the voyage some 30 miles from Civitavecchia the Costa Concordia changed course to head for the island of Giglio(Lloyd's List, 2012).

There are much speculations as to why this change of course was away from the normal track - midway between the island and the mainland. The most likely cause is that the captain decided to sail closer to the island to salute some friends and to afford the passengers the wonderful view of this beautiful island and its little port. The La Stampa newspaper published a letter from August 2011 in which Porto Giglio's mayor Sergio Ortelli thanked the Concordia's captain for the "incredible spectacle" of a previous close pass.

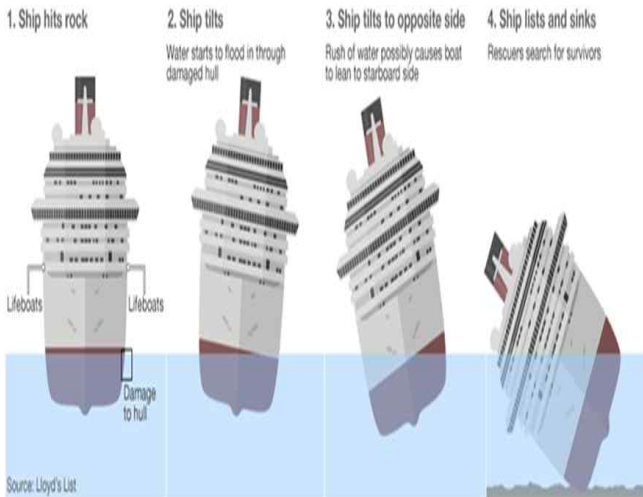
Fig. 5 shows the cruise after hitting rock at port side. Water starts to flood in through damaged hull. Rush of water possibly causes the cruise to lean starboard side(Lloyd's List, 2012). An investigation was opened into the accident. Dutch salvage experts were called in to assess options for removing the ship, with 2,380 tons of fuel needing to be removed first, in order to prevent or mitigate an oil spill. Dutch company Smit International is responsible for removing the fuel, and offered to perform the

Fig. 5. Ship Lists and Sinks(Lloyd's List, 2012).

salvage operation. Carnival expects the ship to be out of service for the remainder of the cruising season. According to the report of Credit Suisse, "Given the extensive damage reported, it appears possible that the ship is a constructive total loss."
