Indirect Detection of Internal Defects in Wooden Rafter with Ultrasound^{*1}

Sang-Joon Lee^{*1}, Sangdae Lee^{*2}, Sung-Jun Pang^{*3}, Chul-Ki Kim^{*3},
Kwang-Mo Kim^{*1}, Ki-Bok Kim^{*4}, and Jun-Jae Lee^{*3}

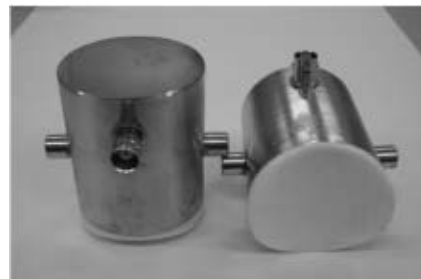
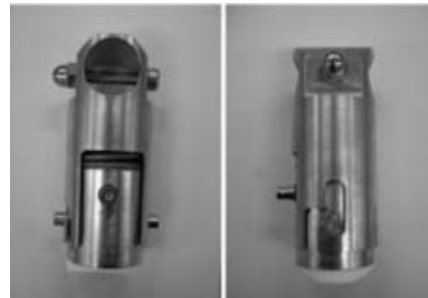
(a) Ultrasonic transducer

(b) Transducer with holder

Fig. 2. Ultrasonic transducers used for this study.

Ultrasonic measurement setup with indirect method was developed for prediction of internal deterioration of wooden rafter (Lee *et al.*, 2011). Sensor apparatus consisted with ultrasonic transducer of 100 kHz central frequency, 40 mm in diameter and holder with spring-zig (Fig. 2). Contact pressure between transducer and test material which derived by inserted coil spring (50 mm diameter, 50 mm height) can be uniformly maintained for considering energy value of received ultrasonic signal.

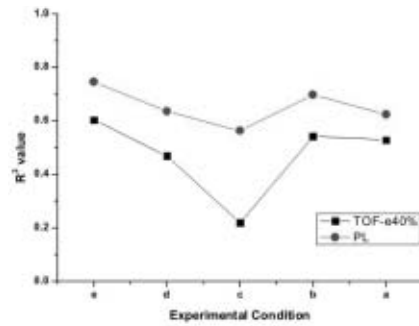
(a) Larch

(b) Rigid

Fig. 10. Coefficients of determination values of TOF-e40% and PL of five experimental conditions for wood.

Different propagation phenomena of ultrasound on wood seems to be cause of this different results. So ultrasonic parameters were checked again to find appropriate parameters which can be applied for detection of artificial slit and hence TOF-e40% and PL (pulse length) showed relatively

high coefficient of determination (Fig. 10).
