# Characteristics of Insulation Diagnosis and Failure in Gas Turbine Generator Stator Windings

**Abstract** – In order to evaluate the insulation deterioration in the stator windings of five gas turbine generators (137 MVA, 13.8 kV) which has been operated for more than 13 years, diagnostic test and AC dielectric breakdown test were performed at phases A, B and C. These tests included measurements of AC current, dissipation factor, partial discharge (PD) magnitude and capacitance.  $\Delta I$  and  $\Delta \tan \delta$  in all three phases (A, B and C) of No. 1 generator stator windings showed that they were in good condition but PD magnitude indicated marginally serviceable and bad level to the insulation condition. Overall analysis of the results suggested that the generator stator windings were indicated serious insulation deterioration and patterns of the PD in all three phases were analyzed to be internal, slot and spark discharges. After the diagnostic test, an AC overvoltage test was performed by gradually increasing the voltage applied to the generator stator windings until electrical insulation failure occurred, in order to determine the breakdown voltage. The breakdown v

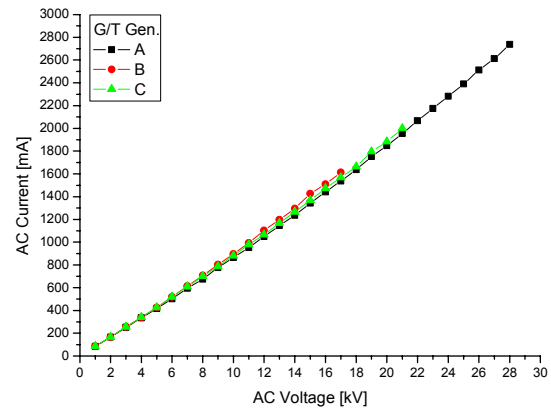
The PI will also tend to be high, in the range of 6.32 to 7.18 as shown in Table 1. The PI (above 2.0) of generator indicated that the stator windings are suitable for overvoltage testing [6]. Fig. 1 shows the change in current where the three phases encapsulated AC voltage was gradually increased in No. 1 generator until insulation breakdown occurred. As can be seen from Fig. 1, there are two turning points ( $P_{i1}$ ,  $P_{i2}$ ) where AC current soared suddenly. As summarized in Table 1,  $\Delta I$  at 13.8 kV ranged among 6.48%, 9.51%, and 6.71%, respectively. The  $\Delta I$  of below 12% in a 13.8 kV generator is usually considered to indicate healthy insulation [7]; however, generator was determined to be in good condition because their  $\Delta I$  was low with values between 6.48% and 9.51% at 13.8 kV.

The  $P_{i1}$  voltage in phases A, B, and C of generator was 4.8 kV, 3.0 kV and 4.0 kV, respectively, and their  $P_{i2}$  voltage were 10.2 kV, 6.1 kV, and 9.3 kV, respectively. As the shown in Fig. 1, the AC current vs. voltage traces for generator was almost linear. These results indicate that the

**Fig. 1.** Comparison of AC current vs. voltage characteristics in No. 1 generator

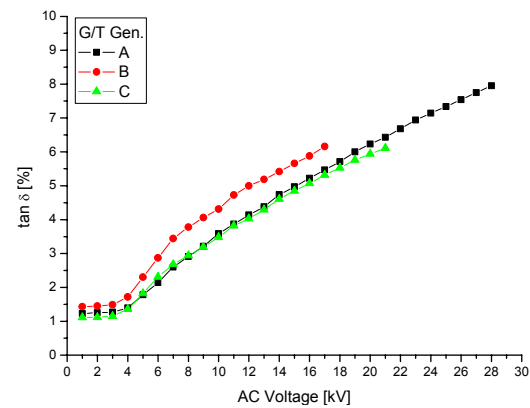
**Fig. 2.** Comparison of  $\tan \delta$  vs. voltage characteristics in No. 1 generator

The change in the dissipation factor while AC voltage applied to the stator winding was gradually increased until it reached the breakdown voltage, as shown in Fig. 2. The  $\Delta \tan \delta$  had to be calculated based on the data from a 13.8 kV generator. As it can be seen from Fig. 2, the dissipation factor increased abruptly about 3 kV. As summarized in Table 2,  $\Delta \tan \delta$  in phases A, B, and C of No. 1 generator were 3.33%, 4.02% and 3.28%, respectively. According to [7],  $\Delta \tan \delta$  above 6.5% is considered to indicate bad insulation condition. Therefore, the insulation condition of the stator winding for all three phases of generator was assessed to be in good condition because their  $\Delta \tan \delta$  values were below 4.02% at 13.8 kV.

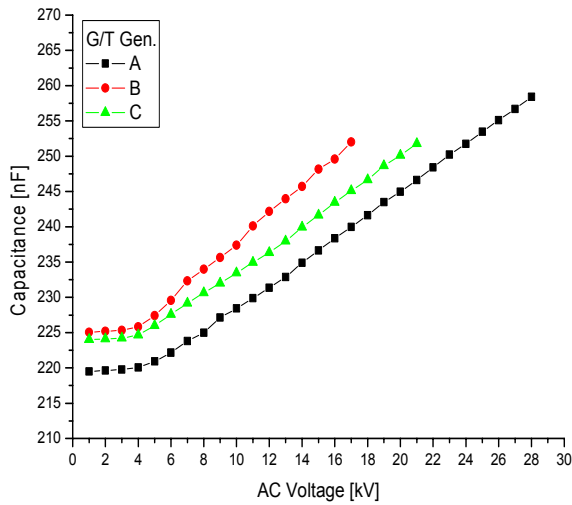
**Fig. 3.** Comparison of capacitance vs. voltage characteristics in No. 1 generator

The capacitances measured as a function of applied voltage (up to 28.0 kV) in three phases of generator stator windings is shown in Fig. 3. The  $\Delta C$  had to be calculated based on the data from a generator. As it can be seen from Fig. 3, the capacitances increased abruptly about 4 kV. As summarized in Table 2,  $\Delta C$  measurements in phases A, B, and C of No. 1 generator were among 6.51%, 8.91% and 6.65%, respectively. The values of the capacitance and dissipation factor in three phases A, B, and C of generator increased abruptly at 4 kV and 3 kV test voltages, as shown in Figs. 2 and 3.

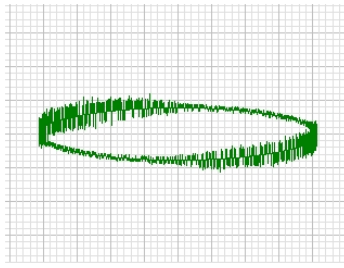
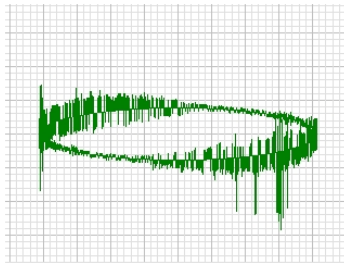
The PD magnitudes of positive ( $0^\circ \sim 180^\circ$ ) and negative ( $180^\circ \sim 360^\circ$ ) polarity in phase B of the No. 1 generator stator windings are shown in Fig. 4, when AC voltage was applied at 8 kV (the line-to-ground voltage) and 10kV. Given that the PD magnitudes of positive ( $0^\circ \sim 90^\circ$ ) and negative ( $180^\circ \sim 270^\circ$ ) polarity are symmetrically similar in Fig. 4(a), the PD pattern in phases A, C was attributed to internal discharge [8]. Internal discharge occurs in the voids created inside the groundwall insulation materials after a long period of operation. It accounts for almost 70% of PD patterns in generators or high-voltage motors. The negative polarity predominance normally indicates slot discharge, as illustrated in Fig. 4(b). This discharge generates in the air gap, between the magnetic core and the side of stator bars [11]. As described above, the PD pattern

Discharge = 60,200 pC  
(a) Voltage = 8 kV

Discharge = 141,000 pC  
(b) Voltage = 10 kV

**Fig. 4.** PD magnitude of No. 1 generator stator windings

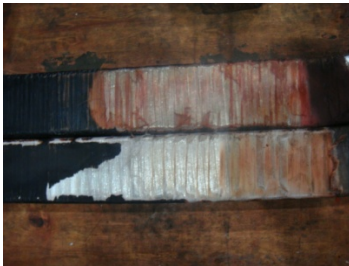
(c) Removal of semiconductive tapes

was presented internal discharge at 8 kV in phase B. And the PD pattern changed slot and spark discharges at 10 kV the increase with the voltage. The semiconductive tape on one side of the bar was abraded away in phase B, as illustrated in Fig. 4(c). As a result of bar vibration, the erosion of the coating will leave bare insulation at high voltage facing the metallic grounded core [8].

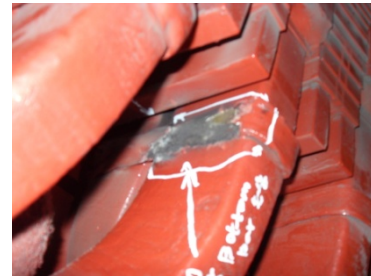
Fig. 5 shows the surface erosion at the bar end of the phase B in No. 1 generator stator windings. The presence of discharges at the bar ends causes progressive degradation of the semiconducting and voltage grading paint surfaces [12]. The semiconducting and voltage grading paints are used to suppress surface discharge in the slot portion of the winding [11]. Consequently, when the phase B of No. 1 generator was dielectric breakdown, spark discharge occurs at the bar ends and grading paint surfaces as shown in Fig. 4(b). This discharge is presented in pulses between positive ( $0^\circ$ ) and negative ( $360^\circ$ ) polarity.

**Fig. 5.** Bar end erosion in No. 1 generator stator windings
