## Cause of Fuel Leakage from the Inner Piston Packing of Afterburner Fuel Pump in an Aircraft J85-GE-21 Turbojet Engine

Ik-Sik Kim<sup>†</sup>, Young-Ha Hwang, Kyung-Suk Sohn, Jung-Hun Lee, and Sung-Uk Kim  
Aero Technology Research Institute, P.O. Box 304-150, 352 Ayang-ro, Dong-gu, Daegu, Korea  
(Received October 24, 2014, Revised November 17, 2014, Accepted November 20, 2014)

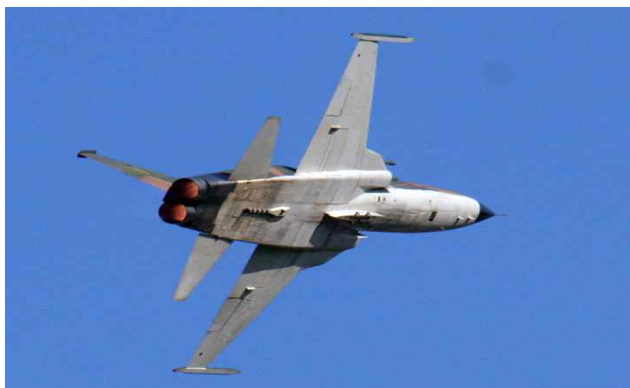
**Figure 1.** Afterburning for supersonic flight of F-5 aircraft.

An afterburner is an additional component present on some jet engines, mostly military supersonic aircraft. It is an extended exhaust section containing extra fuel injectors and is a simple type of ramjet because the jet engine upstream before the turbine uses little of the oxygen it ingests. When it is turned on, fuel is injected through afterburner fuel pump and igniters are fired. It does produce remarkably enhanced thrust as well as a very large flame at the back of the engine. Its purpose is to provide an increase in thrust, usually for supersonic flight, takeoff, and combat situations. Figure 1 shows afterburning

for supersonic flight of F-5 aircraft. This exhaust flame may show "shock diamonds", which are caused by shock waves formed due to slight differences between ambient pressure and the exhaust pressure. These unbalances cause oscillations in the exhaust jet diameter over distance and cause the visible banding where the pressure and temperature is highest.

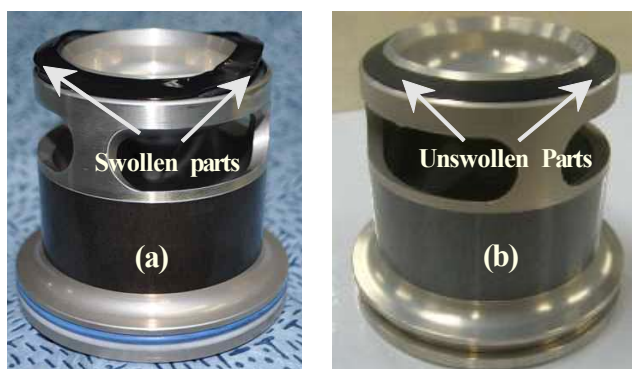
**Figure 3.** Swelling of (a) the failed and (b) the unfailed packing rubber parts in JP-8 fuel.

Figure 3 shows swelling of the failed packing rubber (a) and unfailed packing rubber (b) in JP-8 fuel, respectively. Swelling indicates the ability of rubber to absorb fuel. As swel-

ling increases, the fuel resistance decreases.<sup>6</sup> The results showed that the failed packing rubber (a) was swollen in some parts but the unfailed packing rubber (b) was not swollen at all.
