Assessment of vertical root fracture using cone-beam computed tomography

Purpose: The aim of this study was to investigate the accuracy of cone-beam computed tomography (CBCT) in the diagnosis of vertical root fractures in a tooth with gutta-percha and prefabricated posts.

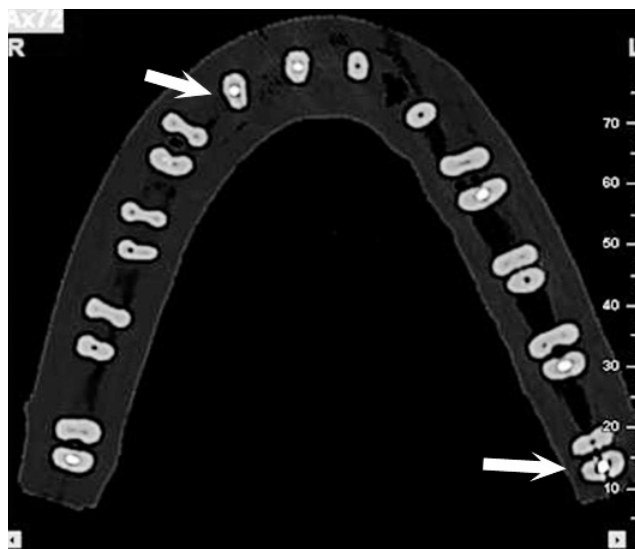
Fig. 1. An axial CBCT image shows the molar and premolar teeth with vertical root fracture.

CBCT scans were obtained using the denture scan mode of a Newton 5G system (QR s.r.l., Verona, Italy) set at 110 kV. Axial and multi-planar reformation (MRP) images were evaluated by using NNT viewer software version 3.0 (QR s.r.l., Verona, Italy). In this study, the slice thickness was 0.3 mm and the interval space was 0.3 mm. All of the obtained scans were examined by three oral and maxillofacial radiologists in the axial (Fig. 1) and MPR planes (Fig. 2) in a low-light room by using a Flatron 18.5-inch monitor (LG, Seoul, Korea). The observers were free to choose the magnification degree. All of the teeth were examined for the presence or absence of a vertical root fracture.

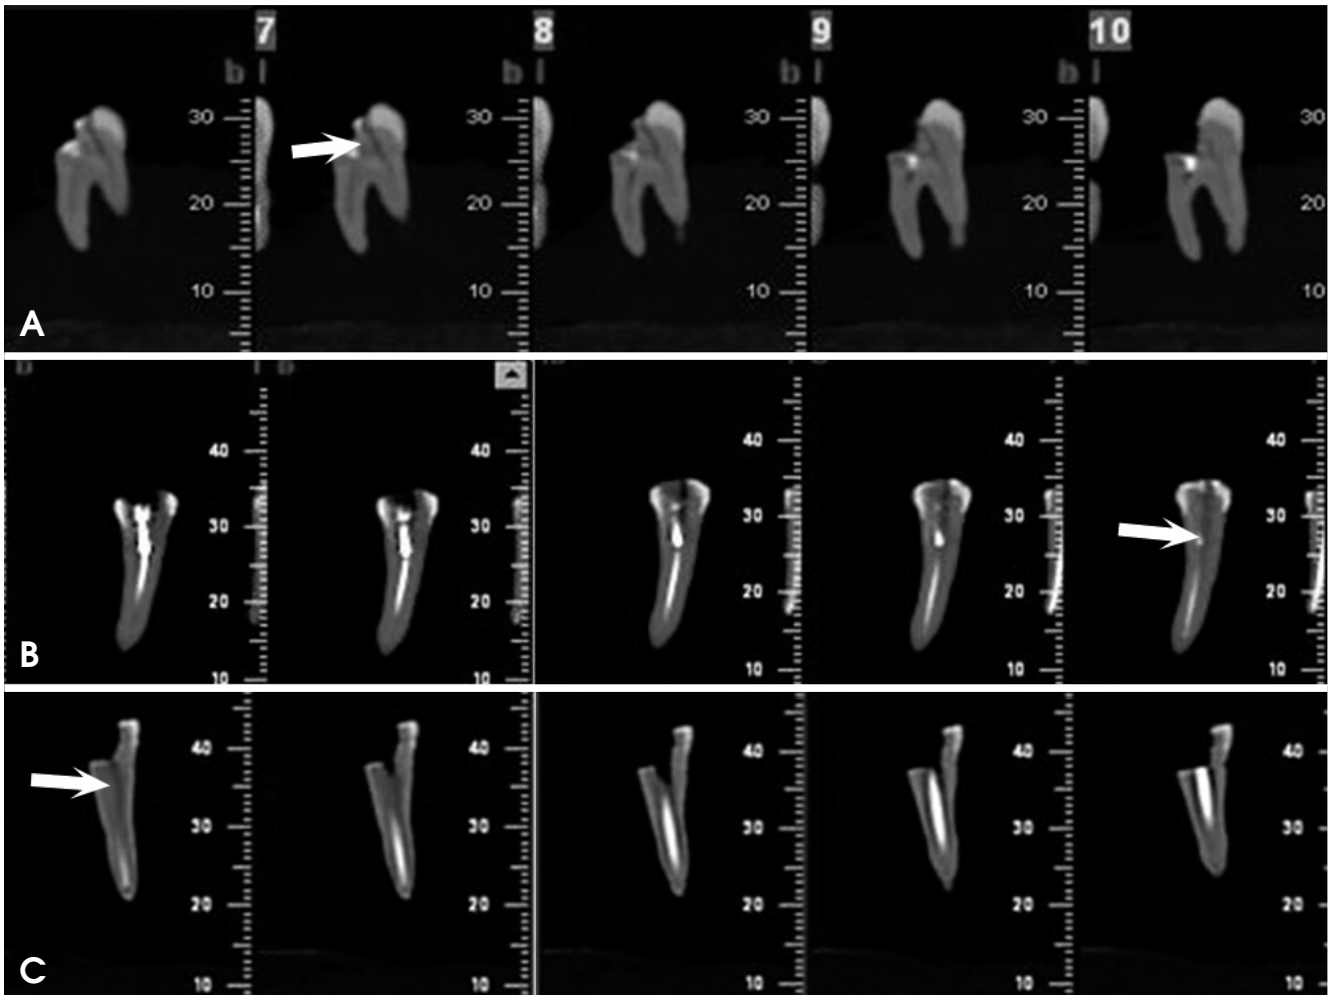
Fig. 2. Cross sectional images of molar and premolar teeth with vertical root fracture. A. A molar tooth with vertical root fracture. B. A premolar tooth with prefabricated post and gutta-percha has vertical root fracture. C. A premolar tooth with gutta-percha shows vertical root fracture.
