## Effect of titanium and stainless steel posts in detection of vertical root fractures using NewTom VG cone beam computed tomography system

**Purpose:** Vertical root fracture (VRF) is a common complication in endodontically treated teeth. Considering the poor prognosis of VRF, a reliable and valid detection method is necessary. Cone beam computed tomography (CBCT) has been reported to be a reliable tool for the detection of VRF; however, the presence of metallic intracanal posts can decrease the diagnostic values of CBCT systems. This study evaluated and compared the effects of intracanal stainless steel or titanium posts on the sensitivity, specificity, and accuracy of VRF detection using a NewTom VG CBCT system.

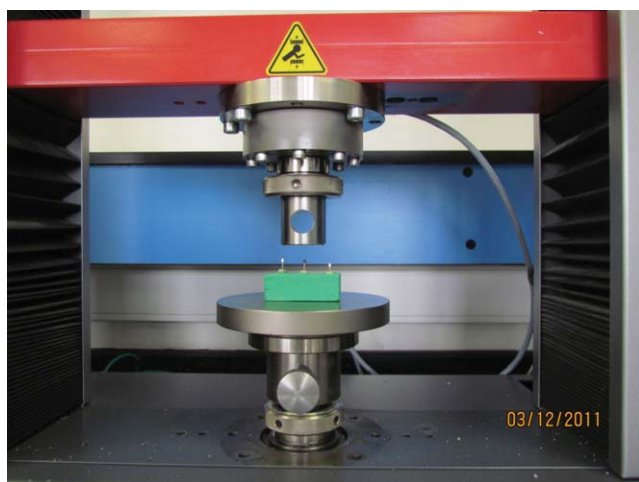
**Fig. 1.** Root fracture is induced using an Instron testing machine.

root fracture occurred (Fig. 1). The amount of force required for the root fracture was recorded in newtons (range: 200-300 N). The moment of fracture was determined by a sudden drop in force on the post in the Instron machine diagram (Fig. 2). In order to confirm the fracture, the teeth were extracted from the acrylic block and stained with 1% methylene blue (Aldon Corporation, Avon, New York, USA). If the fractured segments became separated from the root in a sample, the tooth was excluded from the study. In total, 80 teeth were included in the study, of which 40 teeth contained a fracture and 40 had no fracture.

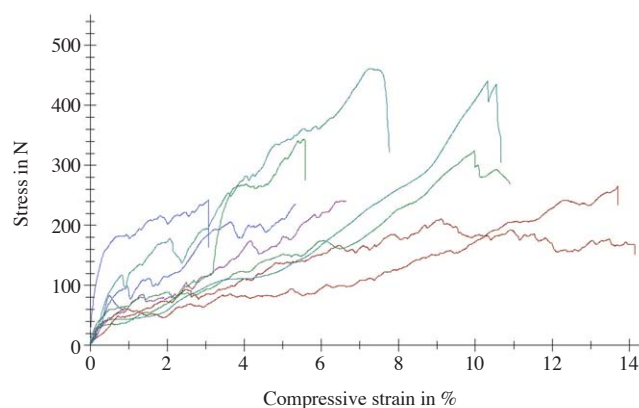
**Fig. 2.** The amount of force required for a root fracture is shown by a sudden drop of force in the Instron machine diagram.

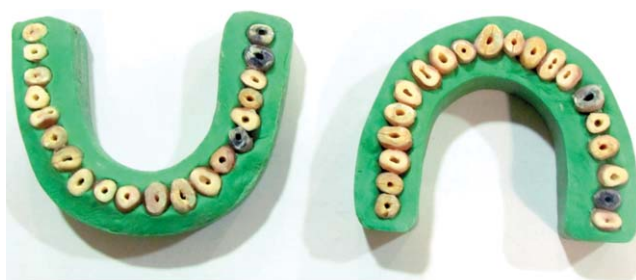
**Fig. 3.** Teeth are randomly mounted on a horseshoe acrylic structure.

The teeth were then randomly mounted on four acrylic casts (20 in each cast), simulating the human mandible (Fig. 3). The acrylic casts (Technovit 4000, Heraeus Kulzer, Wehrheim, Germany) were fixed in a horseshoe shape at a height of 3 cm and width of 2 cm, and with 0.5 cm of acrylic around each root. All four casts were scanned with the NewTom CBCT system (NewTom VG, Quantitative Radiology, Verona, Italy) three times (field of view (FOV): 8 cm × 12 cm, 110 kVp, 13.8 mA, 18 s, voxel size: 0.15 mm). The first scan was completed without posts (NP condition), the second was completed with titanium posts

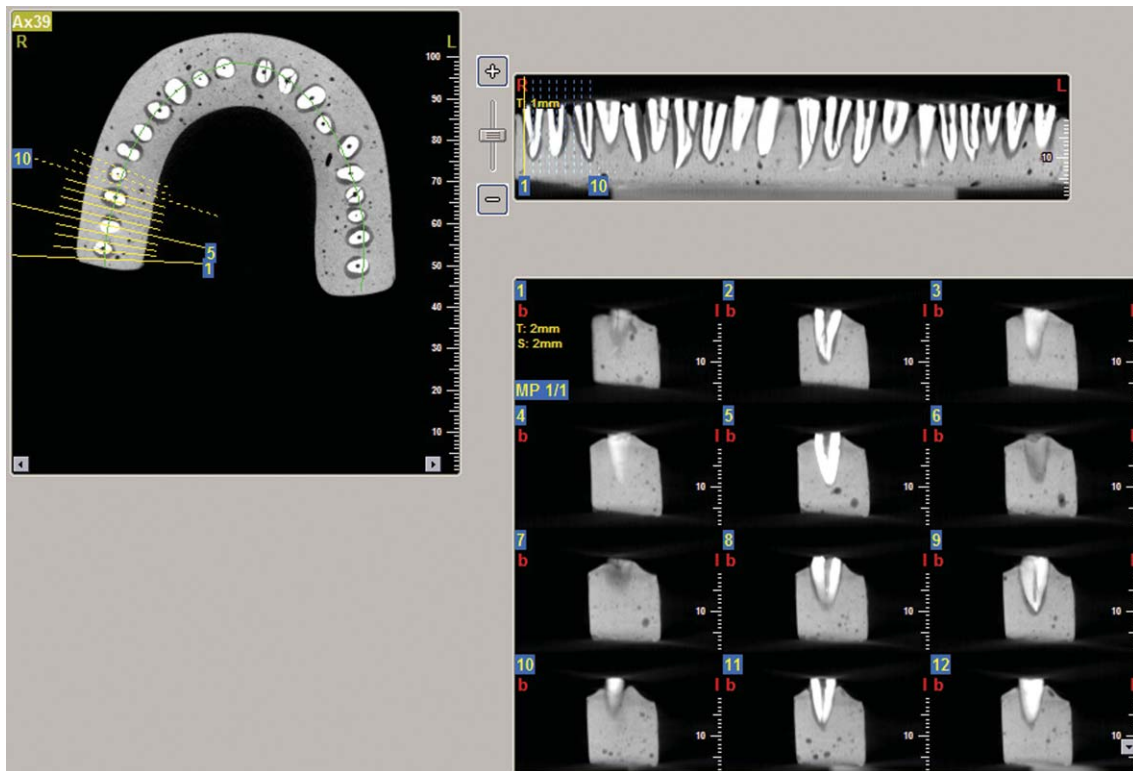
**Fig. 4.** Representative image of one of the samples as produced by cone-beam computed tomography.

(AZtec Anchor 10.5 mm, Dentatus, New York, USA; TP condition), and the third with stainless steel posts (Classic Surtex 10.5 mm, Dentatus, New York, USA; SSP condition) (Fig. 4).
