An esthetic appliance for the management of crown-root fracture: a case report

Orthodontic extrusion is usually performed by means of a fixed orthodontic appliance that utilizes arch wire attached to adjacent teeth and transfers the desired force by elastic from the wire to the root. However, clinicians often encounter cases where the bonding required for tooth traction is not possible because the adjacent teeth have been restored with ceramic or veneer. The purpose of this case report is to describe a modified orthodontic extrusion appliance that is useful when conventional orthodontic treatment is not possible. The modified appliance was fabricated using an artificial tooth, clear plastic sheeting, and a braided fiber-reinforced composite strip that covered adjacent teeth without bonding. It satisfied the esthetic and functional needs of the patient and established the optimal biologic width. (*Restor Dent Endod* 2014;39(3):226-229)

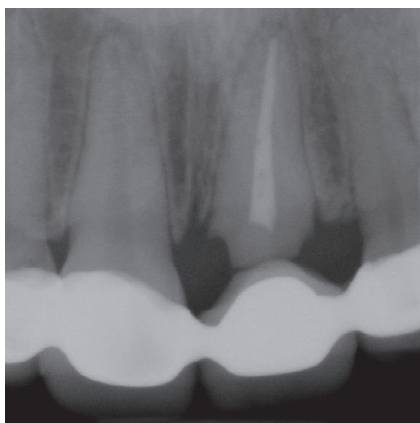
Figure 1. Periapical radiograph of the left central incisor.

A 20-year-old woman presented to the Department of Advanced General Dentistry, Yonsei University, with chronic gingival swelling and bleeding on the left central incisor. A periapical radiograph of the left central incisor showed the level of tooth structure was approximately equal to the osseous crest and so was insufficient for restoration without invasion of the biologic width (Figure 1). Orthodontic forced eruption followed by single ceramic restoration treatment was determined on the basis of esthetic and economic considerations.

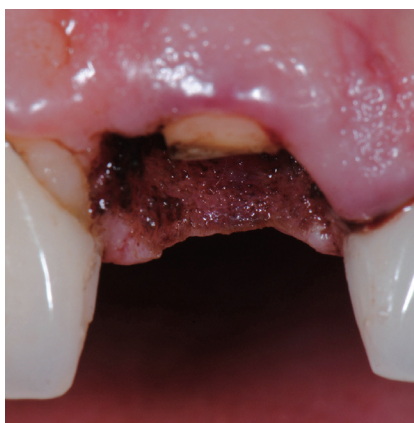
Figure 2. Subgingival fractured left central incisor and inflamed condition of gingiva.

After careful bridge cutting and removal of the crown on the left central incisor (Figure 2), periodontal treatment was performed. A temporary crown with a post was set after the condition of the previous root canal treatment was evaluated by an endodontist. However, considering the adjacent ceramic crowns, conventional methods of forced eruption had an increased risk of ceramic damage. A modified appliance needed to be fabricated.

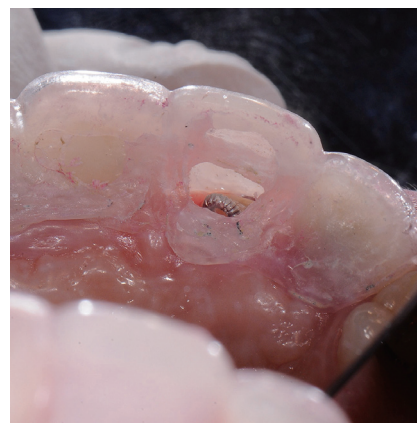
Figure 3. Palatal view of the braided fiber-reinforced composite strip bonded inside the clear appliance.

GmbH, Iserlohn, Germany) in the anterior teeth area. The artificial tooth was removed from the clear appliance and trimmed to leave only the labial shell. The labial shell of the artificial tooth was attached inside the clear appliance for esthetic maintenance. A window was formed on the palatal side of the left central incisor area of the clear appliance. A braided fiber-reinforced composite strip of 2 mm in diameter (Fiber Force, Synca, Le Gardeur, QC, Canada) was bonded to the inner surface of the window as a scaffold to increase the strength of the anchor (Figure 3). An elastic thread was engaged to the loop wire in the root and the horizontal bar of the clear appliance, and activated with a 50 g force after a piece of wire (0.032 inch in diameter) ending in a loop was affixed to the prepared root using glass ionomer cement (Figure 4). The occlusal interference due to the appliance was controlled by cutting the plastic sheet on the contact area of the centric stops. To avoid food impaction or foreign body entrapping, the window was covered with temporary filling material leaving the tooth space empty (Figures 5 and 6).

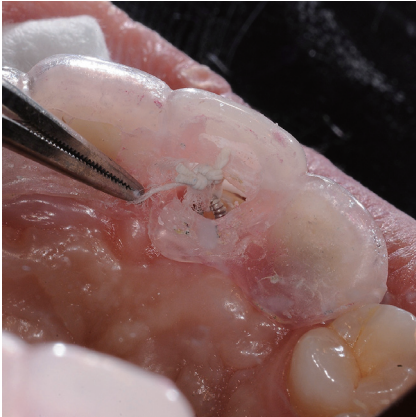
Figure 4. Elastic thread engaged between the loop wire of the root portion and the fiber-reinforced composite strip.

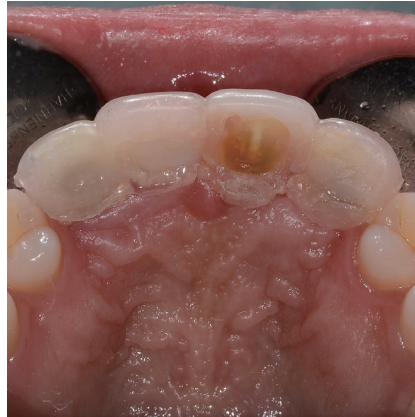
Figure 5. Temporary material covering the window of the palatal surface, leaving the inner space empty.

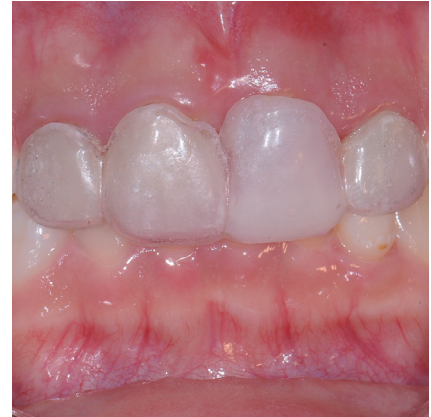
Figure 6. Labial aspect of a modified appliance.

was used to establish an anchor of sufficient strength. The strength was reinforced by scaffolding using the fiber-reinforced composite. To improve the esthetics during the traction or retaining period, the labial shell of the artificial tooth was attached to the inner labial side of the clear appliance. A beam made in the fiber-reinforced composite, crossing over the space of the root rest between the two adjacent teeth, acted as the main anchor to draw the fractured tooth. The clear appliance could not be delivered without occlusal interference, which was controlled by removal of the area of centric stops by making a hollow in the plastic sheet. This appliance and technique incorporated some modifications and provided adequate esthetics, function, and stability.

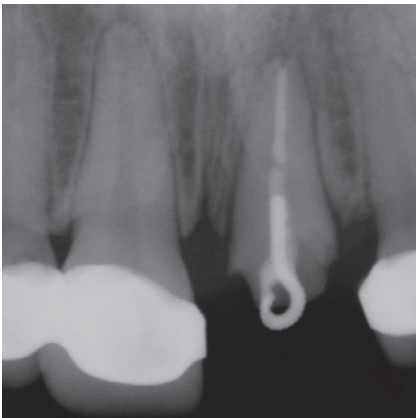
Figure 7. Three weeks after forced eruption, a 3.5 mm eruption for biologic width was achieved.

The amount of tooth movement was 1 mm after 1 week, and 2.5 mm after 2 weeks, and the necessary movement of the tooth (approximately 3.5 mm) to achieve the biologic width had been attained after 3 weeks (Figure 7). A two-month retaining period and gingivectomy was planned along with careful periodontal hygiene control, and a new ceramic crown was fabricated on the tooth in concern (Figure 8). The functionality and periodontal support of the restoration have been maintained in good condition for 2 years (Figure 9).

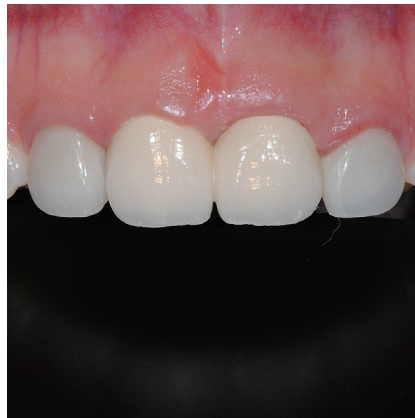
Figure 8. Labial aspect of the porcelain-fused gold restoration at delivery.

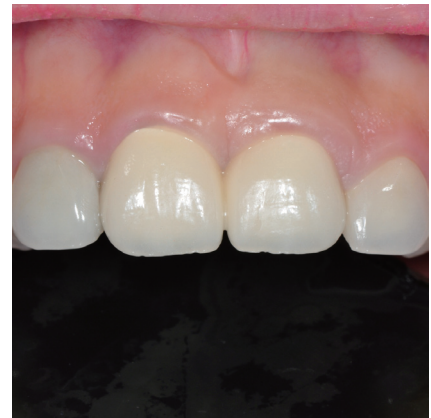
Figure 9. Labial aspect of the restoration at 24 months.
