Analysis of Off-Line and On-Line Partial Discharge in High Voltage Motor Stator Windings

Abstract – The off-line and on-line partial discharge (PD) in the stator winding of three high-voltage (HV) motors (1,400 HP, 6.6 kV) is measured and analyzed in this paper. The off-line PD is measured at high values between 24,300~36,100 pC after 18 years of motor operation. Spare replacement motors were not available for testing the degree of deterioration of the stator windings in standstill status. Therefore, on-line periodic analysis was conducted to monitor the trend of PD after installing a ceramic sensor (110 pF, 6.6 kV) in the terminal box for each phase of each motor. In the stator winding of the No.1 and No.2 HV motors, which showed high magnitudes of off-line PD and low magnitudes of on-line PD, defects are expected to appear in the neutral end of the winding. On the contrary, in the stator windings of the No.3 HV motor, which exhibits high off-line and on-line PD magnitude, defects are expected to appear in the terminal end of the winding where a voltage close to the phase voltage is applied.

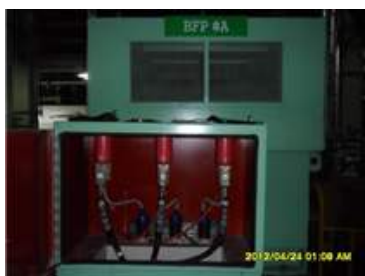
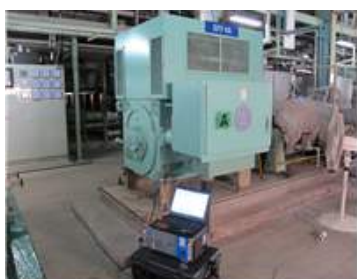
Fig. 2. Installation of ceramic sensors and on-line PD testing system in HV motor

ceramic sensor (110 pF, 6.6 kV) [9] was installed in phases A, B, and C (total of three sensors), as shown in Fig. 2(a). To transmit the voltage signals (mV) for the analysis of the PD in the three ceramic sensors, coaxial cables were laid and connected to the junction box outside the HV motor. Fig. 2(b) shows how the TGA (TGA-B, IRIS Power Engineering) and notebook computer at the junction box were installed. The TGA separates PD from system noise based on pulse time-of-arrival characteristics. The NQN, Q_m magnitude, and PD patterns were analyzed to monitor the trend for the purpose of evaluating insulation deterioration in operating motors. And on-line PD signals are measured by a digital phosphor oscilloscope (5GS/s, 1GMz, Tektronix, TDS5104B) in the No. 1, No. 2 and No. 3 HV motors.

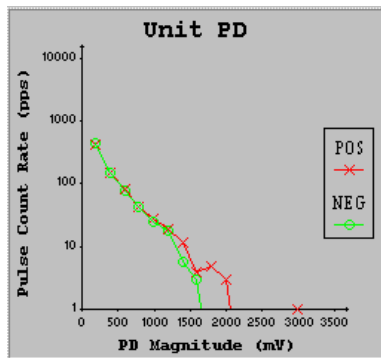
Fig. 3. 2-D and 3-D analysis of off-line PD in No. 3 HV motor

The PD magnitudes in the stator windings of No.3 HV motor with ceramic sensor (110 pF), when line-to-ground voltages of 3.81 kV were applied, are shown in Fig. 3. Figs. 3(a), and (b) show the results of the measurements with TGA-B as described above, where the number and magnitude of the PD pulses were plotted in two dimensional (2-D) and the numbers and magnitudes of the PD pulses versus the ac phase angle were plotted in three

dimensional (3-D). Fig. 3(a) demonstrates similar sizes of positive and negative polarity PD.

The off-line NQN and the maximum PD magnitudes (Q_m) of No.3 HV motor with ceramic sensor (110 pF) were measured using TGA-B as shown in Figs. 3 (a), (b) and the results are listed in Table 3. The measurements of No.3 HV motor stator windings revealed in NQN and Q_m . By measuring the NQN and Q_m magnitude, it was found that the NQN was 2,803 positive polarity and 2,465 negative polarity and the Q_m was 1,450 mV positive polarity and 1,333 mV negative polarity in No.3 HV motor.

measurements representative of internal discharge is shown in Fig. 5(a). As shown in the Fig. 3(a) and Fig. 5 (a) of the No. 3 HV motor stator windings, the off-line and on-line PD patterns were almost the same in sizes of positive and negative polarity PD.

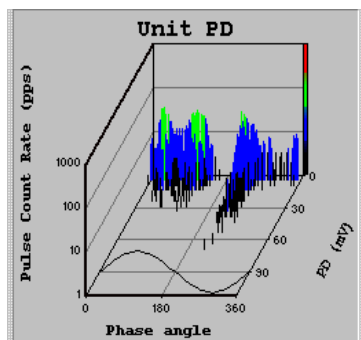
Fig. 4. 2-D and 3-D analysis of on-line PD in phase C of No. 1 HV motor

The Q_m of phase A of the No. 1 HV motor stator windings is shown in Figs. 4(a), (b) where the magnitude of the positive pulse was measured to be higher than that of the negative pulse. As indicated in Table 4, the PD pattern

was estimated as slot discharge since the PD magnitude of the positive polarity is higher than that of the negative polarity [14]. It is suspected that this is due to the frequent start-and-stop operation and the resultant unperceivable but continuous dislocations triggered by the vibrations in the slots of stator windings, which led to semiconductor substrate damage and consequent slot discharges [6]. Slot discharge was observed for phases A, B and C of the No. 1 HV motor and the phase B of the No. 2 HV motor, and the results representative of slot discharge is shown in Fig. 4(a) (a ratio of $+Q_m / -Q_m > 1.5$).

Figs. 4(a), (b) and Figs. 5(a), (b) show the results of the measurements with TGA-B as described above, where the numbers and magnitudes of the PD pulses were plotted in two dimensional (2-D) diagrams and three dimensional (3-D) diagrams.

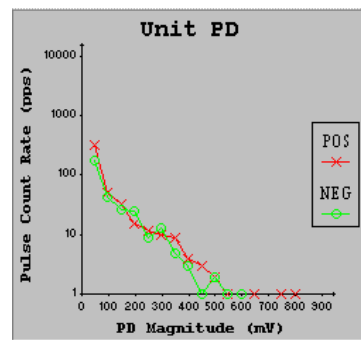
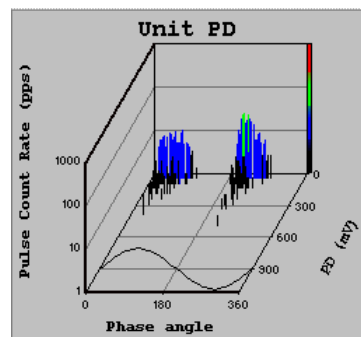
Fig. 5. 2-D and 3-D analysis of on-line PD in phase A of No. 3 HV motor

The reason why Q_m of phase A of the No. 3 HV motor stator windings demonstrates similar sizes of positive and negative polarity PD, as illustrated in Figs. 5(a), (b) is the voids within the main insulation materials of the stator windings. The voids within the main insulation materials are formed either through an inadequate fusion of varnish and resin during production or through the stripping of the insulation layer during operation. When HV is applied to these voids, PD occurs. The insulation breakdown triggered by the PD within the main insulation materials progresses slowly. Unfortunately, the characteristics of PD related to the main insulation materials involve the internal system, and no corrective measures are possible. Therefore, in case of high PD magnitude within the main insulation materials, the windings must be replaced. Internal discharge was observed for phases A and C of the No. 2 HV motor and the phases A, B and C of No. 3 HV motor, and the

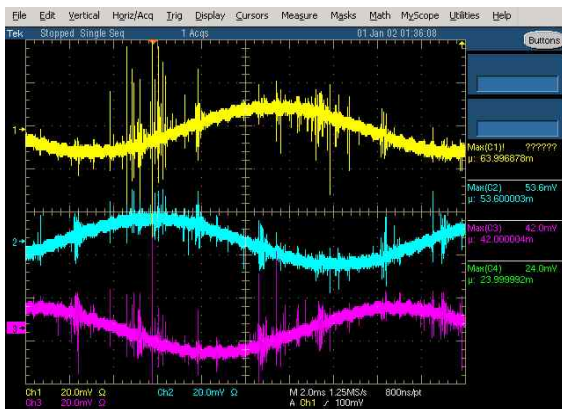
Fig. 6. PD signals from two HV motors

In Figs. 6(a) and (b), two types of on-line PD signals are measured by a digital oscilloscope(5GS/s, 1 GMz) in the No. 1 and No. 3 HV motors. The results are shown with the oscilloscope set at a sampling rate of 1.25 MS/s and resolution time of 800ns. PD signals containing the low peak (less than 100mV) are shown in Fig. 6(a) for phase A of No.1 HV motor. And PD signals containing the low peak (more than 50mV) are measured the phases B and C of No. 1 HV motor. However, PD signals containing the high peak (more than 300mV) are shown in Fig. 6(b) for phase A of No.3 HV motor. And PD signals containing the high peak (more than 100mV) are measured the phases B and C of No.3 HV motor. As shown in Fig. 6 PD signals only with high repetition rate could be detected by a conventional PD detector. The PD measurements obtained with the commercial PD instrument and with a digital oscilloscope are in good agreement, as can be observed in Figs. 4, 5 and 6.
