Delayed Orbital Hemorrhage around Alloplastic Implants after Blowout Fracture Reduction

Yong Ah Ryu,
Jae Beom Park,
Hyun Woo Kyung,
Seung Han Song,
Nak Heon Kang

*Department of Plastic and Reconstructive
Surgery, Chungnam National University
School of Medicine, Daejeon, Korea*

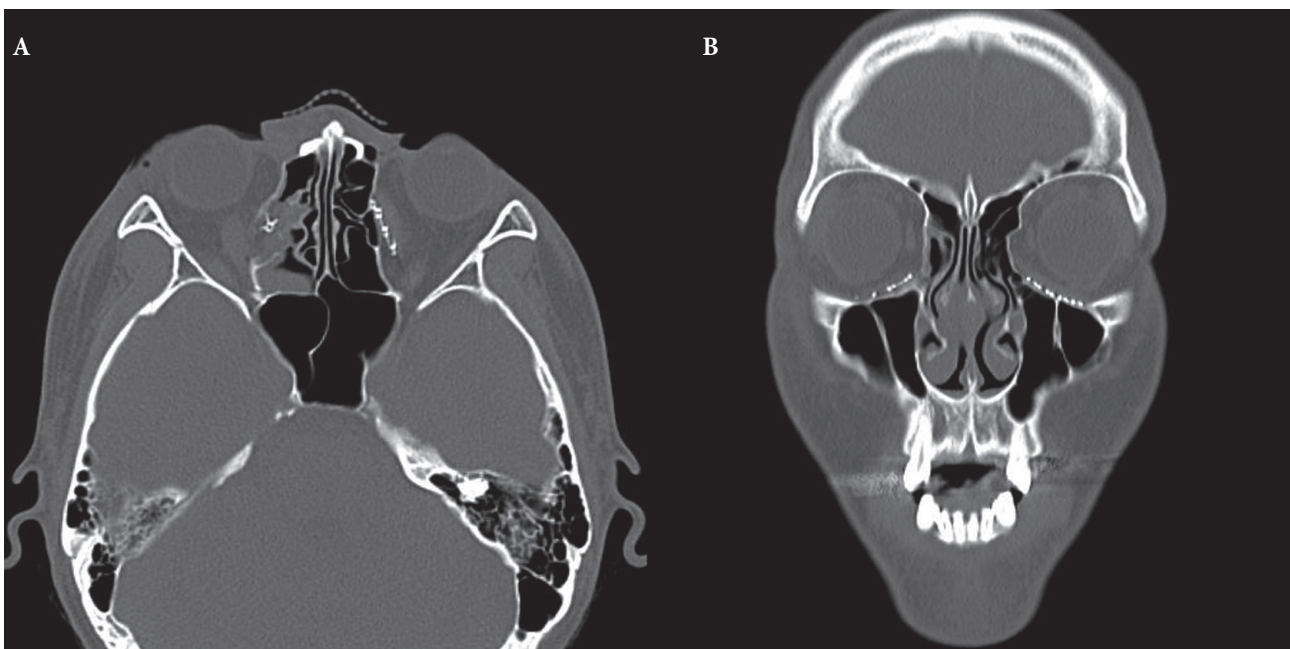
Fig. 1. (A, B) Postoperative computed tomography images after previous orbital floor reconstruction with Medpor implant 8 months earlier.

A 20-year-old male had blowout fractures of bilateral orbital floors that were reconstructed with Medpor implants 8 months prior at our institution (Fig. 1). The patient presented to our clinic because of gradual protusion of the right eye, which had started 4 days earlier without any additional trauma history since the initial operation. He had diplopia and restricted ocular motility on primary or down gaze, without headache. Exophthalmos was determined by a Hertel exophthalmometer with a relative protrusion of 20 mm for the right eye. The patient also had scleral show and vertical dystopia with the right eye being approximately 3 mm higher than the left. CT scan revealed a subperiosteal mass around the orbital floor implant. The right inferior rectus muscle was displaced 0.7 cm superiorly. The size of the mass was 2.3×2.0×1.0 cm (Fig. 2).

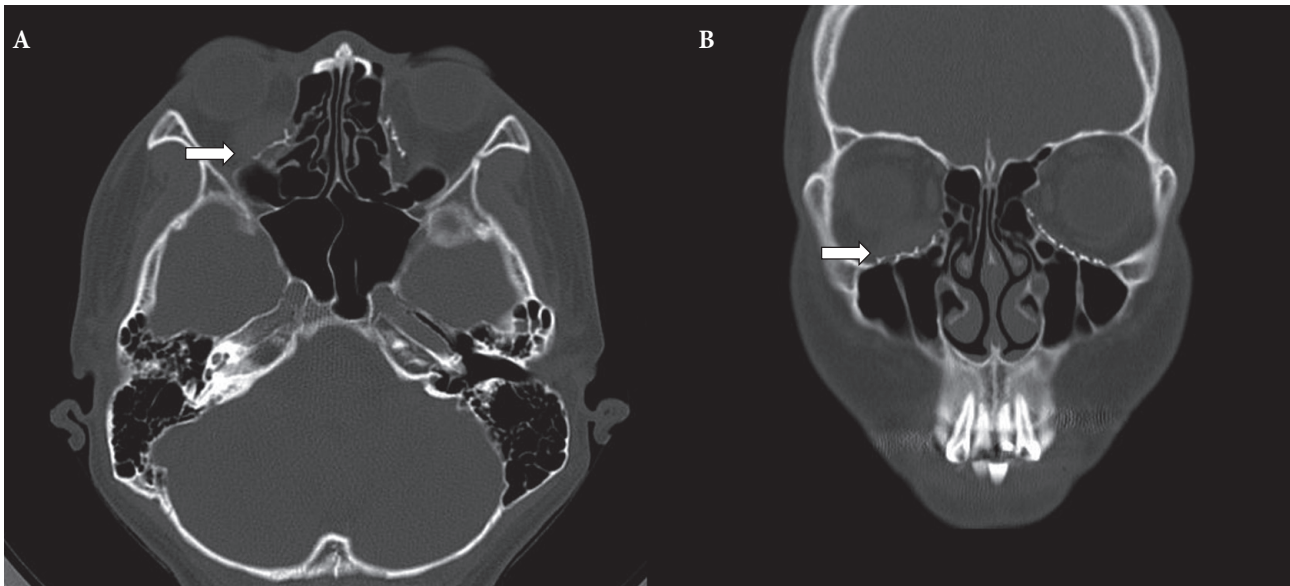
Fig. 2. (A, B) Postoperative computed tomography images showing about 2.5×1.5 cm mass (arrows) and extruded orbit with displaced inferior rectus muscle.

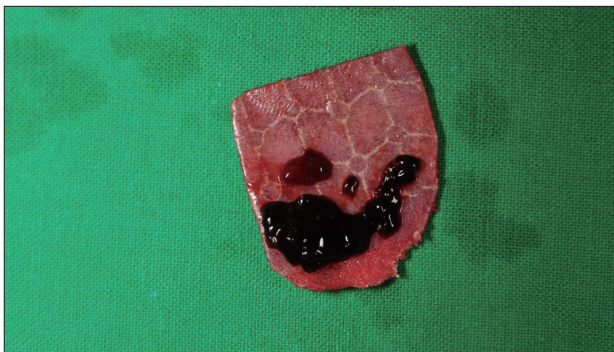
Fig. 3. Removed Medpor titanium meshed alloplastic implant and overlying hematoma.

through the previous scar. A fibrous capsule was surrounding the mass presumed to be hematoma. The fibrous capsule was dissected and partially removed because of the adhesions to the surrounding orbital structure and implant. A dark brown hematoma was identified and evacuated from the subperiosteal plane above the previously inserted Medpor implant, which was removed during this operation (Fig. 3). The patient did not wish to remove the implant in the contralateral orbit. Postoperatively, the ptosis was fully resolved. At one week, the remaining symptoms improved significantly by one week without diplopia or visual disturbance. No complications, such as pain, ocular muscle restriction, recurrence of hematoma, or bleeding were noted during the 11-month follow-up period.
