도시화에 따른 하천의 변화탐지
- Dhobikhola, Kathmandu를 중심으로

Temporal Change of River Shape due to Urbanization in
Dhobikhola, Kathmandu

양 인 태* 아차르야 트리데브** 신 문 승***
Yang, In-Tae Acharya, Tri Dev Shin, Moon-Seung

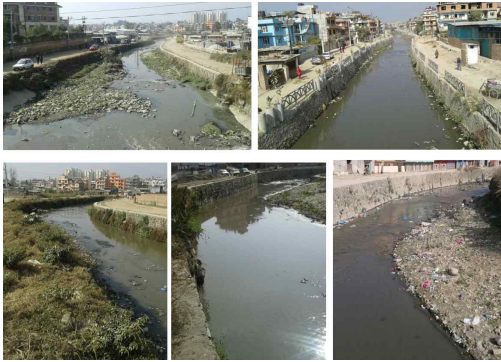
Fig. 1 Current status of River and concrete banks

In lack of demarcation, Bagmati spines were the only open space left in some city core areas, the land has been encroached for various purposes like squatter settlements, residential, commercial, institutional developments, infrastructure development etc. (UN-Habitat, 2008). Recently, the government's effort under Bagmati Action Plan(NTNC, 2009), has trained to make the river banks wider and deeper with stone walls and roads along the banks to serve urbanizing areas (Fig. 1).

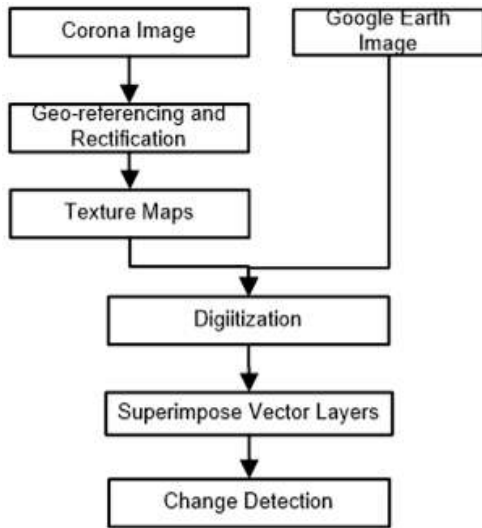
Methodology adapted here is illustrated in Fig 3.

Fig. 3 Flow Chart of the Study

The basis of the study is comparing the available satellite scenes from 1966 to 2014. First of all, the Panchromatic Corona image was obtained from USGS EarthExplorer. The image was geo-referenced and rectified to WGS 1984 UTM zone 45N based on the known landmarks and road cross-sections. The study area was clipped using ArcGIS to obtain the data for computing. Different texture maps were derived using MATLAB. Texture map helps in identifying the edges. Using the texture map and panchromatic images, polygon of the river were digitized.

Similarly, in Google Earth, the polygon of the river shape was digitized for 2003 and 2014. The digitized KML file were imported in ArcGIS and projected to the same scale geographic coordinate system. Lastly, layers were superimposed on one another for mapping change detection.

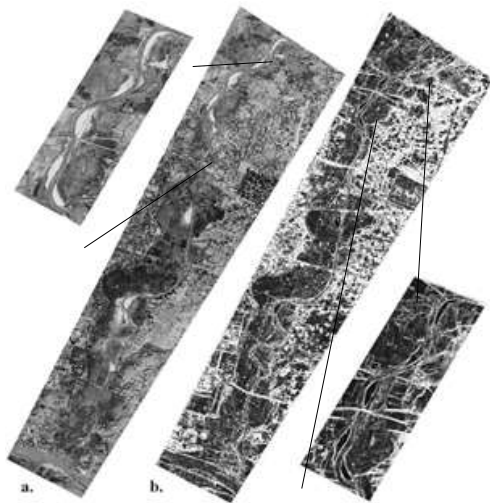
Fig. 4(a). Corona Image
4(b). Standard Deviation Texture

The clipped texture image derived from the panchromatic Corona image is standard deviation. From the image, the edges were easily detectable and helpful in digitizing the river banks(Fig. 4).

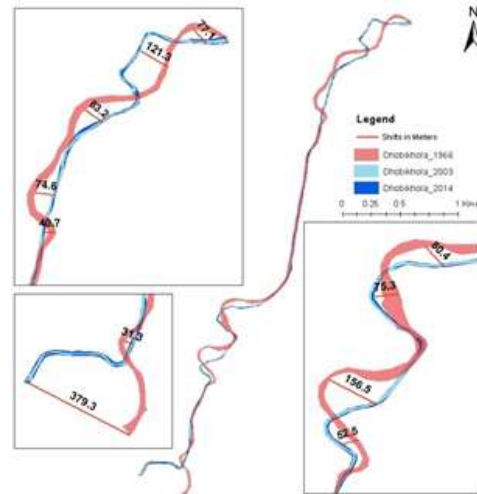
land has been encroached and converted in personal lands. The image from 1966 and other show much change in three sections, which can be seen in Fig 5. The River has shifted mostly in bends and has shown a complete change in course at the meeting point with Bagmati.

Fig. 5 Superimposed river shape during 1966, 2003 and 2014

After comparing with the Google Earth digitized vector layers in ArcGIS, it has been found that even in such a small tributary, huge

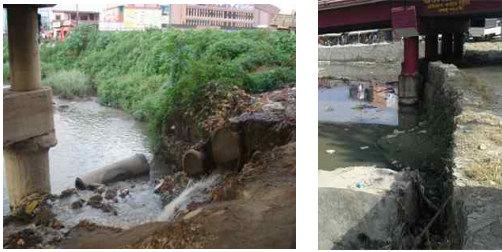
Fig. 6 Change in river bank under Chabhail Ringroad Bridge. (2005 and 2014)

Similarly, during the 2003 and 2014, it has been found that, illegal settling and construction activities had made the river a small channel. While following the Bagmati Action Plan 2009–2014 (NTNC, 2009), river training walls has been constructed to channelize the river water wide and roads along the banks to serve urbanizing areas. Hence, the river has been widen again in 2014 compared to 2003. Some of the changes in the river channel can be seen in the following Fig 6. and 7.

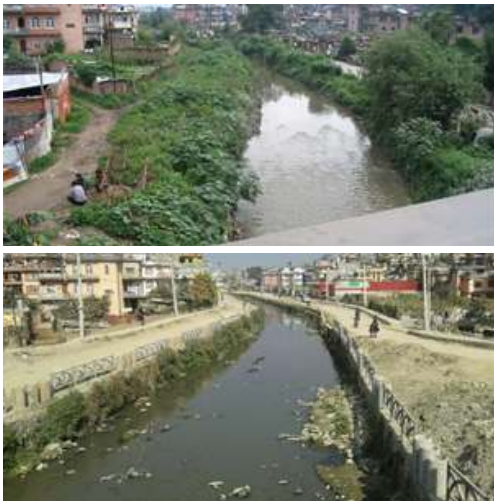
Fig. 7 River section before and after the river management at Kalopul (2005 and 2014)
