## Development of method to remove weld scallop and ceramic backing material of wedge type and its application

Sung-Koo Kang, Jong-Soo Yang and Ho-Kyung Kim

*Research Institute of Technology, STX Offshore & Shipbuilding, Changwon, Korea*

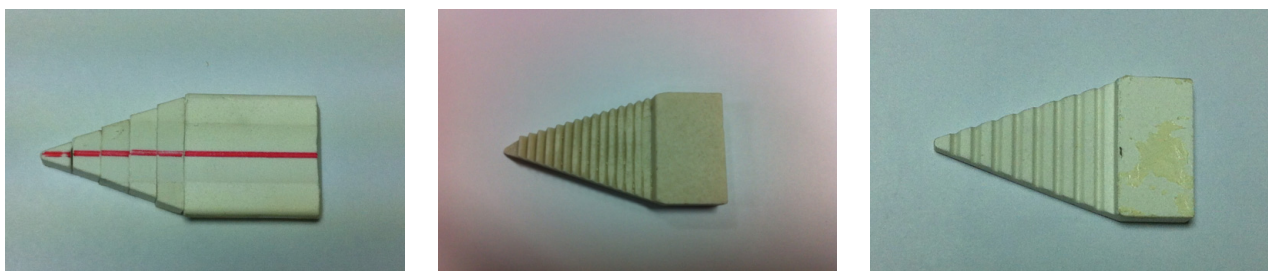
(a) Sliced type. (b) Saw tooth type. (c) Saw tooth + flat surface type.

Fig. 4 Tested CBM sample of wedge type.

Several attempts have been made to develop a suitable CBM. Fig. 3 shows the three attempted shape types. One is a sliced type. The second is a saw tooth type. The third is a saw tooth + flat surface type. The sliced type, as shown in Fig. 4(a), is difficult to fit up because of the low strength of the sliced structure. The structure's wedge-shaped part does not keep straight at the fit-up. Several tests show that the saw tooth type has bad sinterability due to the triangular shape of each tooth. It is smashed to pieces easily after sintering. Fig. 4(b) shows a broken sample. Finally, the saw tooth + flat surface type is tested. The dense slit interval is good as a proper reply for various root gaps. However, the dense tooth type has bad formability. It is necessary to engage in a tradeoff between formability and operability. Through several tests, the slit interval of 4 mm is found to be appropriate. Fig. 4(c) shows the developed type of CBM with 4 mm interval. Its length is 75 mm, which cannot make up for the weld of the face plate completely. A length of at least 150 mm of the CBM is needed to cover the weld of the face plate fully. Fig. 5 displays the final CBM, which is of wedge shape with a 150 mm length. Its top side is similar to the general form of the back bead. This CBM can stick to the root side of the face plate with an adhesive tape, like a general CBM.

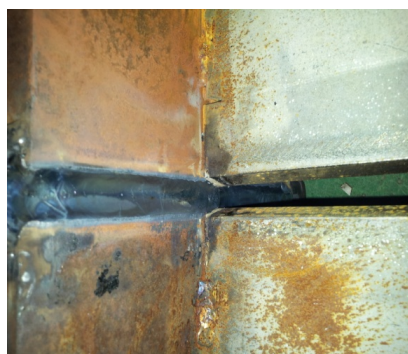
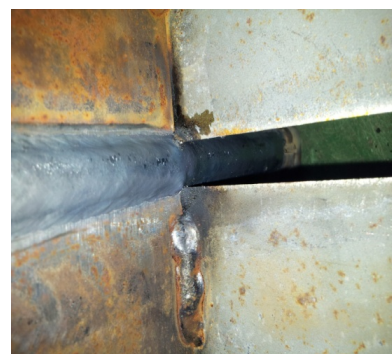
It is necessary to analyze the effect of removing a weld scallop. For this, the root side of the face plate is surveyed after the welding of the face plate is conducted. Fig. 9 shows the root side in case 1, in which there are no defects such as burn-through or slag inclusion. The other cases show the same results. After the web plate welding is carried out, the specimens are surveyed visually. Fig. 10 shows the finished welding specimens for case 1 and case 6. It shows that there are no defects, which is the same for the other cases.

(a) From the direction of face side of web. (b) From the direction of root side of web.

Fig. 9 Root side after welding of face plate.

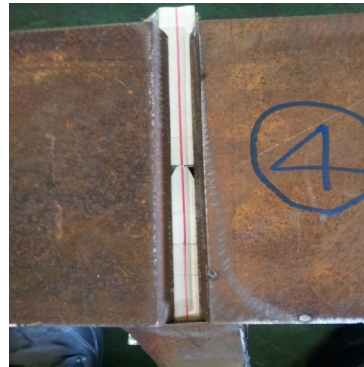
Fig. 14 shows the fit-up shape in case 1 and case 4. Because the root gap of the face plate is larger than that of the web plate, a large gap is seen in the area where the wedge CBM contacts the general CBM. This shows the possibility that burn-through may happen after the first pass welding of the face plate.

(a) Case 1.

(b) Case 4.

Fig. 14 CBM fit-up shape in abnormal conditions.

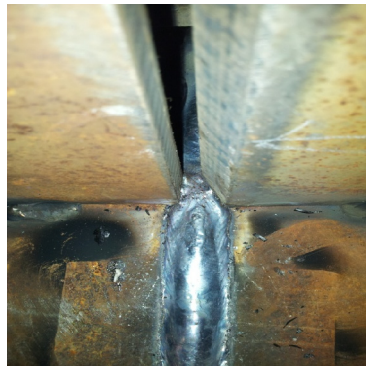
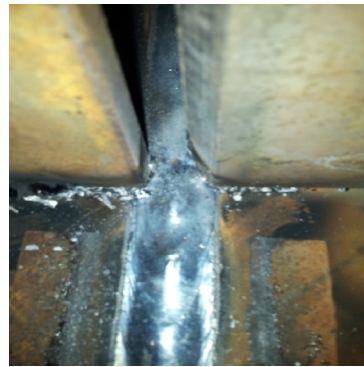
After the first weld of the face plate for cases 1 and 4, the root side of the face plate is surveyed visually. This survey reveals that burn-through does not happen, as can be seen in Fig. 15. The other cases do not have burn-through, either.

(a) Case 1.

(b) Case 4.

Fig. 15 Root side of face plate after the first pass welding of face plate.

In order to cause burn-through, high heat input is necessary. SAW usually has high heat input, but this process uses FCAW, which has low heat input. The specimen temperature is usually as low as the air temperature. Also, the T-bar has three directions in which to dissipate the weld heat. This heat dissipation results in rapid bead cooling and prevents burn-through from occurring. The results of visual inspection are provided in Table 3.
