A study on the corrosion evaluation and lifetime prediction of fire extinguishing pipeline in residential buildings

Abstract: This study is conducted for the evaluation of corrosion and lifetime prediction of fire extinguishing pipelines in residential buildings. The fire extinguishing pipeline is made of carbon steel. Twenty-four samples were selected among all the fire extinguishing pipelines in a building; the selection was based on specimens positions, pipeline diameters, and pipeline thickness. Analysis was conducted by using the results of visual inspection, electrochemical potentiodynamic anodic polarization test, pitting depth measurements, and extreme value statistics with the Gumbel distribution. The maximum pitting depth and remaining life were statistically predicted using extreme value statistics. During visual inspection, pitting corrosion was observed in several samples. In addition, extreme value statistics demonstrated that there were several pipelines that were very sensitive to pitting corrosion. However, the pitting corrosion was not critical in all the pipelines; thus, it was necessary to change only those pipelines that were severely corroded.

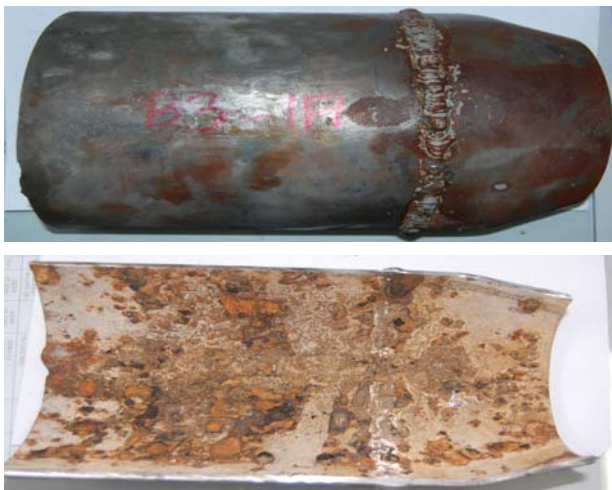
Figure 1: An example of Selected pipeline in this study

The structures investigated in our study were each equipped with a fire extinguishing system. The fire extinguishing system was installed on six ground floors and three basement floors. The samples for testing were randomly selected based on visual inspection from outside. Figure 1 shows one of these pipelines that was selected for this experiment. Six different types of samples were selected, considering mainly the pipeline diameter. In this study, the diameters were chosen as 150 mm, 100 mm, 50 mm, 40 mm, 32 mm, and 25 mm; the details are presented in Table 1.

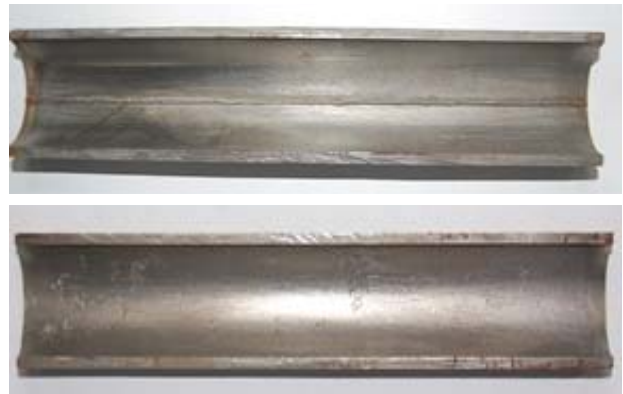
It can be seen from the visual inspection that not all samples are severely corroded. Evidence of corrosion cannot be confirmed in several samples, as shown in **Figure 4**. In addition, the closer the distance of the pipeline from the water supply facilities, the higher the corrosion traces are. It is ex-

pected that corrosion may be higher in the areas closer to water supply facilities, since that pipelines in such areas are more likely to be influenced by water and air simultaneously.

Figure 4: Inner surface of specimens
