## 습지보호지역의 습지보전 · 이용시설 현황에 관한 기초 연구\*

## Fundamental Research of Preservation & Utility Facilities in Wetland Protected Area\*

- 5 Wetland Protected Areas were Used as Main Subjects -

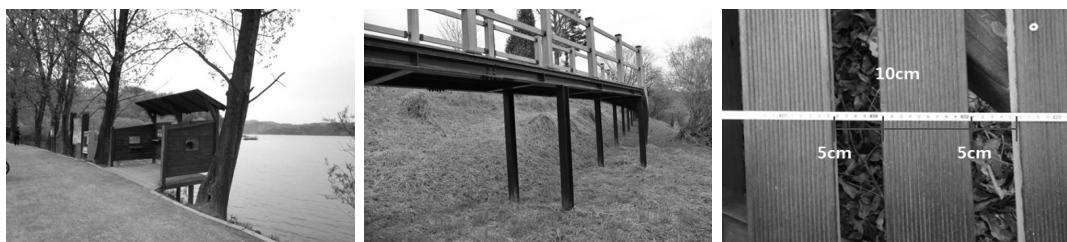
**Figure 2. Comments Regarding Wetlands Preservation & Utility Facilities.**

Lack of sheltering at bird observation deck surroundings

Decks installed so wild animals can walk around

Distanced footholds used for a trail

관찰·학습시설의 경우 조류관찰대 설치 시 주변 차폐 기능이 미약하여 조류관찰대의 기능이 어려운 경우가 나타났다. 탐방 데크 설치 시 높이를 조절하여 야생동물의 이동이 가능하도록 한 경우도 나타났지만 대부분 이에 대한 고려가 미흡하였다. 주변 환경 훼손을 최소화하기 위해 폭이 좁고 발판의 사이가 넓어 발판 밑으로 햇빛이 투과되어 식물 서식에 유리한 환경을 조성한 경우도 나타났다. 그러나 발판 간격이 넓은 경우 탐방객의 실족이 우려되므로 이에 대해서는 구체적인 연구가 필요하다고 판단된다(Figure 2).

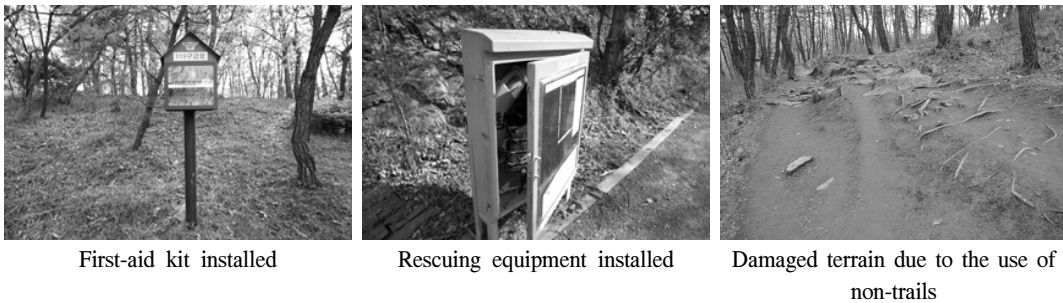
Figure 4. Comments Regarding Safety & Protection Facilities.

안전시설의 경우 다른 시설에 비해 매우 미흡한 상황으로 습지보호지역은 대부분 물이 있는 지역으로 안전사고가 상시 발생할 수 있으므로 곳곳에 안전시설의 비치와 필요하고 사고 발생 시 탐방객의 위치를 쉽게 알릴 수 있도록 방안이 필요하다고 판단된다. 보호시설의 경우 설치 미비로 인하여 탐방객이 관리 동선 외 지역을 이동하여 지형의 훼손이 나타났다. 탐방객의 이용이 집중되는 지역의 경우 관리 동선 외 다른 지역으로 이탈되는 경우가 많으므로(KNPS, 2009), 탐방객의 접근이 용이한 지역을 중심으로 진입 차단시설 및 감시를 위한 CCTV 도입이 필요하다고 판단된다(Figure 4).
