# Effect of Microstructure on the Environmentally Induced Cracking Behavior of Al-Zn-Mg-Cu-Zr Aluminum Alloy

**Keywords:** Aluminum alloys, Potentiodynamic polarization, Stress corrosion cracking (SCC), Nanomechanical

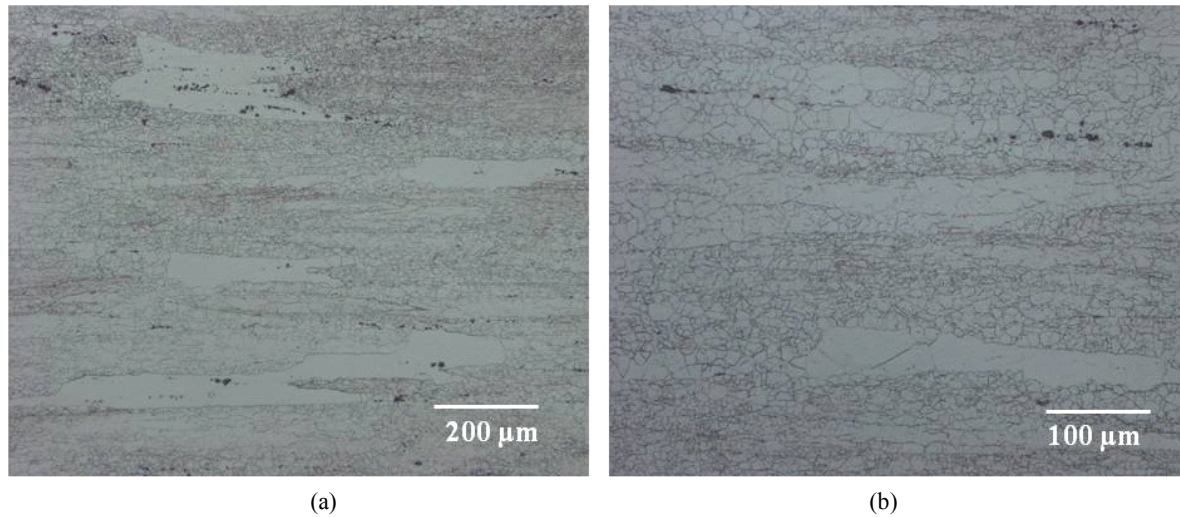
Fig. 1 Optical micrographs of the AA7010-T7452 aluminum alloy.

The optical microstructure of the alloy presented in Fig. 1 exhibits fully recrystallized grains in which the fiber-like structure typical of thermomechanically treated structure is not seen. Few second phase particles appearing black in color are distributed in the matrix. These phases are constituent intermetallics particles as reported in the literature [10,11]. Fig. 2 shows the surface (Fig. 2a) and cross section (Fig. 2b) of the PEO coating. Micro pores of diameter less than 8  $\mu\text{m}$  are seen on the coating typical of PEO coating. The coating thickness is of the order of 10  $\mu\text{m}$  as seen from the cross-sectional SEM image (Fig. 2 b). SEM-EDS line scan across the coating cross section revealed the presence of  $\text{Al}_2\text{O}_3$  coating with minor Mg content diffused during PEO process.

(a) AA7010-T7452 alloy used in the present work exhibited completely recrystallized microstructure. This is attributed to the intermittent pre-heating steps during forging operations resulting in dynamically recrystallized structure and its subsequent grain growth during solution treatment

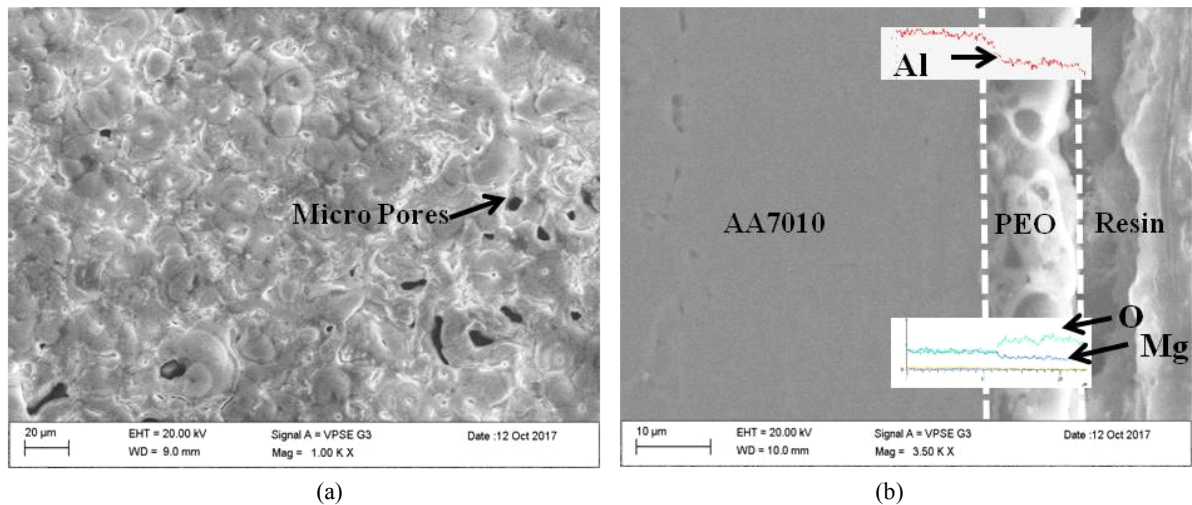
Fig. 2 SEM micrographs showing the surface (a) and cross section morphology (b) of the PEO coating on AA7010-T7452 alloy.

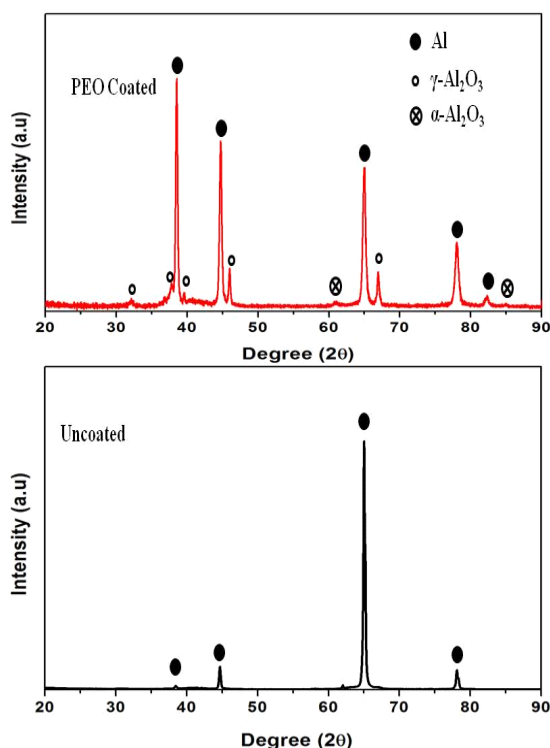
Fig. 3 XRD pattern of PEO coated and uncoated (base metal) AA7010-T7452 aluminum alloy.

Fig. 3 shows the XRD pattern of the PEO coated and uncoated AA7010-T7452 aluminum alloy. XRD analysis of the coating revealed that the coating consists of mainly  $\gamma\text{-Al}_2\text{O}_3$  and few low intensity peaks of  $\alpha\text{-Al}_2\text{O}_3$ . In addition, peaks generating from the aluminum base metal can be seen due to x-rays penetration through the coating.

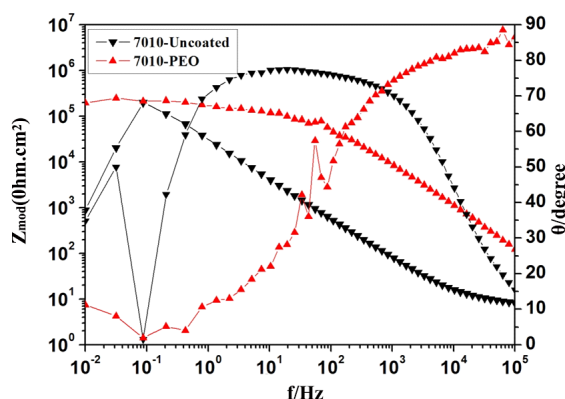
Fig. 4 Typical Bode impedance plots obtained for the uncoated and PEO coated AA7010-T7452 aluminum alloy: Impedance Vs. Frequency and Phase angle Vs. Frequency.

Fig. 4 represents the impedance data obtained for the uncoated and PEO coated AA7010-T7452 alloy after immersion for 1 hour in 3.5% NaCl. The Bode plots in Fig. 4 indicate that the impedance values as seen from the low frequency end of the spectra are higher for PEO coated sample ( $2 \times 10^5 \Omega \text{ cm}^2$ ) than the uncoated ( $9 \times 10^2 \Omega \text{ cm}^2$ ) alloy. This indicates that the corrosion resistance of PEO coated alloy is better than the uncoated alloy. Gradual decrease in phase angle with respect to frequency for the coated alloy can be ascribed to the porous nature of the coating as already indicated in Fig. 2. The polar-

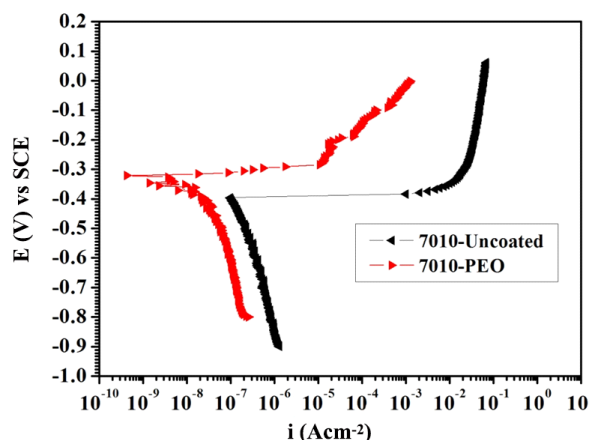
Fig. 5 Potentiodynamic polarization plots for the uncoated and PEO coated AA7010-T7452 aluminum alloy.

ization plots for the uncoated and PEO coated AA7010-T7452 alloy are represented in Fig. 5. An examination of the plots shows that the corrosion potential ( $E_{\text{corr}}$ ) of the uncoated alloy is more active (-0.4V) than the PEO coated (-0.3 V) alloy. It also indicates that the corrosion current density ( $i_{\text{corr}}$ ) of the PEO coated alloy is one order magnitude lower than the uncoated alloy as a result of 10  $\mu\text{m}$  thick PEO coating. Observation of the sample after polarization test revealed severe localized corrosion attack for uncoated alloy and its absence in the case of PEO coated alloy as depicted in Fig. 6a, b. Absence of localised attack in the case of PEO coated alloy as shown in Fig. 6b further corroborates better corrosion resistance.

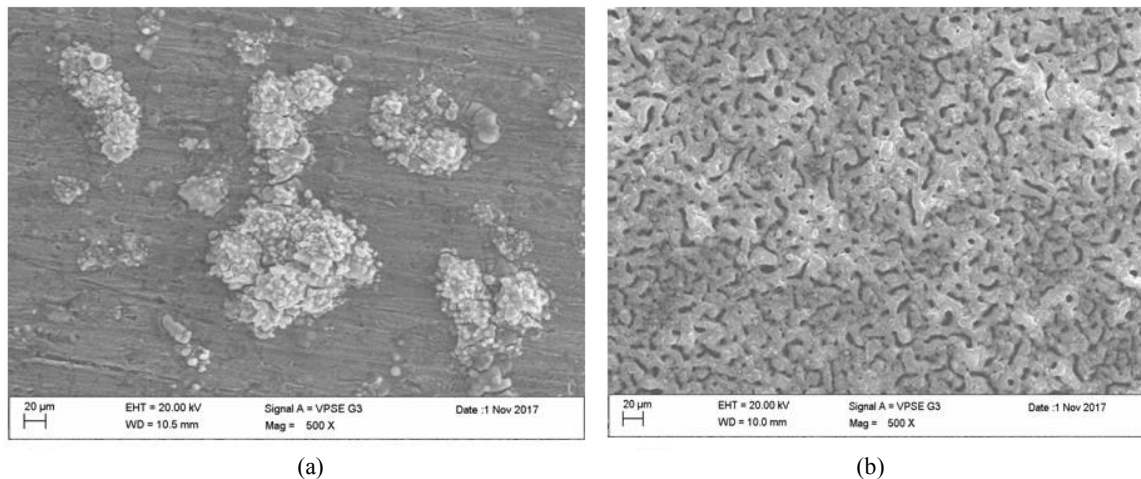
Fig. 6 Corrosion morphology of (a) uncoated and (b) PEO coated AA7010-T7452 aluminum alloy after polarization tests in 3.5% NaCl solution.

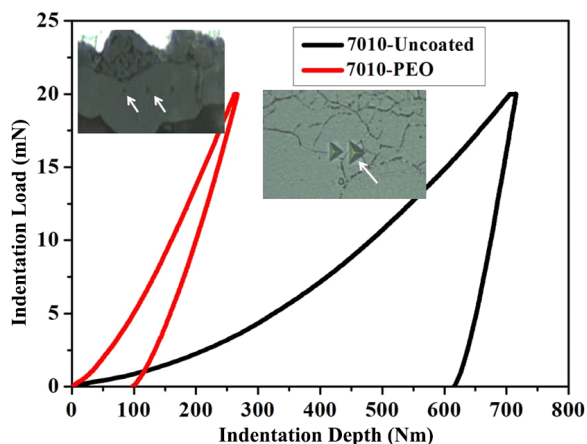
Fig. 7 Typical load-depth data obtained during indentation tests on uncoated and PEO coated AA7010-T7452aluminum alloy.

measurements are shown in the Fig. 7. It can be seen that the elastic recovery of the PEO coated alloy is comparatively higher than the uncoated sample as indicated by the shift in the indentation depth after the test. The hardness was calculated from the load and indentation depth data, and the modulus was determined from the unloading response using the standard Oliver and Pharr technique [9]. The indentation hardness and elastic modulus of the uncoated alloy were determined as  $2.7 \pm 0.2$  GPa and  $83 \pm 10$  GPa respectively. Similar values obtained for PEO coated alloy were  $16 \pm 2$  GPa and  $178 \pm 10$  GPa which are significantly higher than the uncoated alloy. The XRD results of the present study indicated the presence of mainly  $\gamma\text{-Al}_2\text{O}_3$  (Fig. 3) having the reported hardness in literature of 17 GPa which is excellent agreement with the hardness ( $16 \pm 2$  GPa) achieved in the present work.

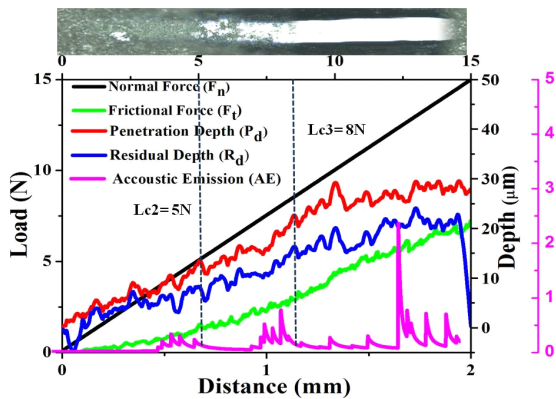
Fig. 8 Optical micrograph and measured scratch performance of PEO coated AA7010-T7452 aluminum alloy.

The mechanical, general corrosion and the stress corrosion resistance of the coating are determined by the adhesion of the coating with the base metal. In order to understand the adhesion behavior, scratch tests were performed on the PEO coated alloy. The optical image of the scratch and the other scratch test results such as acoustic emission, frictional force, penetration depth and residual depth recorded during the scratch tests are shown in Fig. 8.

By comparing the optical images and the acousting emission signals shown in Fig. 8, distinct regions could

be marked indicating different damage levels. The critical loads determined at these locations are  $Lc1=2.5$  N,  $Lc2=5$  N and  $Lc3=8$  N. The PEO coating damage at  $Lc1$  and  $Lc2$  can be attributed to the cohesive damage of the coating. This could be due to the porous nature of the coating as already shown in Fig. 2. After a certain load due to continuous perforation complete damage of the coating by spallation has occurred revealing the underlying base metal. However, no delamination of the coating has taken place at the border or outside the scratch track. The measured  $Lc3$  value (8N) and the corresponding frictional force (4 N) are slightly lower than the values re-

ported for AA7075 alloy [13], probably due to lesser thickness (10  $\mu$ m) used in the present work. Beyond  $Lc3$ , further increase in load causes marginal fluctuation in penetration depth due to chipping of the metal and its interaction with the scratch indenter.

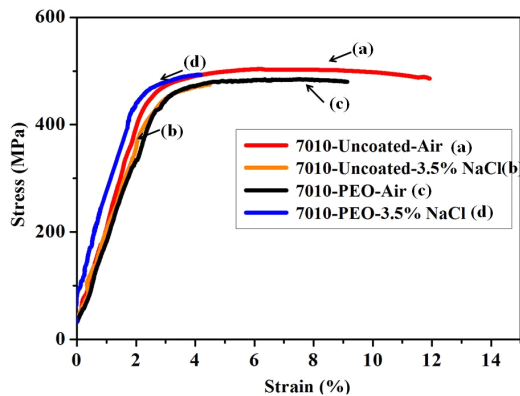
Fig. 9 Stress vs Strain plots obtained for uncoated and PEO coated AA7010-T7452 alloy.

The stress-strain curves obtained for the uncoated and PEO coated AA7010-T7452 alloy specimens are presented in Fig. 9. The SSRT data such as UTS, % El and SCC index obtained from the SSRT plots are shown in Table 1. It can be seen that the UTS values are comparable for both uncoated and coated samples in both environments. However, significant reduction in elongation values can be noted for both uncoated and coated samples after exposing to 3.5% NaCl solution. For the uncoated sample the elongation has decreased from 11.90% (air) to 4.5% (NaCl). As a result of this, the SCC index ( $\epsilon_{(NaCl)}/\epsilon_{(Air)}$ ) was very low (0.38) which is the ratio of the elongation of the samples tested in 3.5% NaCl solution and the air. The greater the SI value, the better the SCC resistance. An index value of unity implies that the material exhibits no SCC susceptibility. The poor SCC index value (0.38) measured for the uncoated alloy indicates that the alloy is highly susceptible to SCC. In the case of PEO coated sample also the measured index value was very low (0.45) which is similar to that of uncoated sample. This shows that the fabricated PEO coating did not provide any resistance towards SCC for this alloy. Further examination of the fractured samples under SEM showed typical intergranular cracking mode of failure for both uncoated and coated samples exposed to 3.5% NaCl solution. However, the air tested sample exhibited predominantly ductile mode of failure.

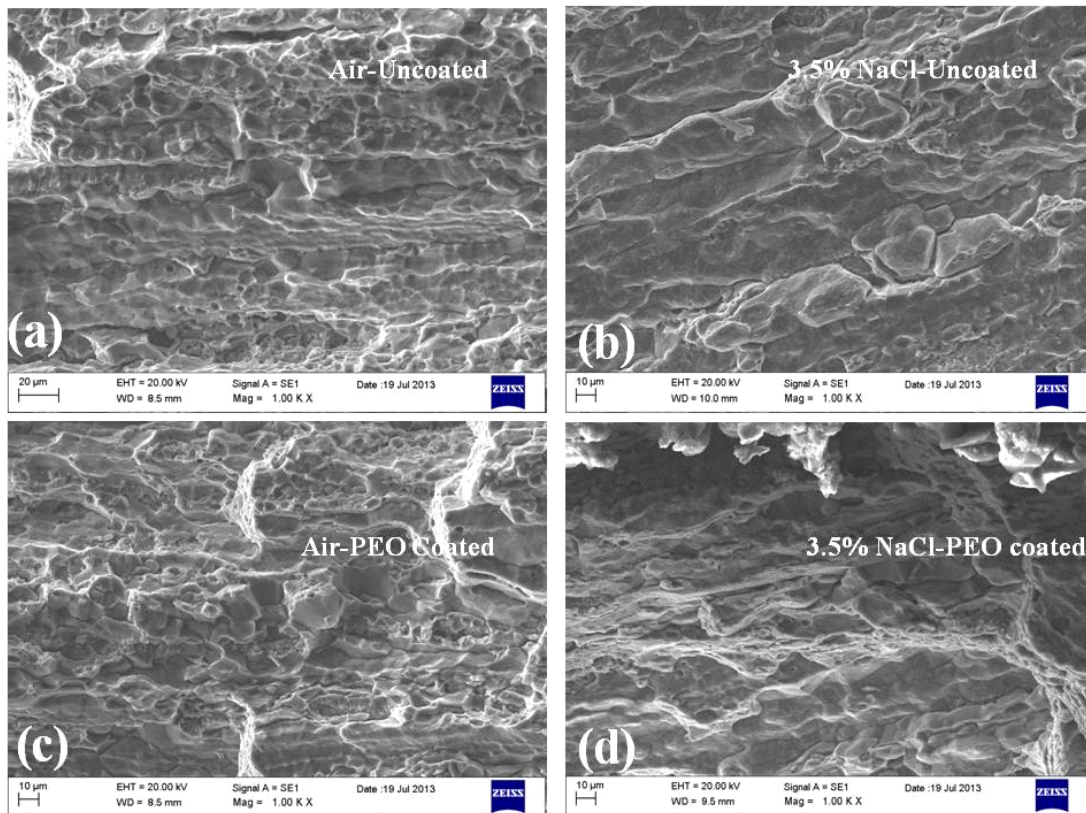
Fig. 10 Fracture morphology of uncoated (a,b) and PEO coated (c,d) samples after SSRT in air and 3.5% NaCl solution.
