# A Research on Stray-Current Corrosion Mechanism of High Voltage Cable Connector on Electrification Vehicles

Hwi Yong Lee<sup>1</sup>, Seung Ho Ahn<sup>1,†</sup>, and Hyun Taek Im<sup>2</sup>

<sup>1</sup>Accelerated Durability Development Team, Hyundai Motors Company, 150 Hyundaiyeonguso-ro, Namyang-eup, Hwaseong-si, Gyeonggi-do, 18280, Korea

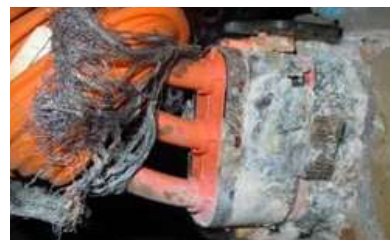
**Fig. 1** High voltage cable and Stray-Current Corrosion in electric vehicles.

different from general environmental corrosion phenomena. This is because when the stray current is generated through the shielding line of the high-voltage cable applied to the vehicle, it affects peripheral components (Fig. 1).

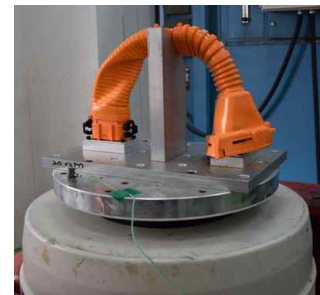
**Fig. 4 Vibration testing machine.**

In order to confirm such an estimation mechanism, first, the vibration phenomenon between the cable and the connector was reproduced through ISO-16750-3 (vehicle electronic vibration condition on the road) vibration test. The reason why the ISO standard was adopted was that the input load of the durability test using the actual vehicle was higher than that of the durability test, and to verify in a harsh environment. Mounted like an actual fastening, vibration was applied in three axes of X, Y, Z axis, causing
