Repeated failure of implants at the same site: a retrospective clinical study

Background: Implants are becoming the first choice of rehabilitation for tooth loss. Even though they have a high success rate, failures still occur for many reasons. The objective of this study is to analyze the reasons for recurring failure at the same site and the results of re-implantation.

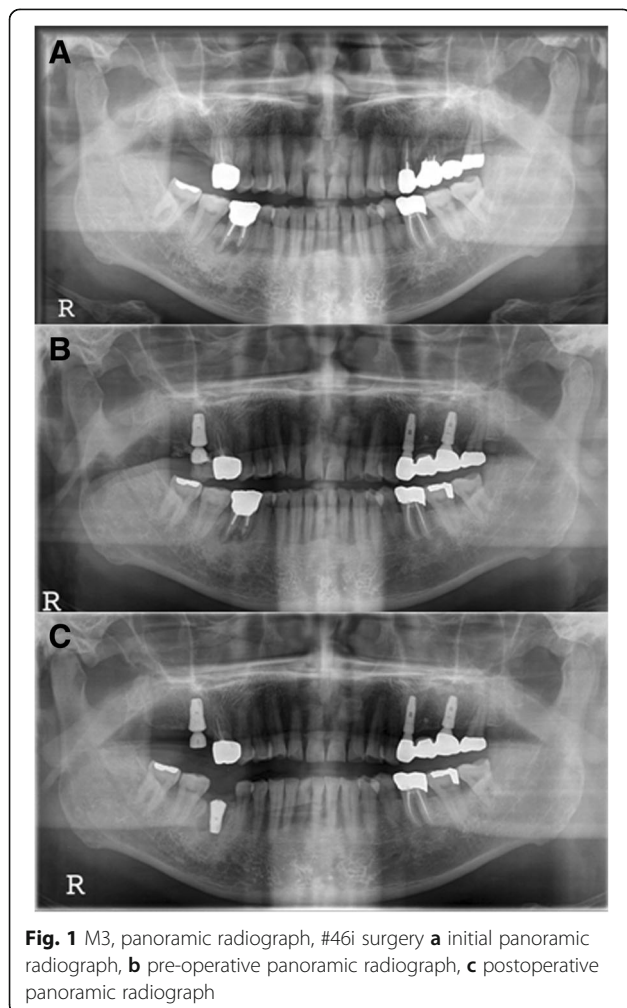
Fig. 1 M3, panoramic radiograph, #46i surgery **a** initial panoramic radiograph, **b** pre-operative panoramic radiograph, **c** postoperative panoramic radiograph

A 68-year-old male patient (M3) with no underlying disease exhibited symptoms of #46 pain with a buccal gingival fistula. Tooth extraction and implant placement were planned under the diagnosis of a periapical abscess (Fig. 1a). After extraction of #46 in April 2008, an Implantium Superline 4.8 × 12 mm implant was placed. A buccally fenestrated 4-wall bony defect at the apical area was detected, and bone grafting was performed with Orthoblast II and a Bio-Arm barrier membrane with sutures (Fig. 1b, c). Four months later, the second surgery was performed (Fig. 2a). Six months after implantation, prosthetic treatment was carried out, and secondary stability was measured with an Osstell Mentor as 68 ISQ (Fig. 2b). Three months after insertion of the prosthesis, the patient exhibited symptoms of pain, hypersensitivity, and micromovement of the fixture. One month later, peri-implant curettage and antibiotic therapy were performed with an ISQ value of 59. Heavy occlusal forces with night clenching or bruxism were suspected due to

fracture of the abutment connection of the #26 implant and observation of severe attrition on the upper and lower teeth. Eventually, the #46 implant was removed 6 months after prosthetic loading, and delayed re-implantation was planned for 3 months later (Fig. 3a). During the recovery period, a night guard was fitted to the upper dental arch to protect the teeth from parafunctional habits. In August 2009, a SinusQuick IS 5 × 11.5 mm implant was placed after the 3-month recovery period (Fig. 3b). At that time, the ISQ of primary stability was measured with an Osstell Mentor at 94. Three months later, the second surgery was performed, and the ISQ of secondary stability measured by the Osstell Mentor was 94 (Fig. 4a). Two months later, the final prosthetic treatment was completed (Fig. 4b). Since then, the implant has performed well, with regular check-ups 3 times a year. Two years later, night clenching and bruxism persisted with fracture of the cervical areas of residual teeth. Mobility of the #46 implant was observed in August 2016, approximately 6 years 7 months after prosthetic loading. After 2 months, the implant was replaced with a wide diameter Superline 7.0 × 10.0 mm implant with an ISQ of primary stability of 85, and the healing abutment was connected (Fig. 5a, b). Four months later, prosthetic treatment was completed (Fig. 5c). The final observation point was in November 2018, and the implant was maintained and had good prosthetic function after 1 year 9 months.

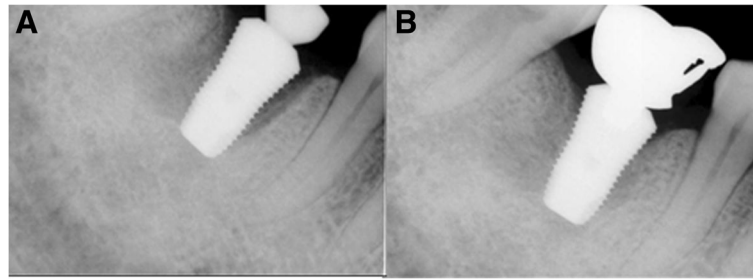
Fig. 2 M3, periapical radiograph, **a** #46i second operation, **b** #46i prosthesis delivery

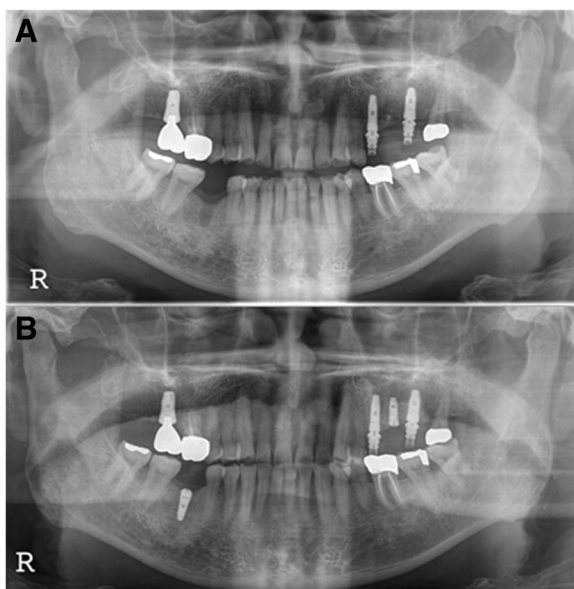
Fig. 3 M3, panoramic radiograph, **a** postoperative 1-month removal of fixture state, **b** #46i, second installation

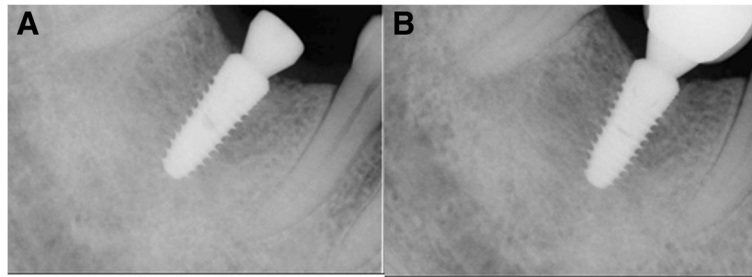
Fig. 4 M3, periapical radiograph, **a** #46i, second operation, **b** #46i, prosthesis delivery

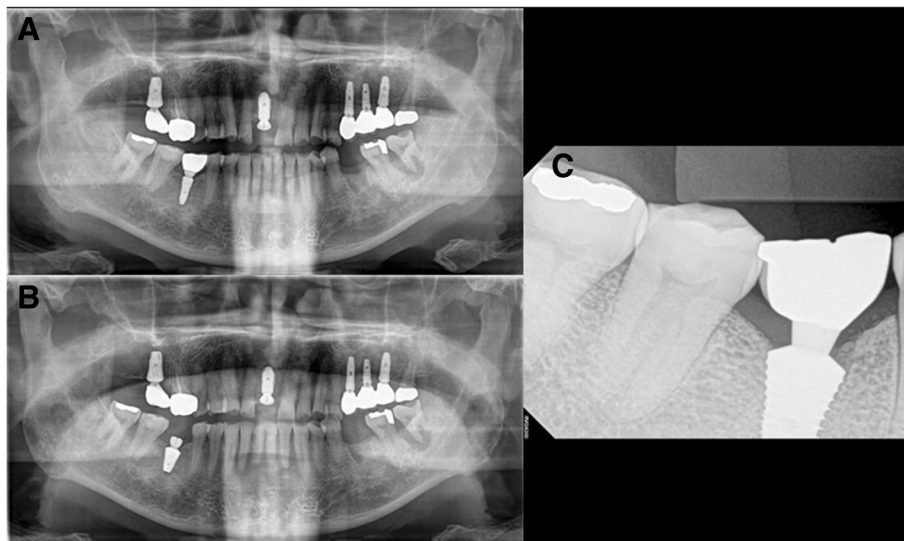
Fig. 5 M3, radiographs **a** #46i second failure, preoperative panoramic radiograph, **b** #46i, third installation, **c** #46i, prosthesis delivery

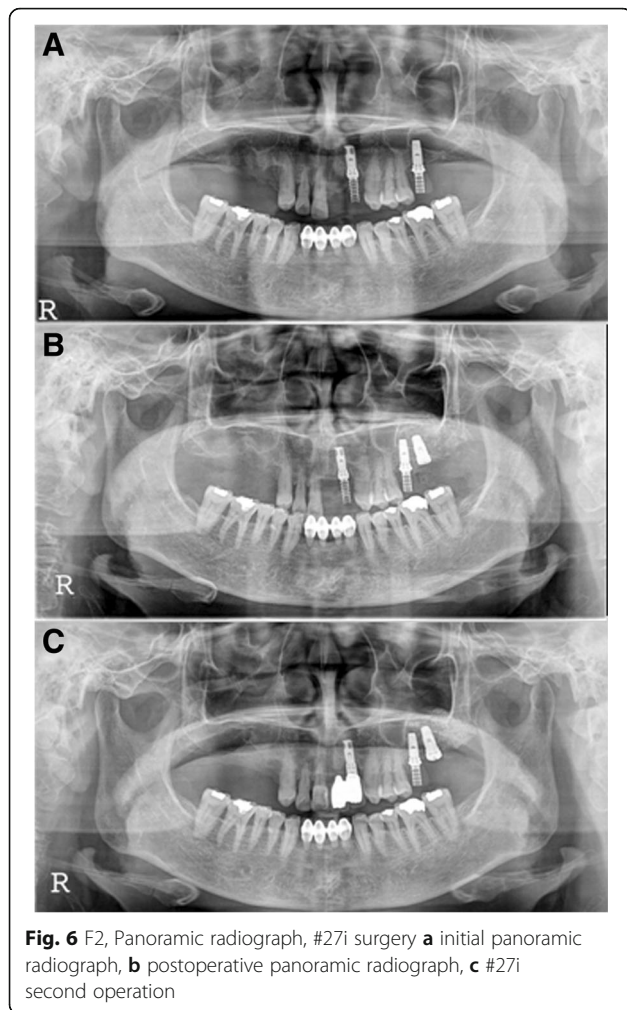
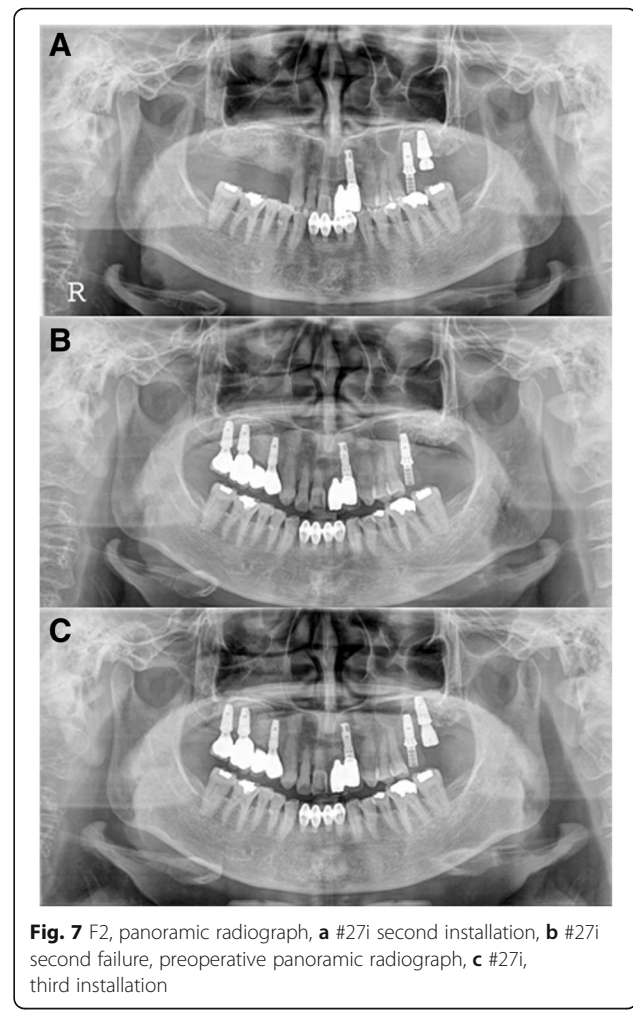
the ISQ of secondary stability was measured with an Osstell Mentor at 62, and a healing abutment was connected (Fig. 6c). Five months after implantation, rotation of the implant fixture was detected during removal of the healing abutment for impression creation; treatment was stopped. One month later, the #27 implant was removed, and an Implantium Superline 6 × 10 mm was immediately placed using the trabecular compaction technique with ISQ of primary stability of 55 measured with an Osstell Mentor (Fig. 7a). Two weeks later, dull sounds and mild mobility of the fixture were observed. When checked 6 months after implantation, osseointegration was observed to have failed, and the implant was removed. After an 8-month healing period, the third implantation was performed with a flapless operation. A Superline 5 × 10 mm implant was placed, and the healing abutment was connected, with an ISQ of primary stability of 70 measured with an Osstell Mentor (Fig. 7b, c). Six months later, a cement-retained prosthesis was

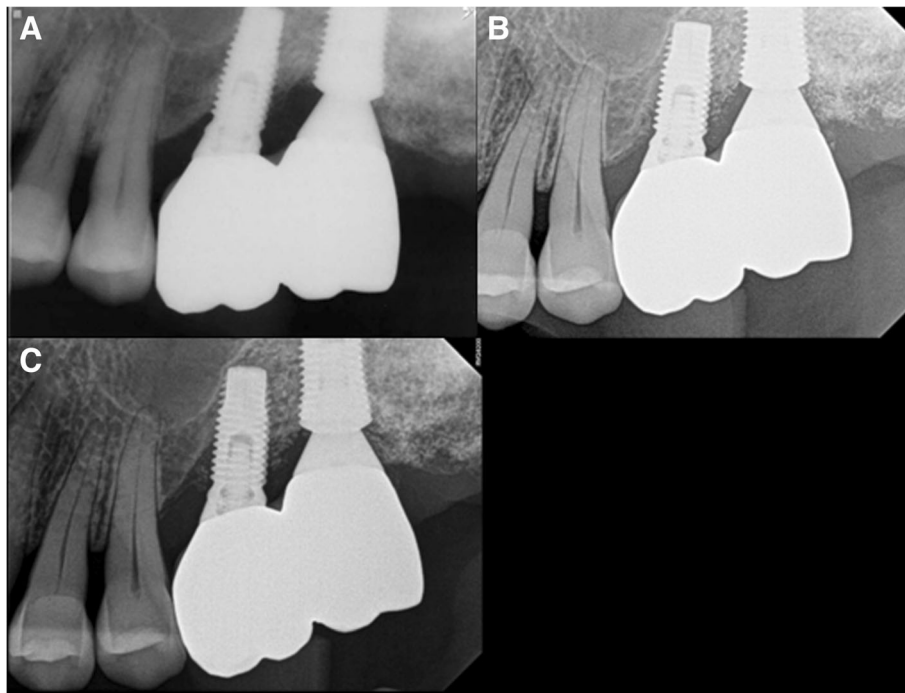
Fig. 8 F2, periapical radiograph, **a** #27i, prosthesis delivery, **b** #27i peri-implantitis, #26i increasing radiolucent lesion, **c** #27i peri-implantitis, #26i mesial bone loss

delivered (Fig. 8a). One year after prosthetic loading, peri-implantitis was observed. Therefore, subgingival curettage and injection of minocycline were performed in the gingival sulcus, and an increasing radiolucent lesion around the #26 implant was detected on periapical X-ray (Fig. 8b). After 3 months, peri-implant curettage on #26–27 implants, iBrush cleansing, KEY laser therapy, and injection of minocycline were performed. After 6 months, another round of curettage and minocycline injection was performed in the #26–27 implants (Fig. 8c). Marginal bone loss around the #26 and 27 implants was observed, but the implants survived without any symptoms. The final observation point was in January 2019, and the implants exhibited ideal loading at approximately 4 years 7 months (Fig. 9).

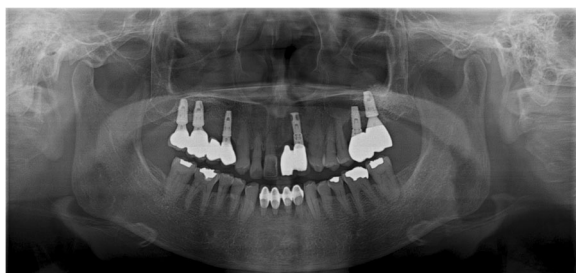
Fig. 9 F2, the final panoramic radiograph showing bone loss at #26i and 27i
