# Review on Coastline Change and Its Response Along the Cotonou Coast, Benin in the Gulf of Guinea, West Africa

**Key Words :** Cotonou, Benin, Coastline, Coastal erosion, Sea level rise

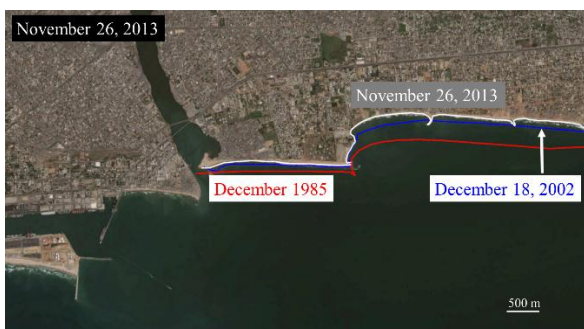
Fig. 6. Change of coastlines in east of Cotonou lagoon (red line: December 1985, blue: December 18, 2002, white/background image: November 26, 2013). Modified from Longueville et al. (2020).

A sign of coastal erosion in Cotonou started to be shown in 1963 (Codjia et al., 1997). After 24 years, the shoreline in east of Cotonou lagoon has been retreated by 400 m at a maximum rate

of 16 m per year. This equals approximately 1,120,000 m<sup>2</sup> of area. Even after 1987, the coastal erosion did not stop but kept recessing land. As a result, about 370 m additionally retreated between 1985 and 2002 (Fig. 6).

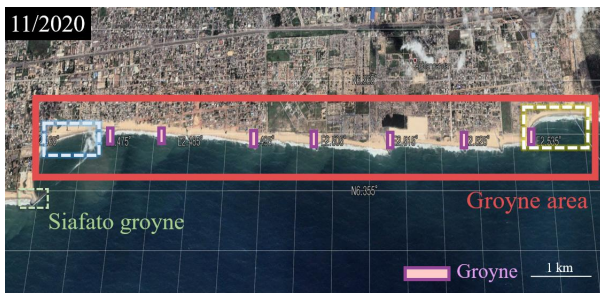
Fig. 8. Locations of Siafato groyne and 7 groynes in a groyne area on Google Map (November 2020)

In March 2009, the authorities in Benin implemented a measure to reduce erosion by closing all marine sand quarries at the Groyne zone. The measure showed positive result but was not enough to keep the coastline from retreating. Finally, Beninese government decided to build seven groynes, 8.3 km along the sea (Gulf of Benin) to the east of Sifato groyne, so that coastline can be stabilized (Fig. 8).

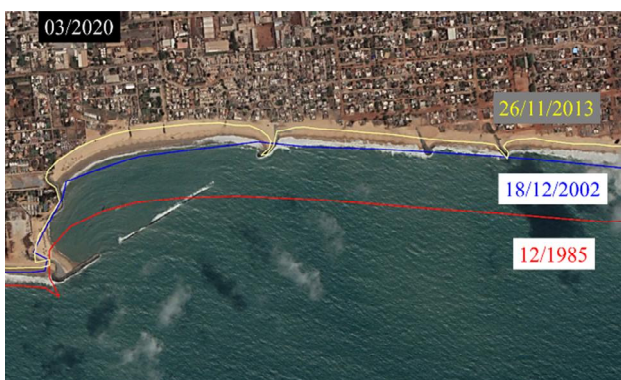
Fig. 9. Progress of destruction of coastline between 1985 to November 26, 2013 on Google Map (March 2020).

After implementing of seven groynes in 2013, notable local variations in groyne scale observed. The west side of groyne showed accretion while the east side of groyne showed fast erosion. However, still general stabilization was observed in Groyne zone (Fig. 9). In contrast, the next kilometers east of the Groyne zone where protective structures were not installed showed significantly severe erosion. As see in Fig. 10, coastline retreated rapidly with rate of 49m per year (2013-2018). This is likely caused by littoral drift that often brings unwanted effects to the neighboring beaches due to protective measures such as groynes (Choi et al., 2016).

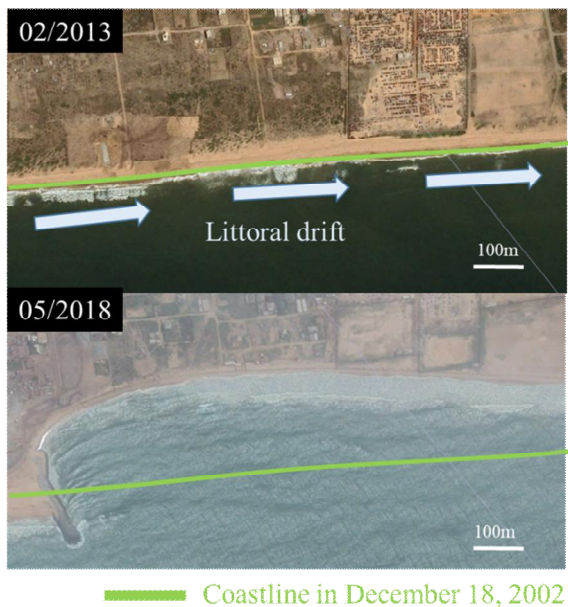
Fig. 10. Severe erosion at yellow boxed area in Fig. 5 due to littoral drift between February 21, 2013 and May 5, 2018.

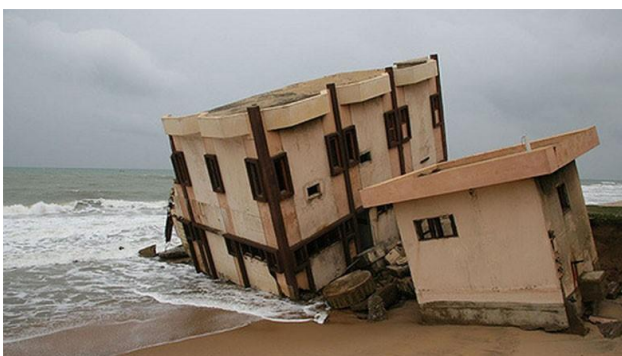
Fig. 11. Damaged hotel infrastructures by coastal erosion (Ocean Climate Alliance).

The industrial and the tourism sector of Benin are under the risk as well. The great parts of the industries of Benin located in the fourth district where coastal erosion gradually progresses. If coastal erosion keeps exacerbating, then over 1500 people who are working in over 30 state or private enterprises would lose their jobs (Dossou and Glehouenou-Dossou, 2007). Hotel infrastructure in Benin is also damaged and destroyed by the sea (Fig. 11). Since those two sectors considerably contribute to the national economy, the disappearance of these facilities would possibly lead Benin towards great economical danger.

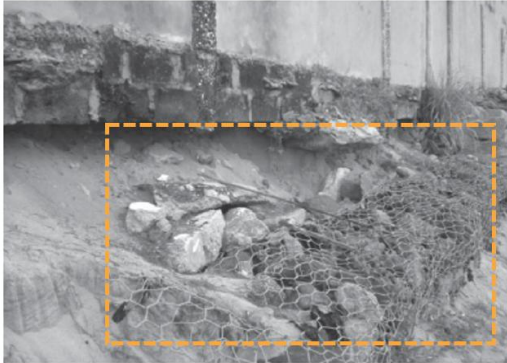
Fig. 12. An example of passive adaptation (reprinted from: The vulnerability to climate change of Cotonou (Benin): the rise in sea level).

Passive measures require the adoption of decisions or attitudes to avoid or mitigate the negative effects of rising sea levels and coastal erosion (Dossou and Glehouenou-Dossou, 2007). These measures were implemented shortly after the construction of the Port of Cotonou. As see in Fig. 12, beach rocks used to protect the shoreline. In addition, sandy sediment was added to erosion risk

area, so that sandy sediments can be transferred from well-stocked area to poor-stocked area.

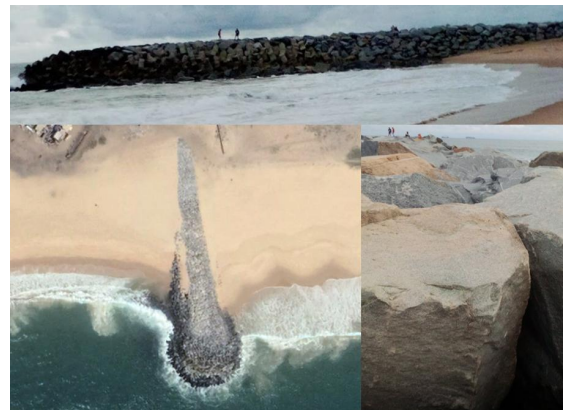
Fig. 14. One of seven groynes built in 2013 as a technical measure.

Later in 2013, Benin authorities built another seven groynes at 8.3 km along the sea (Gulf of Benin) to the east of Siafato groyne (Fig. 14). It also successfully mitigated the coastal erosion in the area. 33 out of 37 risk residents who participated in the 2013 interview answered that they felt serenity accordingly (Longueville et al., 2020). However, erosion transferring to the east founded in 2018 as Siafato groyne case.
