Review of Fatigue Failures in LWR
Plants in Japan

A review of fatigue failures in LWR plants in Japan

Kunihiro Iida

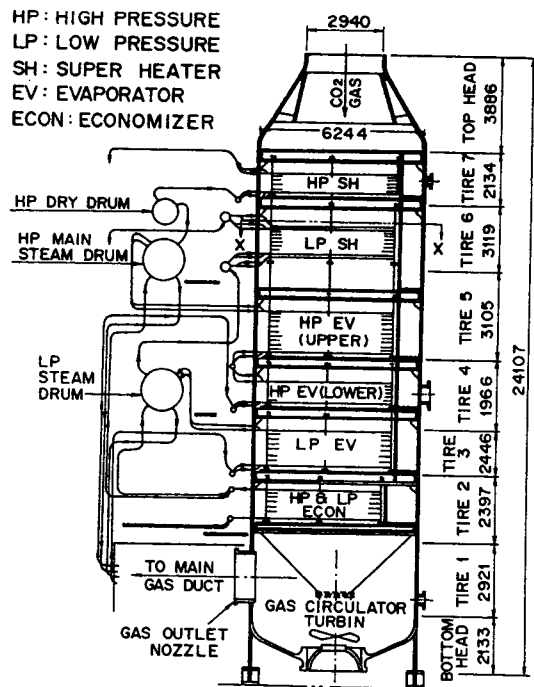
Fig. 1. Vertical section of steam raising unit.

The first case of service fatigue failure in the history of Japanese nuclear power plant operation was experienced in 1966 in Tokai No. 1 Nuclear Plant [3]. This is the first plant constructed in Japan, and even today it is the only gas-cooling-type reactor. One month after the start of commercial operation the plant had to be shut down because of steam leakage from low-pressure super heater tubes in all four steam raising units. Figure 1 shows the vertical section of a steam raising unit. A high-speed flow of CO₂ gas comes down from the top of the unit for the purpose of heat exchange. The fatigue failure occurred in tubes located in the low-pressure super heater unit.

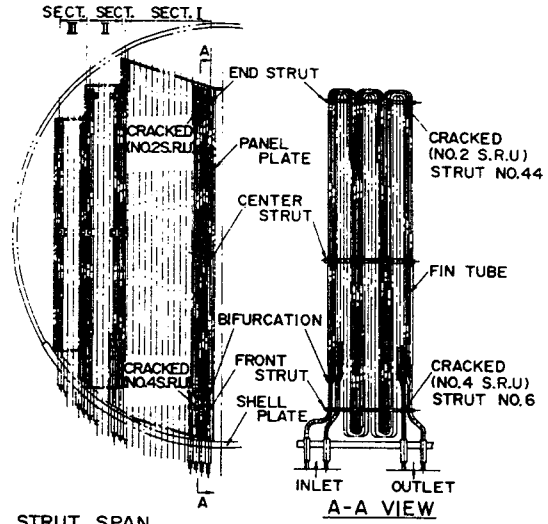
Fig. 2. Horizontal section (X-X in fig. 1) of steam raising unit.

As shown in fig. 2, tubes of low carbon steel were supported by struts in three groups with a span of 2.2

m and 2.5 m. Because of the requirement for anti-oscillation in an earthquake condition, a semicylindrical cover plate of 7 mm thick was fillet-welded on a strut to fix the tube, which was inlaid in a groove on the strut, as shown in fig. 3. Finally circumferential fillet welding was executed on both edge faces of the strut and the cover plate.

Fatigue cracks were found in a certain range of fillet toes, which is a localized area perpendicular to the coolant gas flow direction. This observation was considered to afford an evidence of fatigue cracking caused by bending vibration in the horizontal plane. Dynamic displacement measurement was carried out to prove the bending vibration due to Kármán vortex generated by the coolant flow. The fracture surfaces were examined by micro-fractography. Although most

of the fracture surface was covered by heavy scale, it was successful to find, at some spots of the fracture surface, well-defined striations, which propagated from the inside to the outside of the tube. In order to obtain information about the striation spacing versus fatigue crack propagation rate relation for the material of the tube, displacement-controlled fatigue tests of full-size tubular specimens of the same material as that of the damaged tube were carried out in a laboratory. As a result of comparative examination of the fracture surfaces by service failure and by fatigue experiment, it was concluded that the repeated load at a relatively high frequency caused the service fatigue failure. High frequency bending loading could be caused by resonance when the frequency of the Kármán vortex generated by the gas flow matched with the natural frequency of the supported tube. Superimposed on this loading might be low-cycle thermal stress cycling, which was possibly caused from the restraint imposed by the rigidity of the supporting structure.

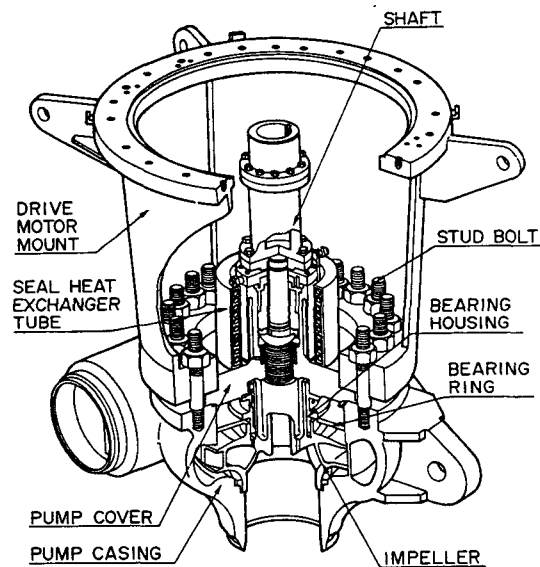
Fig. 7. Re-circulation pump assembly.

A vibration fatigue failure not by Kármán vortex, but by forced vibration due to impeller revolution, was first experienced in 1984 in a BWR plant. In the course of the start-up run after a periodic exchange of mechanical sealing, a re-circulation pump produced abnormal noise from the inside. The pump was immediately dismantled, revealing that about one-half of the bearing ring plate welded to the hydrostatic bearing housing had been removed, and it rested on the upper shroud of the impeller. A schematic view of the pump is shown in fig. 7. As shown in fig. 8, it is the purpose of the bearing ring plate to form an orifice, a narrow gap between the bearing ring plate edge and the inside surface of the pump casing. Due to the passage resistance at the orifice, the amplitude of fluctuation of hydraulic pressure caused by the revolution of the impeller blades is reduced considerably, and the hydraulic pressure with little pulsation works as hydrostatic bearing action. The bearing ring of ASME A-240-type 304 stainless steel is fillet-welded on the cir-

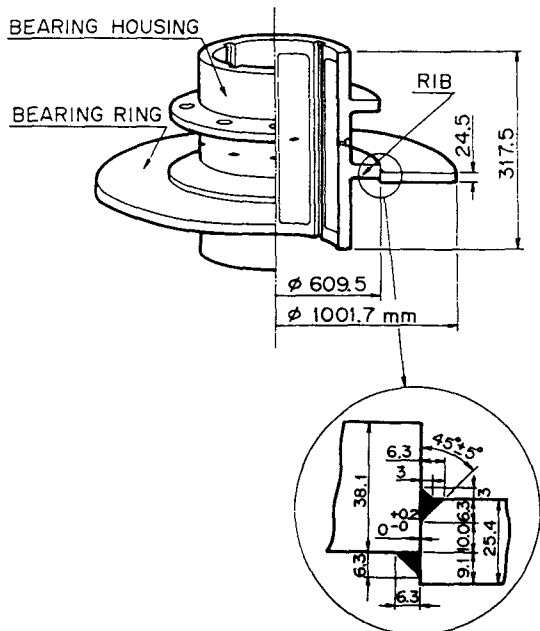
Fig. 11. Welding design of fillet welded joint in hydrostatic bearing.

Figure 10 shows the cross-sectional weld shape at several sections. Despite the welding requirement of full penetration in upper and lower edge preparations, as shown in fig. 11, lack of penetration is obviously found in the greater part of the girth length of the fractured welded joint. In particular, very poor penetration, approximately one-half depth penetration, was observed in the range of about 30 degrees of the angle at the circumference. These joints were welded by manual arc welding. A quantitative examination on the percentage of lack of penetration, which is the ratio of the lack of penetration depth to the designed penetration depth, was made, showing the following results: 50% at a maximum and 23% on average for the upper side fillet joint, and 3% at a maximum and 1% on average for the lower side fillet joint. Microfracto-

A lesson obtained from the failures mentioned above is that use of a welded joint, whose soundness is difficult to check by non-destructive inspection, should be avoided in a strength member. Following this philosophy, all hydrostatic bearing rings in all BWR plants were replaced, as a countermeasure for recurrence prevention, either by full penetration butt welded type or monoblock casting type, shown in fig. 13.

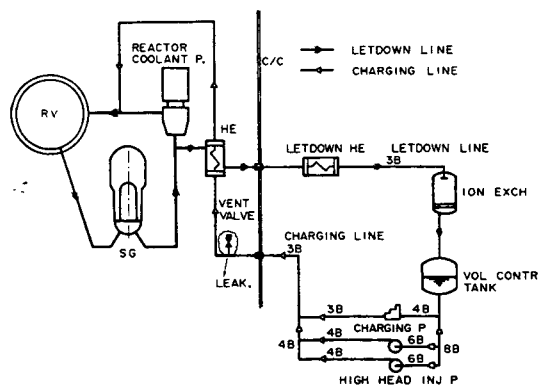
Fig. 14. Chemical and volume control system.

It may be generally said that the piping system is usually subjected to vibration induced by the connected motor, self-excited vibration, parasitic vibration, and others. Often experienced is resonance-induced fatigue failure of a short pipe with a top-heavy element. One example of such phenomenon was experienced in a PWR plant, which was under service operation at the rated output. During the service, the rise of water level was found abnormal in a sump pit, suggesting possible leakage of the coolant in the container vessel. A leakage occurred from a crack at a toe of welds joining a vent pipe to a charging line pipe in the chemical and volume control system, as shown in fig. 14 and fig. 15.

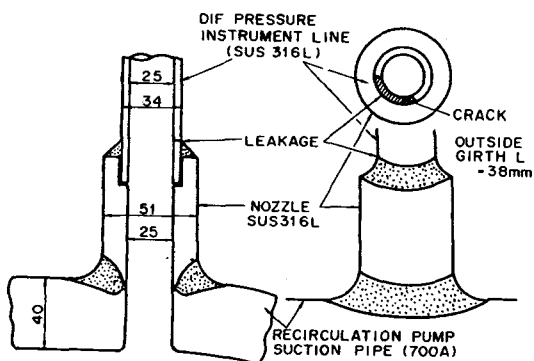
Fig. 19. Details of welded joints.

Figure 18 shows another example of service fatigue failure that occurred in a different pressure measuring instrument line for a primary re-circulation line due to the resonance vibration of the piping system. As shown in the dotted line frame labelled "initial," the structural component was top-heavy and the rigidity of the horizontal pipe branched from the tee was not high enough to prevent oscillation of the pipe-valve system. Details of the weld design of the set-on and socket welded joints are shown in fig. 19. Leakage occurred

from a crack, which initiated from a toe of the welds. Microfractographic examination showed well-defined striation on the fracture surface. The valve was temporarily assembled only for the trial operation. Although the valve was not used after the trial operation, it was left as it was, while the opening of the pipe downstream of the valve was stopped by a welded plug.

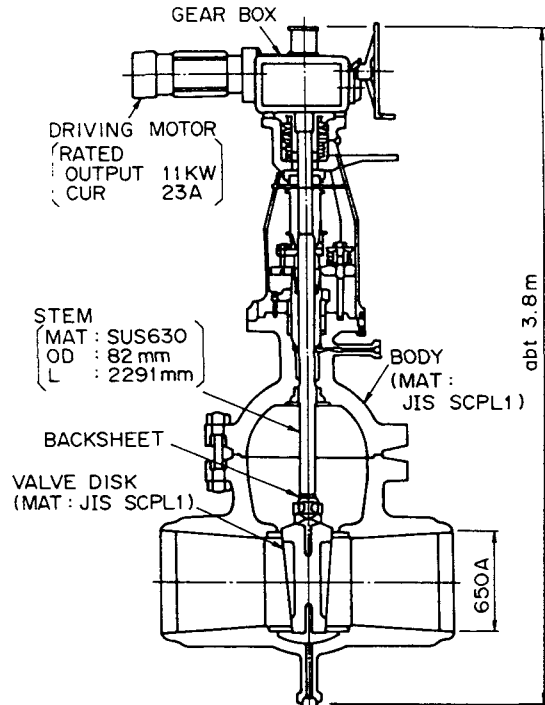
Fig. 25. Section of main steam stop valve.

Figure 24 illustrates fatigue failure of a valve component. A fatigue crack started from a corner of a cut-out in the yoke. Fatigue failure of a valve stem rod is shown in figs. 25 and 26. Such fatigue failures are due to vibration of a valve disk, which is forced to vibrate by by-path turbulent flow, when the disk is pulled up.

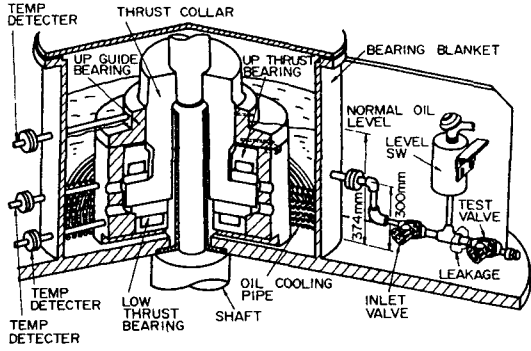
Fig. 27. Bearings and oil level gauge piping.

The final example of vibration-induced fatigue failure is shown in fig. 27 and fig. 28. In this case a lack of root penetration of the socket welds contributed to the initiation of the fatigue crack.

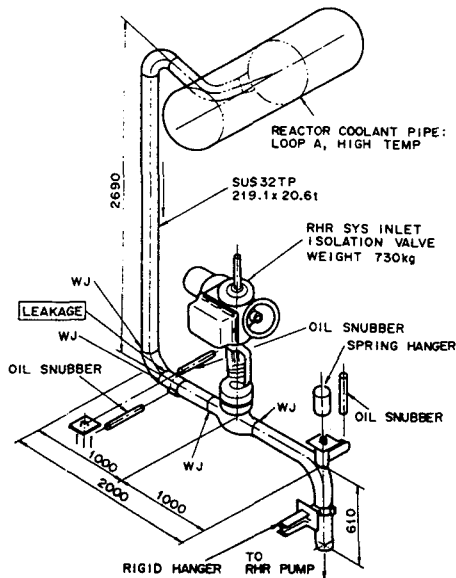
Fig. 32. Residual heat removal system piping.

Recently an interesting and extraordinary fatigue failure, which was experienced for the first time in Japan, occurred in a PWR plant. Because of an increase in flow rate to the containment sump pit, the plant was brought to a shut-down for inspection. Leakage was found at the butt welded joint between an elbow and a straight pipe, which was welded to the first isolation valve in the A-loop residual heat removal system piping, as shown in fig. 31. A sketch of the

layout of the pipes and valve is shown in fig. 32. An examination showed, as shown in fig. 33, that multi-site cracks initiated on the elbow side toe line of the welded joint, and propagated through the weld metal

As a result of observation of the inner surface of the elbows and the horizontal straight pipes illustrated in fig. 32, it was found that the inner surface of the straight pipe, which was welded both to the upstream side flange housing of the isolation valve and to the cracked elbow, was covered by oxide, showing classification into three regions depending on colour and oxide thickness, as shown in fig. 34.
