# ASTUDY ON THE FORMATION OF IMPERFECTIONS IN CW CO<sub>2</sub> LASER WELD OF DIAMOND SAW BLADE

by Minhyo Shin<sup>1\*</sup>, Changhee Lee<sup>1</sup>, Taiwoung Kim<sup>2</sup>, Heedong Park<sup>2</sup>

## ABSTRACT

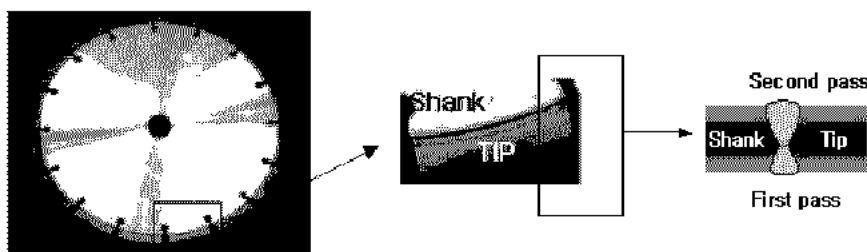
Fig. 1 Components of a diamond saw blade

Fig. 1 shows two components of a diamond saw blade, 1.8mm thickness mild steel shank and 2.4mm thickness Fe-base sintered tips joined by a continuous CO<sub>2</sub> laser. Weld tests were conducted with the various parameter combinations shown in table 1. The first welding was done at a fixed low heat input condition (3.5m/min of travel speed and 750W of beam power) and the second pass welding was made with variable conditions shown in table 1. The laser beam was focused on the top surface of the shank. The shielding gas was Ar with 80ℓ/min flow rate.
