Development of Dismantling Techniques for Irradiated HANARO Instrumented Capsule (03M-06U) in IMEF

Yong-Sun CHOO, Do-Sik KIM, Wan-ho OH, Seung-Je BAIK, Byung-Ok YOO,
Dae-Kyu Park, Sang-Ryul Baek, Ki-Nam JOO
Irradiated Materials Examination Facility, Korea Atomic Energy Research Institute,
P.O. Box 150, Yuseong, Korea, 305-600

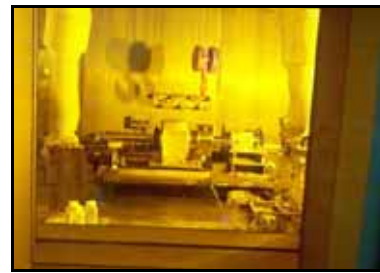
Figure 2. Cut and dismantle 02M-02K by capsule cutting machine in M2 Hot cell.

The top and the bottom parts of capsule were cut by capsule cutting machine as shown in Fig. 2, specially designed for cut the HANARO fuel assembly and capsule irradiated at HANARO. The revolution of wheel and the moving speed was 200 rpm and 0.15 mm/min respectively.
