A CASE STUDY OF GROUND CAVE-IN DUE TO SUBSURFACE EROSION IN OLD LAND FILL

ABSTRACT

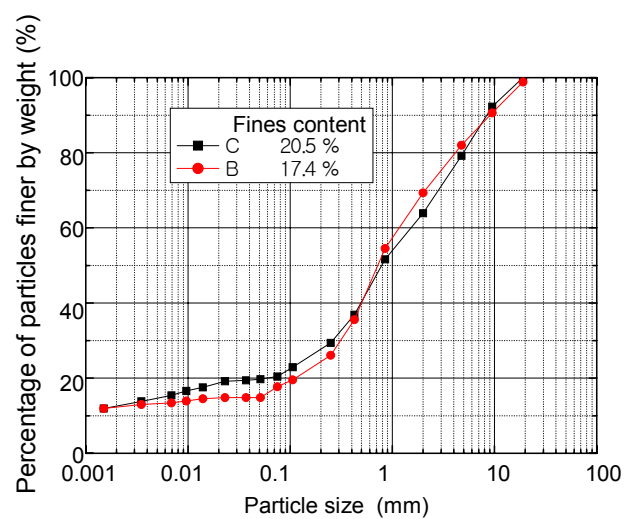
Figure 6. Particle size distribution

were also included, which indicates the excavated strata were filled soil. Atterberg limits and particle size distribution are shown in Table 1 and Figure 6, respectively.

Table 1 Atterberg limits of soil sample taken from the hole

B	C
Liquid Limit	24.4	23.2
Plastic Limit	18.4	15.3
Plasticity Index	6.1	7.9

The soil was permeable, subjected to the erosion relatively easily. Fines can be first flown away with water, which created ground loosening around the cavity.

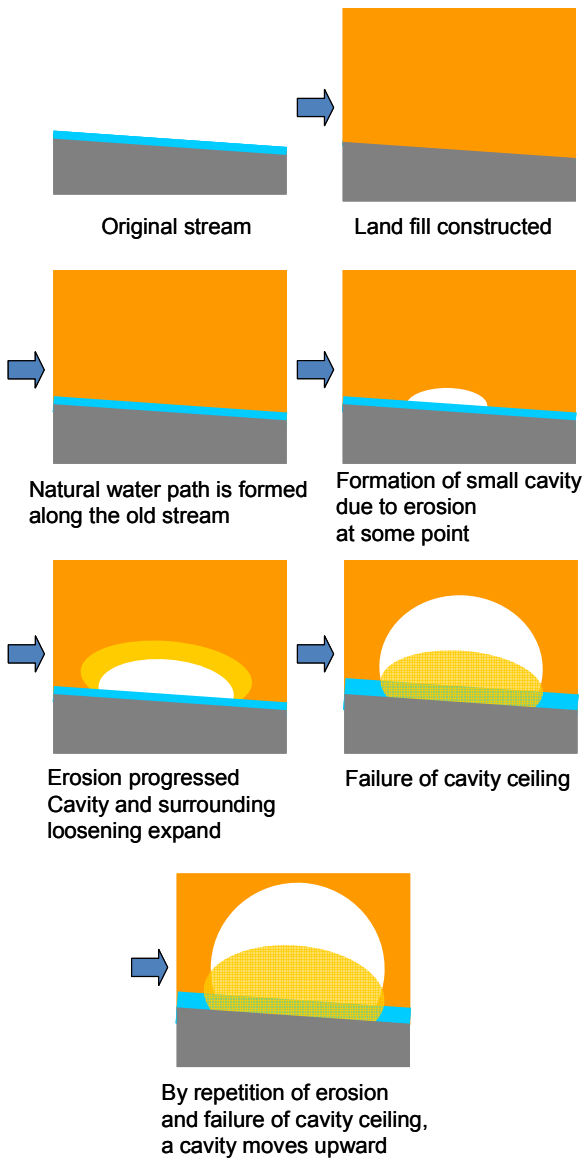
Figure 10. Formation of underground cavity

Ground appeared to be internally eroded by the natural water path formed at the old stream. It is like a natural drainage pipe, so that it is generally called soil pipe. As the erosion of the soil at the location of the collapse seemed to be accelerated for some reason, a distinctive ground cavity was created. The hidden cavity grew silently, possibly due to the seasonal change of ground water level and eventually caused ground collapse. Such a process is schematically shown in Figure 10. However, the state and the condition of the installed drainage pipes are not yet examined. Further investigation is required in this aspect.

There was a subsurface water path which can transport soil out of the hole with water. There is also seasonal change in ground water level, which may accelerate the cavity growth as the saturation of soil at the ceiling helps failure and expansion of the cavity.

Direct trigger of the formation of natural water path may be a defect of drainage pipe. But the state and the current condition of the pipes have not yet examined.

A case of large scale ground collapse in the old fill ground was investigated and described in this paper. The underground cavity appeared to be caused by subsurface erosion deep in the ground and to expand upward till it was eventually caused the catastrophic failure. It should be noted again the importance of proper drainage work in land fill construction.

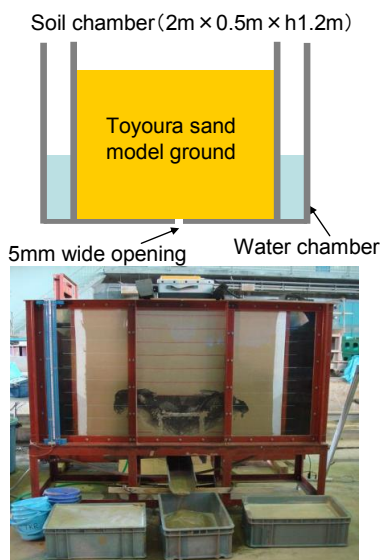
Figure 11. A soil chamber for cavity formation test

Kuwano et al. (2010)¹⁾ and Sato & Kuwano (2008)²⁾ investigated the mechanism of ground cavity and surrounding loosening due to the failure of sewer pipes. It was found that the state of water infiltration and soil properties are the governing factors for the growth of the ground cavity and loosening, while the failure of pipe is a trigger of the phenomenon. Kuwano et al. (2010)³⁾ further conducted a series of mode tests to examine the pattern of underground cavity formed in Toyoura sand model ground in case that constant subsurface water flow exists, using soil chamber as shown in Figure 11. A cavity expanded laterally, as shown in Figure 12, with time until the ceiling of the cavity lost its stability.

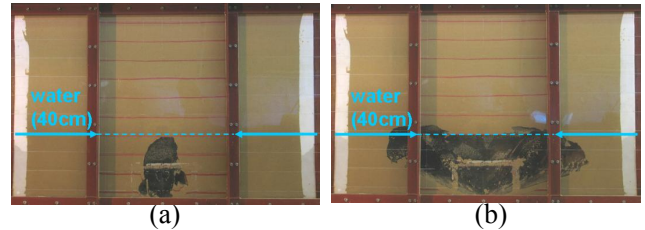
Figure 12. Process of cavity formation (a: 16 minutes after water table was raised to 40cm, b) 84 minutes after water table was raised to 40cm.
