# The Effects of Remedial Works to Control the Leakage Problem in Earth Fill Dam by Compaction Grouting

## 콤팩션 그라우팅에 의한 흙댐의 누수복원 공사효과 분석

The sinkhole and leakage in dam core were detected at one of earth fill dams in Korea. The damage areas in the core of the dam were repaired by compaction grouting method. This study is to evaluate compaction grouting activity by in-situ and laboratory experiments before, during and after the remedial work. The intensive site investigation and geophysical survey were conducted during and after the compaction grouting work. The compaction grouting work was carried out for the damaged dam core between June 16 and August 24, 2000. The leakage reduction generally occurred in the core of the dam after the remedial work. The use of compaction grouting was considered the proper countermeasures for repairing the damaged dam. It shows that the loose or voided zones have been properly filled and the leakage has been reduced by about 96% of that before the treatment of the remedial work performed at dam core by compaction grouting.

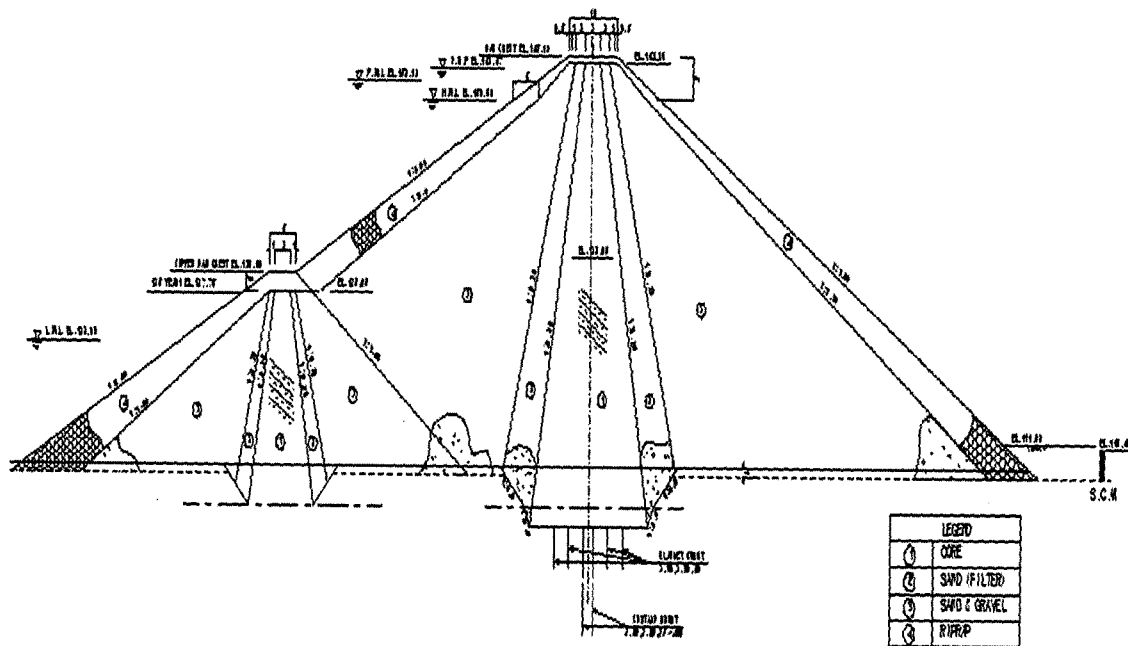
Fig. 1. Cross section of earth fill dam

shown in Figure 1 (Korea Water Resources Corporation, 2000; Lim et al., 2004). The dam reservoir was filled with water in October, 1993 and was full by 1998. A small cavity was discovered on the dam crest in June, 1998, when the reservoir water level rose to 150 m after the first impounding and the sinkhole developed in the dam body in July, 1999 at Sta. No. 10 and 12 of dam. Although the cavity and sinkhole was refilled by rubble and soil, the cavity and sinkhole continuously occurred. A comprehensive investigation was executed to characterize the leakage through dam body. The leakage of reservoir water was detected at lower stream of dam. The leakage is generally caused by insufficient basic foundation treatment in the process of dam building or dam's behavior such as tension cracks due to weight and water pressure and external corrosion by permeation. Irrigation facilities become weak or degraded by weight and external force as time elapses and this phenomenon causes safety problems of the facilities. Leakage problem, affecting safety of the irrigation facilities most, is caused locally rather than wholly. Infiltration, directly affecting disaster by damage of dam body or large leakage, is rather caused in water stratum than in layer. The water pressure in water stratum rises due to the sudden rise of water level by severe rain storm or typhoon, and it causes high pore water pressure in surrounding soil masses and movement of soil particles in partial. This process

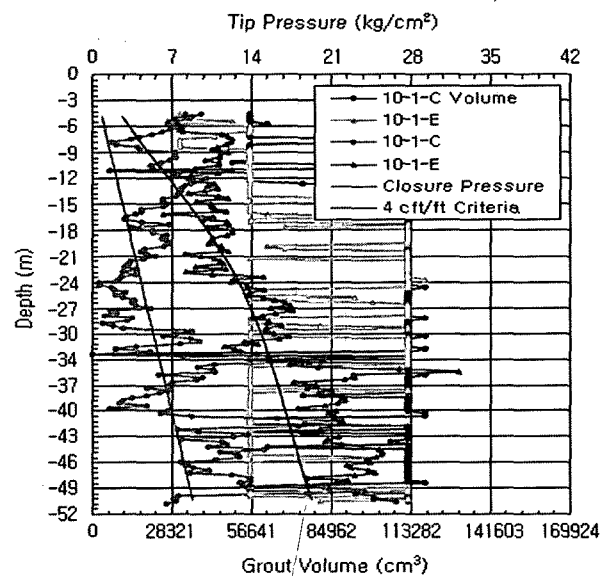
Fig. 3. Pressure and volume of compaction grouting

Based on the logging data for the actual injected pressure and dosage, the core condition prior to the grouting activity was implied. The compaction grouting for the weakest regions was conducted at Sta. No. 10 and Sta. No. 12 from May 18 to August 24, 2000 (Korea Water Resources Corporation, 2000; Lim et al., 2004). A dry drilling method for the best application of compaction grouting was used. The compaction grouting was conducted in advance for every 0.3m from the bottom of excavation. It was reported that the grouting activity continued until the designed injection pressure-dosage. The injection pressure and slurry amount were automatically measured and recorded. It was speculated that the point in which a large amount of slurry was injected would be loose; it thus means the risky points in terms of stability. The grouting injection analysis on the pressure and dosage was intensively conducted through many sections of the dam core. Figure 4 demonstrates the order of drilling borehole and grouting works to confirm the grouting effects. The compaction grouting was applied at the distance of 80 m around Sta. No.10 and 12 as shown in Figure 4. The number means the order of compaction grouting works and the unit of cubic cm ( $\text{cm}^3$ ) at the lower figure means the injected grouting volume.

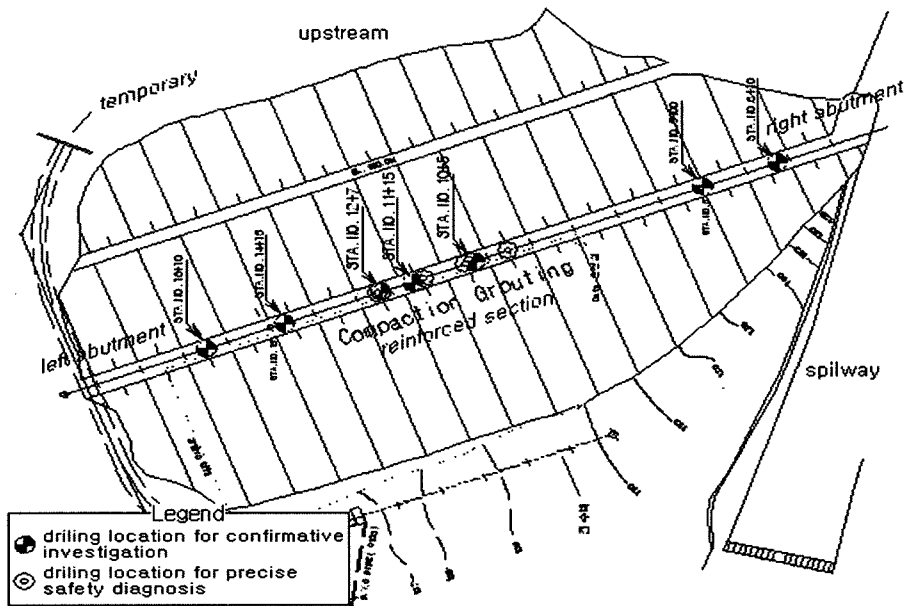
Fig. 6. The investigation drilling location which enforced in precise safety diagnosis and confirmative investigation

Figure 6 presents the borehole location for precise safety diagnosis and confirmative investigation (Korea Water Resources Corporation, 2000; Lim et al., 2004). At the region repaired by the compaction grouting, the four boreholes were drilled for the detail investigation and three boreholes were drilled for the confirmation of the grouting. In-situ and laboratory experiment were conducted through the borehole to determine pore pressure, permeability, N value, water content, liquid and plastic limit, etc. and the V-notch to determine leakage and seepage through dam body. V-notch was used as a weir installed at downstream to determine discharge and flowrate. In addition, geophysical survey was performed at crest and downstream of the dam. The measuring device was installed at Sta. No. 9 to 13. To investigate

the remediation effects on the damaged core zone, the injection materials were sampled at the site (D-2) where originally the core materials were existed.

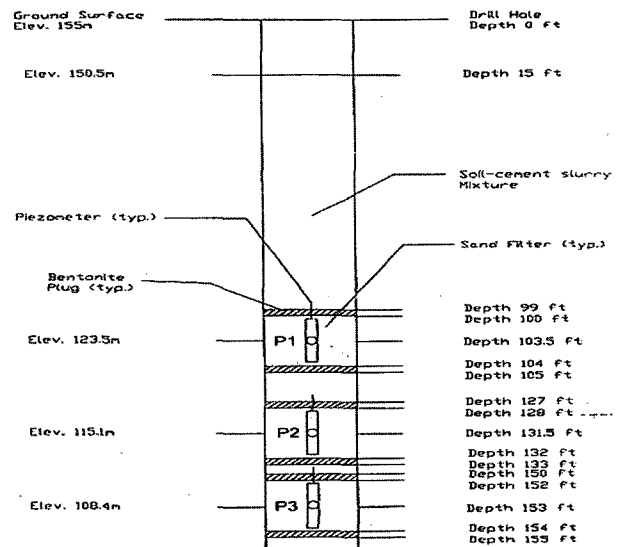
Fig. 14. Pore pressure instrumentation

When the compaction grouting was performed, piezometers were installed at Sta. No. 10 and Sta. No. 12. The three piezometers were installed at each measuring point as shown in Figure 14 and Figure 15. The pore pressure was automatically measured and recorded with the injection pressure and dosage. Table 2 shows the pore pressure measuring location, grouting date, dosage and reservoir water level. The measured pore pressures of the borehole at Sta. No. 10 and Sta. No. 12 were illustrated in Figure
