## Investigation and Analysis of the Occurrence of Rail Head Checks

Ying JIN\*, Fusayoshi AOKI\*\*, Makoto ISHIDA\*, and Akira Namura\*

### Abstract

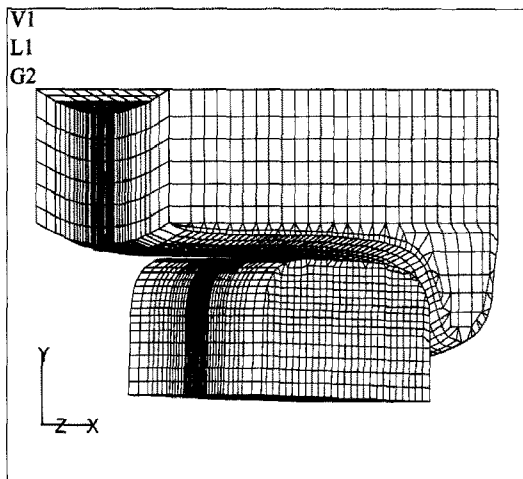
Fig. 10 A Wheel-rail Contact Model of Three-dimensional FEM

A three-dimensional wheel-rail contact model shown in Fig. 10 was used to simulate the contact between the wheel and the rail. The contact stress analysis for various profile combinations of wheels and rails was carried out elasto-plastic finite element method (FEM). To realize the contact geometry of actual wheel and rail, the wheel load, the lateral force and the angle of attack measured at dynamic test points, and the worn profiles of actual wheel and rail were used in stress analyses. Table 2 describes conditions for contact stress analysis including various load conditions. Here, the averages of wheel load and the maximum of lateral force for each type car are given, and the static and dynamic friction coefficients are assumed as 0.5 and 0.3 respectively.
