Preliminary Round Robin Test(RRT) for Program for the Inspection of Nickel Alloy Components(PINC) - Reactor Vessel Head Penetration (RVHP) -

Kyungcho Kim*[†], Sungsik Kang*, Hosang Shin*, Myungho Song*,
Haedong Chung* and Yongsik Kim**

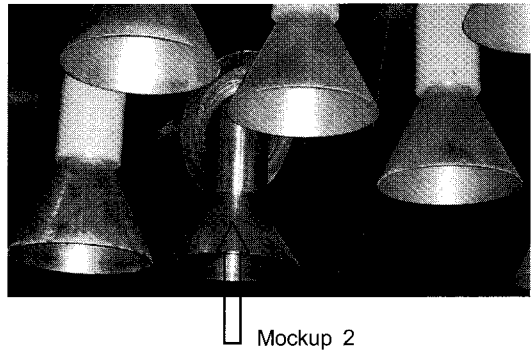
Fig. 2 Photo of Pre RRT mockups

Preliminary RVHP RRT (Pre RRT, from now) has been performed using four mockups during 2005.11.17-19(A) and 2006.03.27-3.30(B) and the result of Pre RRT was analyzed during 2005.11.17-19(A) and 2006.03.30-4.30(B) due to that PINC RVHP RRT was supposed to start from the beginning of 2007. In the Pre-RRT, 2 teams(A, B) used the TOFD and ECT method. Pre-RRT objects are 4 mockups which were supported by KPS as in Table 1 and Fig. 2. Table 2-5 shows information for RVHP mockups.
