# A Case Study on the Assessment of Damaged Cause for the Damaged Reinforced Concrete Pier

**Abstract :** In this thesis, appearance inspection, compressive strength of concrete test, arrangement of bar inspection, survey, and bearing stress analysis were performed on a damaged coping of reinforced concrete pier to investigate the damage cause. According to the performed a series of inspections, it was found that the coping of pier was damaged during PSC (Pre-stressed Concrete) beam construction. In this thesis, the repair method for damaged pier was studied. The repair procedure used in this thesis was follows : chipping for damaged part, clean by high-pressure, installation of wire mesh, coating of surface hardening, construction of section restoration material, copula grinding, and prevent coating for far-infrared radiation.

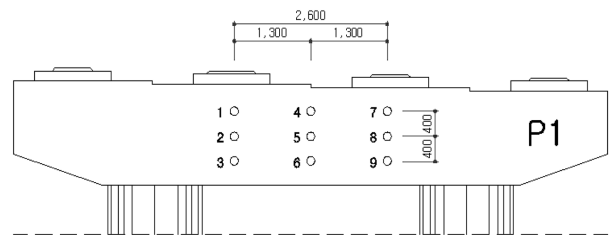
Fig. 13. Measurement location of NDT at direction to abutment 1 and pier 2.

In this study it were evaluated the range influence of local bearing load or impact load. For the damaged coping and sound coping was evaluated the difference of concrete quality variation. Hereunder the ultrasonic pulse velocity tests were measured, and the location is illustrated in Fig. 5 and Fig. 6 for the northbound lane, in Fig. 13 for the southbound lane.

Descending process of the current damage of the PSC beam is a large stress is generated locally. This exceeds the allowable bearing stress was believed to be due to the bearing stress. It is estimated the main damage cause when deflection or eccentric load act the edge of bearing concrete. The damaged concrete is restrict to concrete exfoliation.
