DETECTION OF ODSCC IN SG TUBES DEPENDING ON THE SIZE OF THE CRACK AND ON THE PRESENCE OF SLUDGE DEPOSITS

HANSUB CHUNG*, HONG-DEOK KIM, YONG-SEOK KANG, JAE-GON LEE, and MINWOO NAM
Korea Hydro Nuclear Power - Central Research Institute
70 1312-gil Yuseong-Daero Yuseong-Gu Daejeon, 305-343, Korea
*Corresponding author. E-mail : 007chung@khnp.co.kr

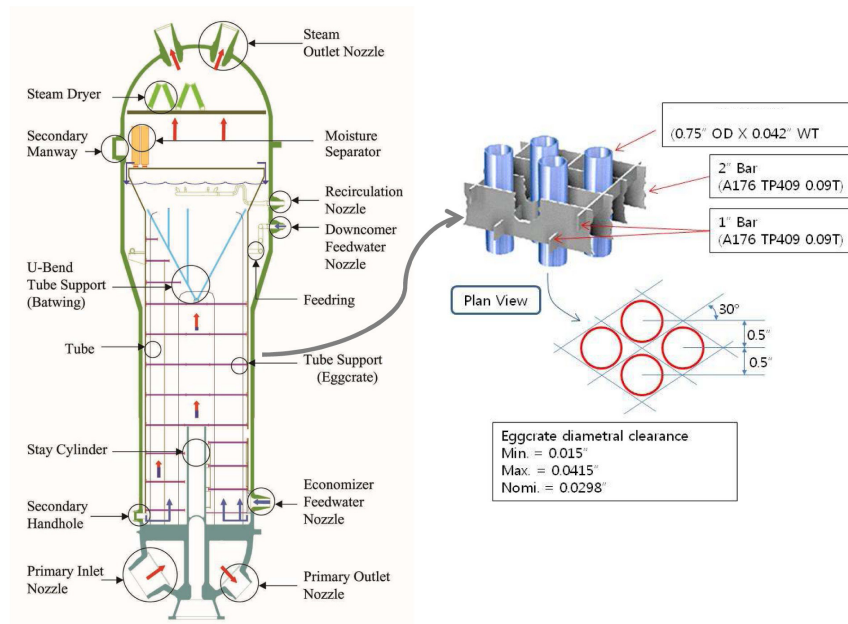
Fig. 1. Steam Generator and Egg Crate Tube Support Plate

Since an extensive number of the SG tubes had been affected by ODSCC in HU3&4, their SGs were replaced during the 12th and 10th refueling outages respectively. Details of the ODSCC were reviewed and discussed in the previous paper [1]. Axial cracks had developed near the line contacts between the tubes and the strips of the TSPs, where an occluded region formed preferentially by sludge deposition. It is understood that the corrosive en-

environment formed by concentration of impurities inside the occluded region causes ODSCC. It is a hideout mechanism that impurities are concentrated inside the occluded region by localized boiling under heat flux from the inside to the outside of SG tubes [2, 3]. The ODSCC was found to occur mostly in the heavy sludge deposit zone of the SG. The heavy sludge deposit zone was near the center of the hot leg half circle in the elevations between the 5~9th TSPs, as defined by a thermal-hydraulic analysis using the ATHOS code [4]. The Thermal Hydraulic Aided Colloidal Concentration deposit parameter is defined as $\rho v / (1-x)$, where ρ is the two phase fluid density, v is the fluid velocity, and x is the steam quality. The higher the THACC deposit parameter, the heavier the sludge deposit. Figure 2 shows the distribution of the THACC deposit parameter as analyzed by the thermal hydraulic calculation. The thickness of the sludge deposit can be estimated by analyzing the bobbin coil probe eddy current inspection signal, since the magnetic permeability is increased by the sludge deposit [5]. Careful analysis of the plant bobbin coil inspection signals indicated that the trend in Figure 2 was valid.
