Blocking of Fuel Filter in Aircraft by an Accelerator Blooming

Ik-Sik Kim[†], Young-Ha Hwang, Kyung-Suk Sohn, Jung-Hun Lee, and Byung-Hoon Sohn^{*}

Aero Technology Research Institute, The Republic of Korea Air Force, P.O. Box 304-150,
352 Ayang-ro, Dong-gu, Daegu, Korea

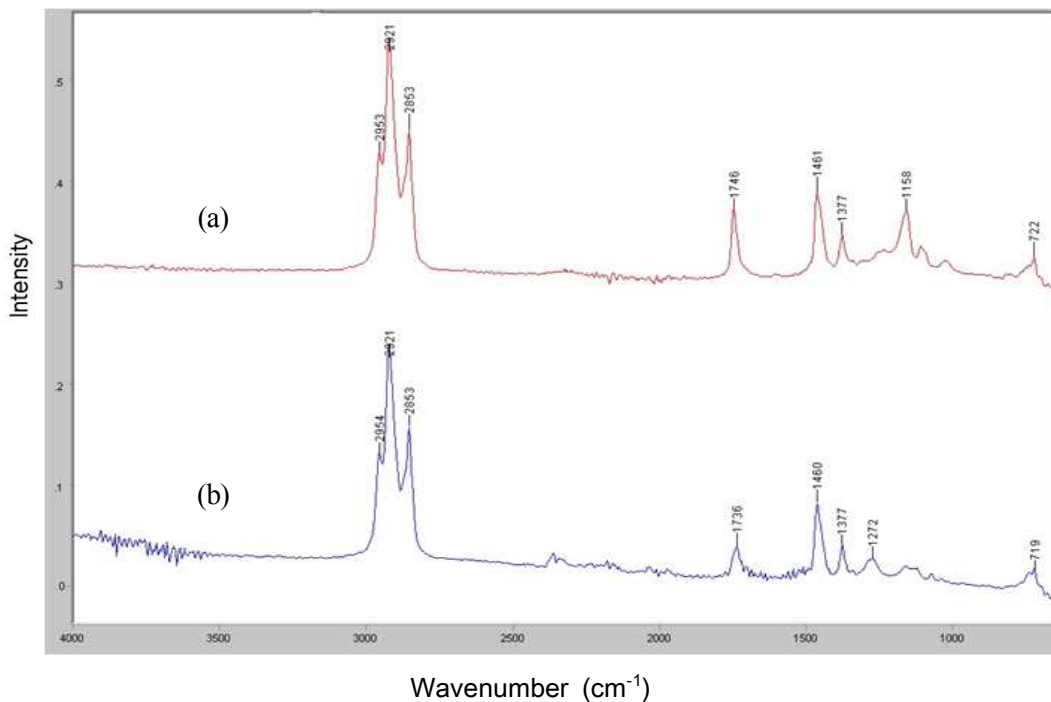
Figure 4. FT-IR spectra of yellow-brownish liquid for (a) the more severely failed fuel filter and (b) the less severely failed fuel filter.

Before disassembling the fuel filter, extraction of impurities from outside of two failed fuel filters was performed. After completely digging fuel filter in *n*-hexane, an ultrasonicator was worked about 10 min. Figures 3(a) and (b) show that the extract of the failed fuel filter (a) is more black-brownish than that of the failed fuel filter (b) in beaker. Each extract is separated into a yellow-brownish liquid and blackish particles by filter paper (No.10). A yellow-brownish liquid is evaporated by heating and then identified with FT-IR microscopy. Figures 4(a) and (b) show the IR spectral patterns of yellow-brownish liquid for two failed fuel filters. A yellow-brownish liquid of two failed fuel filters is identified to
