Characterization of Burned Architectural Woods by Fire Using SEM-EDXS and Computerized Tomography¹

The nation's first national treasure, Sungnyemun, which was badly damaged by fire on February 10th 2008, had 10% and 90% physical damage on the first floor and second floor of a gate tower, respectively.

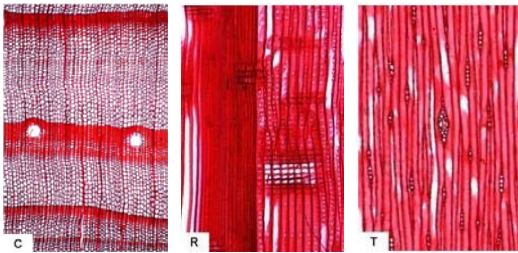
Fig. 4. A fan-rib rafter 1's 3sections structure. C: cross section, R: radial section, T: tangential section.

Tracheid arrangements in the transverse phase (Fig. 4. C) was orderly and longitudinal resin canals were present and epithelial cells surrounding resin canals were observed. In the radial section, a radial structure was made of ray tracheids and ray parenchyma cells. Ray tracheids were distributed in the upper and lower sides and dentate thickening was found in the ray tracheid's internal wall. Whether dentate thickening existed or not is an important systematic characteristic to distinguish *Pinus* and *Pinus koraiensis*. Cross filed putting's structure was window like and was distributed one at a part (Fig. 4. R). In the tangential section (Fig. 4. T), radial structure was uniseriate, 1-15 cells, most 10 cells and longitudinal resin canal was distributed (Jung *et al.* 2002).
