선체 부식 및 손상 부재를 고려한 침몰선박의 구조 안전성 평가에 관한 연구 - 제7 해성호를 중심으로 -

Structural Safety Assessment of a Sunken Ship Considering Hull Corrosion and Damaged Members - Focus on the Sunken Ship ‘No. 7 HaeSung’ -

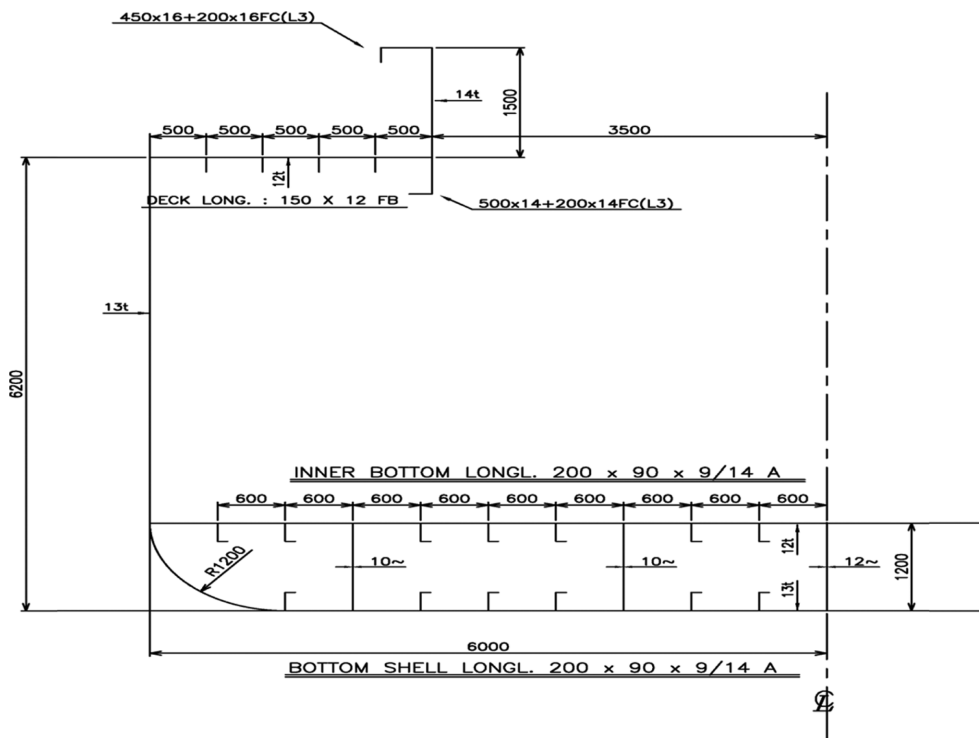
Fig. 4. The Mid-ship Section of 'No.7 HaeSung'.

weight of the vessel and the longitudinal strength. The arrangement of the transverse structure members is determined according to the length and width of the vessel. In this sunken ship, it is determined with reference to the arrangement of the transverse structure members in a similar ship and as per the regulations of the Register. The dimension of the kind girder is referred and chosen by the dimensions of a similar ship. As presented in Figure 4, the general drawing of the mid-ship section of No. 7 HaeSung is shown.

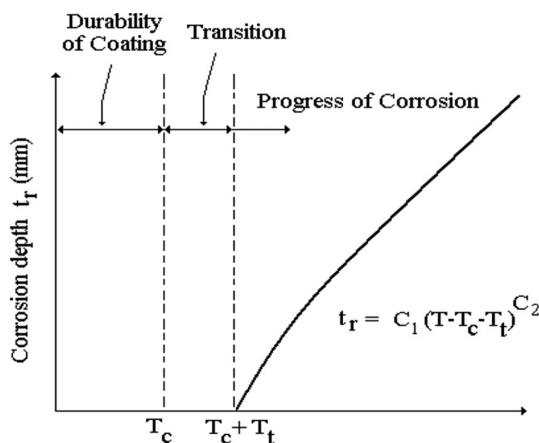
Fig. 5. Progress of Corrosion (KIMM[2009]).

Figure 5 shows the progress of the general corrosion.

The organization of the equation that showed the estimated progress of the hull corrosion was classified as the coating lifetime, the transition period, and the progress of the corrosion.

Here, C1 defined the annual rate of the corrosion progress, T the age of the vessel, Tc the coating lifetime, Tt the transition period after the coating lifetime, and C2 the tendency to the corrosion (0.3-1.0, Default: 1.0) per each.
