Elimination of Screen-Flickering Phenomenon in Multi-Function Display During Flight of Fixed-Wing Aircraft

Jung-Hyuk Kwon¹, Ik-Hyun Kwon¹, Jun-Ho Beak¹, Geun-Hyung Jang¹ and Wang-Sang Lee^{2,†}

¹Korea Aerospace Industries, LTD.

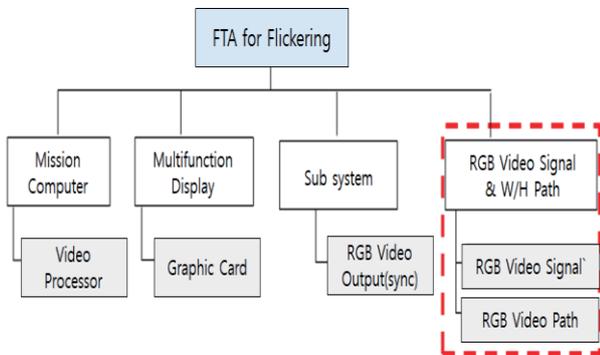
Fig. 3 FTA for flickering phenomenon.

Using fault tree analysis (FTA), as shown in Fig. 3, the avionics equipment (sub-system equipment, mission computer, MFD) and the wire harness path of the video signals were determined to be the major factors. First, the avionics equipment related to the occurrence of flickering was replaced sequentially. However, the phenomenon continued to occur. Even after performing function diagnosis for the individual units of the avionics equipment, the internal error that caused the flickering could not be identified. Therefore, an examination of the video signal and wire harness paths was required.

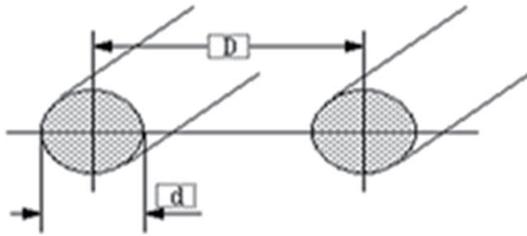
Fig. 10 Characteristic impedances of two parallel wires.

However, the disconnection point has a parallel wire structure and a characteristic impedance that are different from those of the coaxial cables, as shown in Eq. (3) and Fig. (10) [10]. As a result, the characteristic impedance may vary from 100 Ω to 300 Ω depending on the separation between the white and black lead wires at the disconnection point. Because the characteristic impedance does not match that of the coaxial cable (75 Ω), impedance mismatching may occur [11].

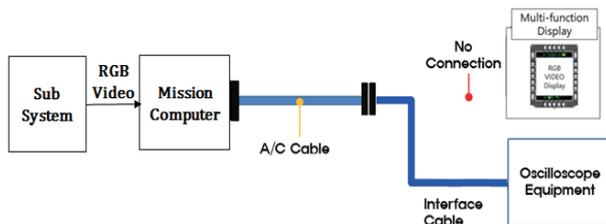
Fig. 11 Improvement in cable configuration.

In particular, because high-frequency energy propagates along the surface of the conductor, the outer diameter of the inner conductor and the inner diameter of the outer conductor are important variables. If the cable length and disconnection point are not characteristics of the coaxial cable, a characteristic impedance mismatch occurs owing to the difference in the characteristic impedance. Accordingly, only a part of the energy is delivered, and the rest is reflected; this produces standing waves inside the cable, which may cause signal loss. Furthermore, the parallel wires have an open-shield structure, which can be affected by external noise, and the length of the video cable is increased significantly because a disconnection point is used instead of a direct connection. Thus, the cable is vulnerable to external noise. Therefore, the characteristics of the output signals transmitted from the mission computer to the MFD were measured, as shown in Fig. 11.

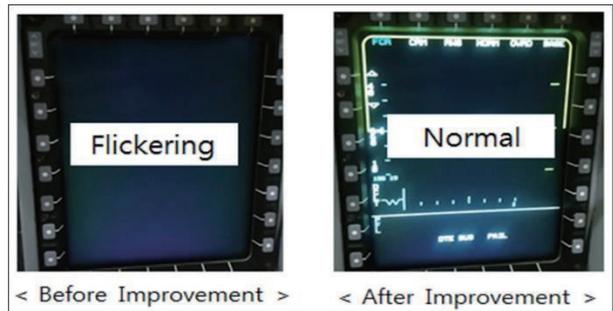
Figs. 14 and 15 depict the direct-connection configuration, which was implemented in an aircraft in which the MFD was affected by screen flickering due to signal loss. The MFD performance was analyzed after implementing the improved configuration.
