# Cause Analysis for a Lining Damage in Sea Water System Piping Installed in a Korean Industrial Plant

K. M. Hwang<sup>1,†</sup> and S. K. Park<sup>2</sup>

<sup>1</sup>KEPCO E&C, 269 Hyeoksin-ro, Gimcheon-si, Gyeongsangbuk-do, 39660

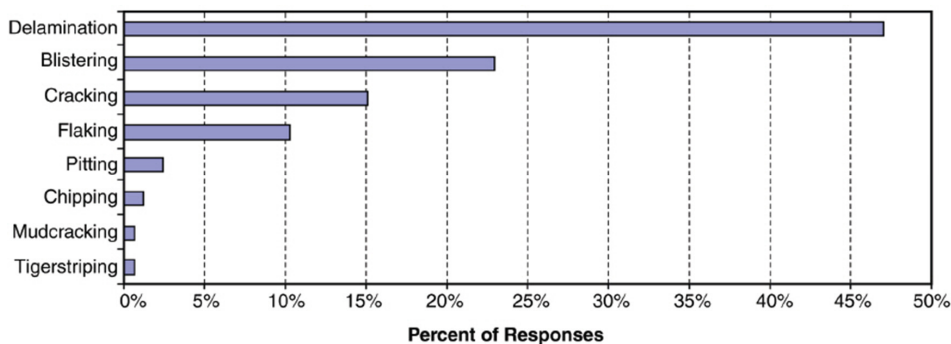
Fig. 1 EPRI survey results for lining damage.

According to a 2006 U.S. EPRI survey on the causes of lining damage [3], it was found that lining damage by delamination was the most common, followed by blistering, cracking, flaking, etc. Fig. 1 shows the EPRI survey results for lining damage.

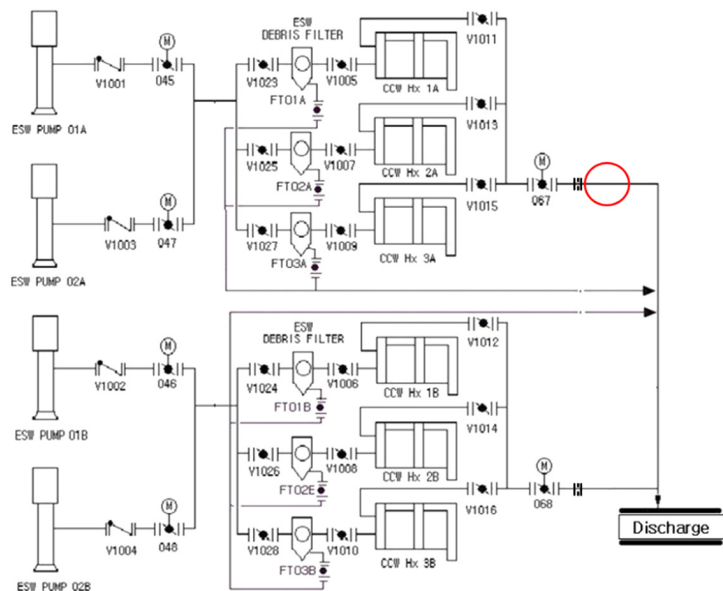
Fig. 2 System schematic diagram of the seawater system

The design characteristics and the damage status were reviewed for analysing the causes of damage in the piping of the component cooling seawater system of a particular nuclear power plant in Korea. Fig. 2 shows a schematic diagram of the area where the damage occurred. Fig. 3 shows the Isometric Drawing of the area. In both figures, the area marked with a circle is the area where the damage occurred, and an orifice is installed in front of the damaged pipe. The pipe is a diameter of 609.6 mm (24 in), a pipe thickness of 9.5 mm, an Archcoat of polyester family, and a coating thickness of about 2 mm. Fig. 4 and Fig. 5 show internal and external photographs of the areas where the damage occurred. As shown in the two figures,

tribution of void fractions in vertical sections of piping in contour and void fraction profile. It was assessed that cavitation occurred as it was assumed to be dissipated after air bubbles were generated near the pipe wall up to an area of approximately  $0.5D$  at the rear of the orifice. This corresponds to the pipe damage areas shown in Fig. 2 and Fig. 3.

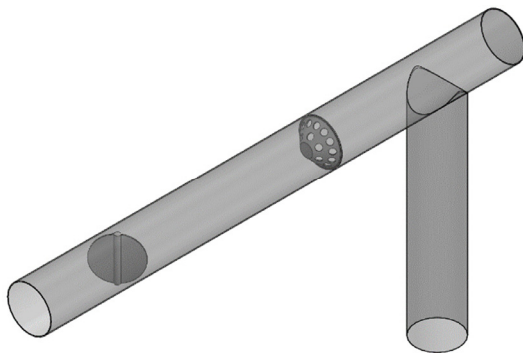
**Fig. 6 Target model.**

Fluid dynamic analysis was conducted to analyse the possibility of cavitation using the ANSYS FLUENT code. The analytical model ranges from the pipe in front of the valve 068 shown in Fig. 3 to the vertical pipe TEW 066 lower 30.34 m (99.526 ft) (elevation). Fig. 6 shows the target model, and Fig. 7 shows the grid system. The composite grid was used. The butterfly valve, orifice, and tee areas with relatively complex features were based on the tetrahedral grid. The rest of the area was based on the prism grid using the sweep mesh technique. The boundary conditions for analysis are same as shown in Table 1.
