Failure Analysis of Circulating Water Pump Shaft in Power Plant

Jaehong Lee, Nam-gun Jung

Abstract

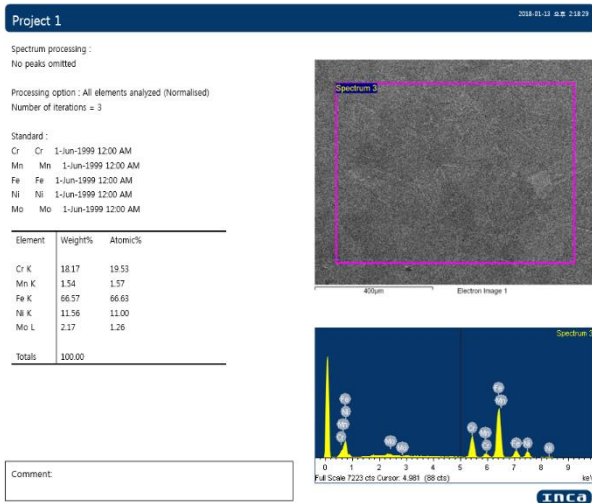
Fig. 2. Semi-quantitative EDX analysis of the shaft material

corrosion resistance of the product made of steel alloy. No detrimental effect to the shaft failure due to the chromium composition was revealed in the following metallurgical analysis.

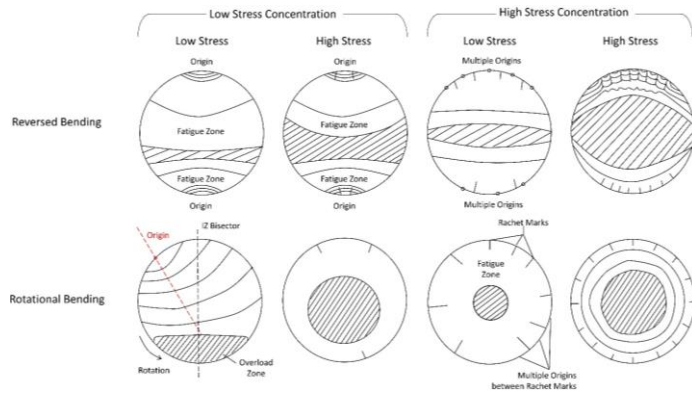
concentration had influenced to the cracking. The fracture surface characteristics according to the type, local and global intensity of load are shown in Fig. 7 [6][7].

Fig. 7. Representative schematic diagrams of fatigue fracture according to types of load and stress concentration factor. The diagram was drawn by the author based on the combination of the knowledge in the literatures [6][7].

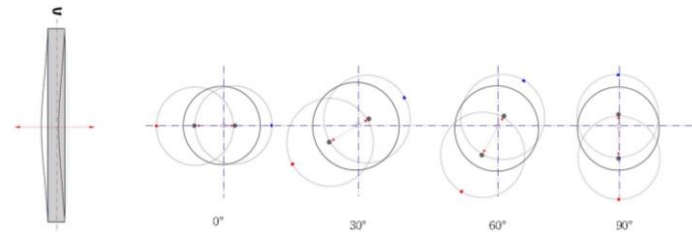
Fig. 8. Representative behavior of rotating shafts which induces reversed bending load.

In rotating shaft, reversed bending usually occurred by the shaft unbalance. Imbalance of the shaft make the eccentricity when a shaft rotates. This eccentricity makes bending deflections in the specific direction when the shaft rotating. The representative behavior of unbalanced shaft with the consideration of the load histories on the shaft are shown in Fig. 8.
