# On the underground imaging using borehole camera

**Abstract:** It is only possible through the image analysis of borehole wall and the core recovered from borehole constructed in rock mass that the real information about geologic characteristics in rock mass is directly obtained in primary research. Monitoring apparatus with multi-functional utility has implemented and applied in-situ condition for finding the geologic condition of target area. But, this apparatus is very expensive to be applied at the risk of loss during monitoring and cause hard work for moving them to the determined position. This paper shows the underground imaging from the borehole information obtained by a borehole camera with the simple utility and low cost enough to investigate the characteristics of borehole wall. Monitoring for this has been done in open-pit mine located at the northeastern part of Fukuoka Prefecture in Japan, and finally the three dimensional imaging of geological discontinuity was discussed relative to the field condition.

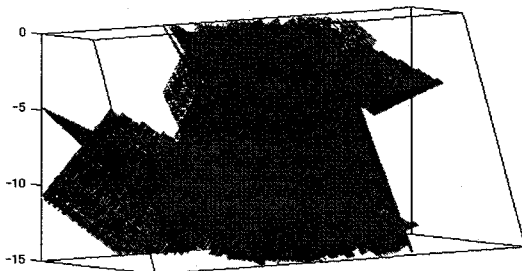
Fig. 13. Three-dimensional image on inclined joints.

In bench B, there were the six types of discontinuities, which were inclined joints, horizontal joints, sub-horizontal joints, open joints, fault and filling. Inclined joints, the largest number of six types, and filling were described in Fig. 13 and Fig. 14, respectively.

As seen in Fig. 13, inclined joints mainly appeared in the area of boreholes 22 and 23, which did not show the development of deep weathering. Also, it was found that there was filling in the areas without the development of weathering in Fig. 14.
