Study on Vitrification of Slag From Metal Melting Process

Mi-hyun Lee*, Young Hwan Hwang, Seok Ju Hwang, Cheon-Woo Kim
KHNP CRI, 70, 1312-gil, Yuseong-daero, Yuseong-gu, Daejeon, Republic of Korea
*mihyun.lee@khnp.co.kr

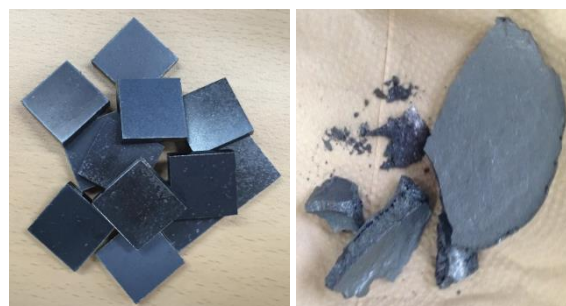
Fig. 1 shows of carbon steel before and slag after melting.

Fig. 1. Carbon steel before melting(left) and slag after melting(right).
