# 알루미나 장섬유 강화 복합금속재의 피로균열성장거동

## Fatigue Crack Growth Behavior of A Continuous Alumina Fiber Reinforced Metal Matrix Composite Materials

김 두 환\* · E. J. Lavernia\*\* · J. C. Earthman\*\*  
Kim, Doo Hwan

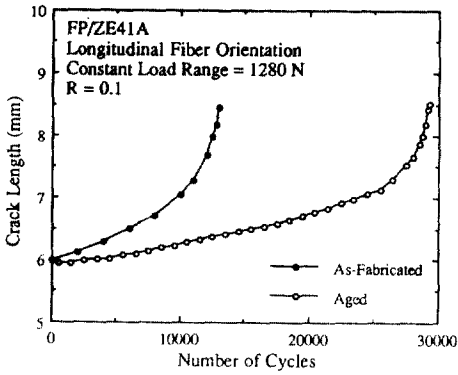
Figure 2. Crack length versus cycle number for FP/ZE41A alumina fiber reinforced Mg alloy with the fibers oriented longitudinally (parallel to the applied stress). Data are shown for both the as-fabricated and aged conditions.

A typical plot of crack length versus cycle number for an as-cast longitudinal specimen and an aged longitudinal specimen tested under identical loading conditions is illustrated in Figure 2. The fatigue crack growth rate, the slope of this data, is always greater for the as-cast specimen resulting in a decrease in fatigue life by over a factor of 2. This indicates that the aged composite has a greater resistance to fatigue crack growth through the fibers. Both specimens fractured catastrophically once the crack length reached about 8.5mm.

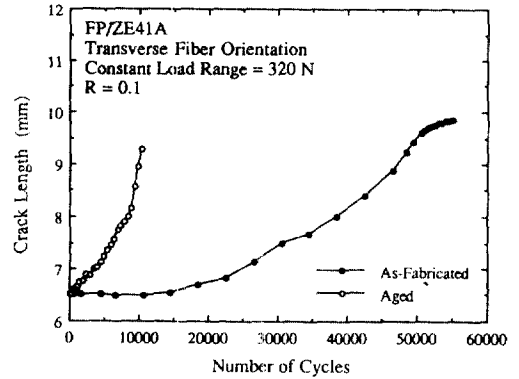
Figure 3. Crack length versus cycle number for FP/ZE41A alumina fiber reinforced Mg alloy with the fibers oriented transverse to the applied stress. Data are shown for both the as-fabricated and aged specimens.

Figure 3 shows a typical plot of crack length versus cycle number for transverse as-fabricated and aged specimens under the same load range. The data in this plot illustrate that the resistance to fatigue crack growth parallel to the fiber direction is greater for the as-fabricated material. We note that the crack growth rate temporarily decelerates for the as-fabricated material corresponding to crack lengths of approximately 7.5mm and 9.5mm. Preliminary observations suggest that these temporary reductions in the crack growth rate result from defects in the fiber structure in regions near the crack tip. Further work is currently underway to examine the cause of this non-uniform

The crack growth data in Figure 3 and the observation of ductile tearing in Figures 6.b and 6.c indicates that more plastic strain energy is
