Shaking Table Test of Waterfront Structure for Liquefaction Countermeasure

항만구조물의 액상화 대책을 위한 진동대 실험에 대한 연구

Park, Jong - Kwan
박 종 관*

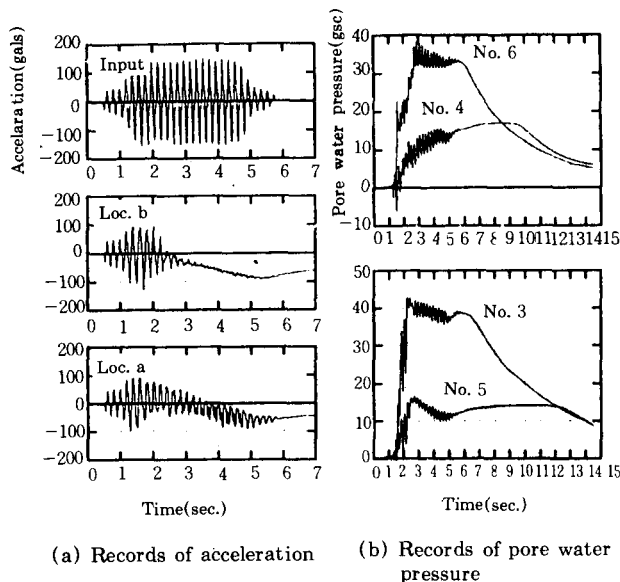
Fig. 4 Records of accelerations and pore pressure in Case 1A-1

Two model embankments with the slope of 1:2.75 were made for Case 1. One embankment(Case 1A) was shaken twice at the frequency of 5Hz and the acceleration of 120gals (Case 1A-1) and 200gals(Case 1A-2), respectively. The other(Case 1B) was shaken at 3Hz and 120gals. Figure 4 shows the acceleration and the pore pressure developments of

The pore pressure build-up and dissipation show different patterns depending on the elevation of the ground. According to the records of pore water pressure developments in Case 1A-1 as shown in Fig. 4(b), at the lower points of Nos. 6, 3 and 1, the pore water pressures have built up suddenly and trigger the liquefaction. Then, they begin to drop gradually when the shaking has finished. On the other hand, at the upper points of Nos. 4 and 5, the developing pore water pressures have remained for quite a long time even after the termination of the shaking. Two lines of pore pressure development at the upper and

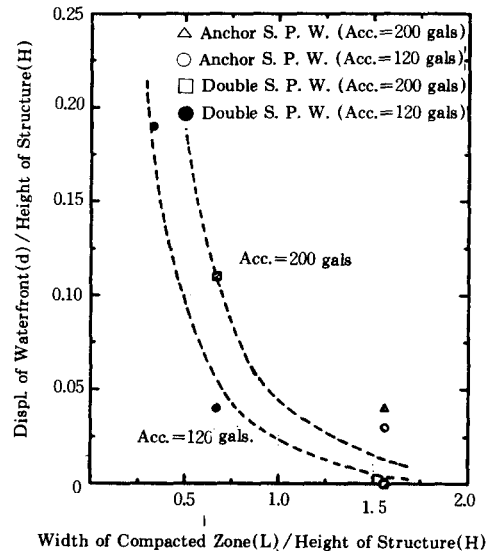
Fig. 8 The displacement of the waterfront structure according to the width of compacted zone.

tent of the compacted zone and the magnitude of the input acceleration. Figure 8 shows the case in which only a limited deformation was observed on the structure. The deformation ratio, d/H represents the maximum wall movement divided by the height of the wall from the fixed end. On the other hand, the reinforced ratio, L/H is the ratio of the width of the compacted zone to the height of the sheet pile wall. Actually, the results include the interplayed resistance of the sheet pile itself and the densified sand. However, since the model sheet pile was made of very flexible material, the resistance of the sheet pile could be neglected.

If an allowable deformation ratio is assumed to be 0.025, the reinforced ratio, L/H is obtained to about 1 for an acceleration of 120gals, and to about 1.5 for 200gals from Fig. 8. It means that a double sheet pile wall requires a compacted zone as wide as the height of the sheet pile wall to be safe from the lateral pressure of the liquefied ground behind the structure. For the practical application in design, the relationship in Fig. 8 has some limitations, because (1) the strength of the sheet pile itself and the effects of scale are not considered, (2) the test data are not sufficient and (3) the fixed end conditions of sheet piles are not guaranteed in the actual field. However, it provides very good quantitative information on the extent of the reinforcement.
