# **A Study of the Mechanical Properties of Patch-Bonded and Riveted Repairs on Cracked Al 6061-T6 alloy Structures**

## **ABSTRACT**

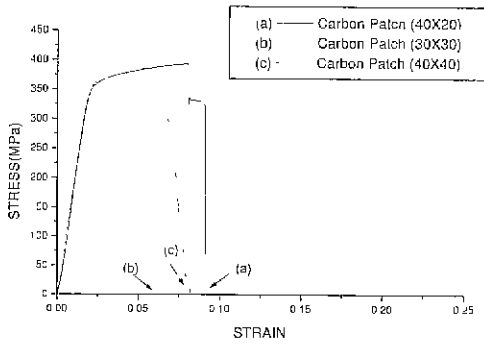
Fig. 7 A comparison of stress-strain curves for different patch shapes

When comparing Fig.5 and Fig.7, the bond repair is good in strength and stable in the crack-growth. Although, the rivet repair does not exhibit net failure behavior, it does reveal bearing failure. Usually, bearing failure is influenced by the strength of both the rivet and the structure itself. Conversely, net failure is affected by the bonding between the structure and the patch.
