Impact Damage Behavior in Filament Wound Composite Pressure Vessel

Abstract : The goals of the paper are to understand the impact damage behavior and identify the effect of surface protective materials on impact resistance in filament wound composite pressure vessels. For these, a series of low velocity impact tests was performed on specimens cutting from the full scale pressure vessel by the instrumented impact testing machine. The specimens are classified into two types, which are with and without surface protective material. The visualization for impact damage by two different impactors is made by metallurgical microscope. Based on the impact force history and damage, the impact resistance parameters were employed and its validity in identifying the damage resistance of filament wound composite pressure vessel was reviewed. As the results, the impact resistance of the filament wound composites and its dependency on the surface protective material were evaluated quantitatively

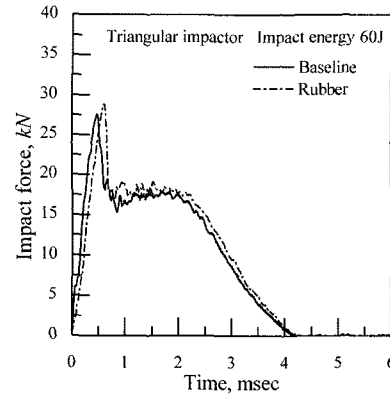
(b) Impact force history for triangular impactor

Fig. 1. Impact force history.

When composites is subjected to impact loading, various impact damage processes, such as matrix cracking, delamination and fiber breakage, can occur [8]. These damage processes are associated with the specimen's energy absorbing capacities and impact damage behavior and can be characterized by the impact force history obtained during an instrumented dropweight impact testing machine. The energy absorbing capacity or impact damage behavior is greatly dependent on material constituents (fiber and matrix), impactor geometry, stacking sequence and boundary conditions [8] and especially for the case that the protective materials are employed on the surface and different impactors are used, these can be remarkably changed. To identify this behavior, the examples of impact force history for baseline specimen that the protective material did not employ and for protective specimen that it did employ, respectively, are shown in Fig. 1.

As shown in Fig. 1(a) which represents histories for spherical impactor, the force history for protective specimen is fairly similar to that of baseline specimen. The protective specimen has, however, the more local peaks and the delayed time-to-maximum load values. When the impact loading is applied to the protective specimen, the impactor does pass the protective material layer and reach to hoop layer. This behavior has influenced on the impact damage incipient load and energy, which has been reported that play major roles for evaluation of impact resistance. And from the Fig. 1(b), the histories exhibit the somewhat different behavior against the spherical impactor. The force history, which is the representative for energy absorbing capacity and impact damage behavior, is, therefore, affected by both the protective material and impactor geometry. Then to identify the energy absorbing capacity and impact damage behavior according to the protective material and impactor

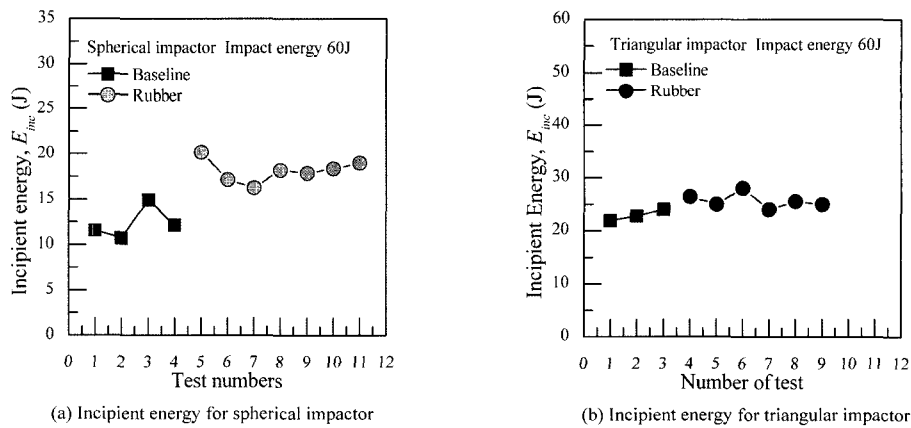
Fig. 3. Impact damage incipient energy, E_{inc}

The impact damage incipient energy (E_{inc}) is pretty similar to the impact damage incipient load conceptually, is closely related to the threshold energy of structure, and is obtained by taking the energy value of the impact damage incipient load. To examine clearly the behavior of the impact damage incipient energy, the impact damage incipient energies are obtained and shown in Fig. 3.

From figure, the impact damage incipient energy is maintained constantly and this tendency appears for impactor and specimen types. This phenomenon coincide with the above descriptions that the impact damage incipient load is maintained constantly regardless of incident impact energy. Also, for the spherical impactor, the energies are 12.7J and 18.1J for baseline and protective specimens, respectively, while the energies are identified as about 22.9J and 25.7J, respectively. It is concluded that the surface protective rubber material

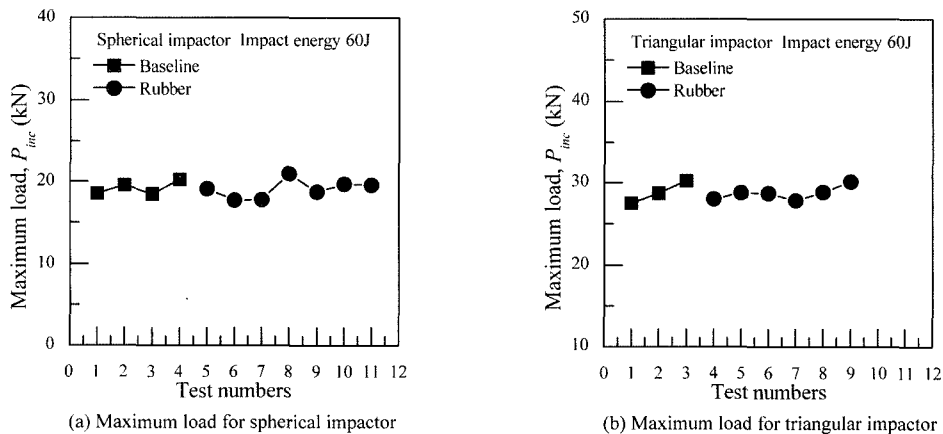
Fig. 4. Maximum impact load, P_{max}

The maximum impact load (P_{max}), which is the maximum value of impact load to which the composite structure is subjected, is a parameter closely related to the bending rigidity, contact rigidity and impact damage of structure. To identify clearly the behavior of the maximum impact load, the maximum impact loads are obtained and shown in Fig. 4. From figure, for the both the impactors, the maximum impact load is nearly constant regardless of specimen types. This tendency is considered to be due to that the impact damage occurs very seriously even for the surface protective specimen, and that more than the load can not be born.

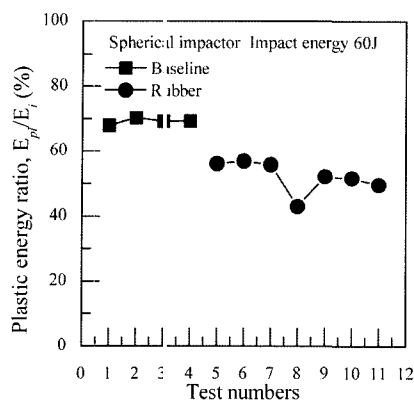
(a) Plastic absorbing energy for spherical impactor

Fig. 5. Plastic absorbing energy, E_{pl}

Fig. 5 represents plastic absorbing energy ratio (the ratio of plastic absorbing energy to incident impact energy), which were obtained using the above method. From figure, the ratio for protective specimen is much lower than for baseline specimen regardless of the impactor types. This means that impact damage is serious by absorbing much energy by the plastic behavior of the baseline specimen, that is, the impact damage for protective specimen is slight due to protective effect of surface rubber material, compared with the baseline specimen.

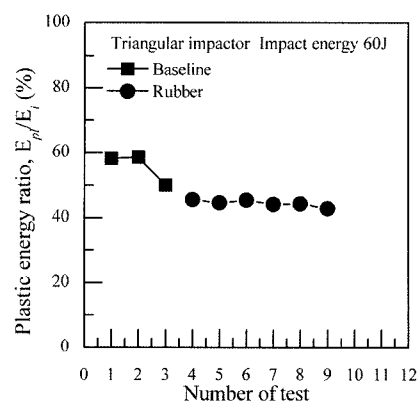
(b) Plastic absorbing energy for triangular impactor
