Nondestructive Evaluation of Temporarily Repaired CFRP Laminates Subjected to Delaminations due to Localized Heating and Cyclic Loading Combined

Tae-Young Han* and Oh-Yang Kwon**†

Abstract The reliability of cold-bonding repair technique of carbon-fiber reinforced plastics (CFRP) laminates, often used as a temporary repair for the airplane maintenance, has been evaluated during cyclic loading and localized heating by nondestructive methods. Major concern was given to the evolution of damage after repair in the form of delaminations due to localized heating and cyclic loading combined. An area of interest both on the specimen repaired by cold-bonding and the specimen without repair where delaminations were induced by localized heating and cyclic loading was monitored by acoustic emission (AE) testing and further examined by pitch-catch low-frequency bond testing, and pulse-echo high-frequency ultrasonic testing. The results showed that the reliability of cold-bonding repair would be significantly reduced by the localized heating and cyclic loading combined rather than by the cyclic loading only. AE monitoring appeared to be an effective and reliable tool to monitor the integrity o

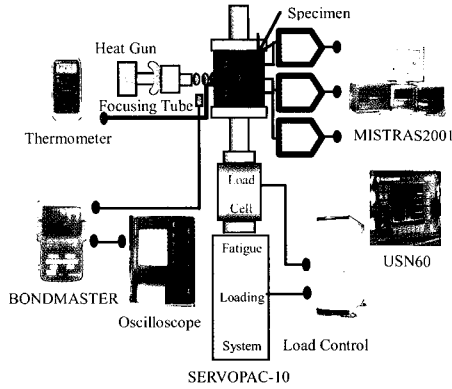
Fig. 7 A schematic of experimental setup

To acquire and monitor delamination signals from the specimens, an experimental setup as shown in Fig. 7 was prepared. It included an AE testing equipment (Mistras2001), a pitch-catch low-frequency bond tester (BondMaster), a pulse-echo high-frequency ultrasonic flaw detector (USN60), and an electro-hydraulic fatigue loading machine (Servopac-10). The minimum and the maximum load of cyclic loading were 10 kN and 50 kN, respectively, with a loading frequency of 5 Hz. The specimen was loaded symmetrically with respect to the specimen centerline. The system was also equipped with a heat-gun to

apply localized heating to the specimen according to the temperature control plan: 1) the rise time (1 second to 60 seconds): 77 °F to 300 ± 15 °F, 2) the duration (61 seconds to 300 seconds): 301 °F to 340 ± 15 °F, and 3) the decline time (without heating, 301 seconds to 360 seconds): 340 °F to 95 ± 15 °F. While the cyclic loading was continuously applied to the specimens, the localized heating to the specimen was applied at eight different stages. In order to have the heat-flow focused onto the specimen, a focusing tube with inner diameter (exit side) of 15 mm was attached to the heat-gun. Table 1 shows the experimental cycle conditions in the experiments.

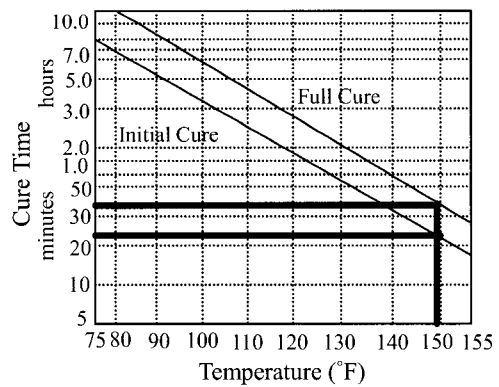
Fig. 9 Cold-bonding curing cycle

Fig. 8 and Fig. 9 show the cure cycle of hot-bonding and cold-bonding, respectively. The thick solid lines in Fig. 9 mean the total curing time required to cure the local area of the specimen at 150°F. The lower line in X-axis represents the initial curing time of 25 minutes and the upper line in X-axis indicates the full curing time of 40 minutes. Table 2 shows comparable information of repair conditions for hot-bonding and cold-bonding. As shown in the

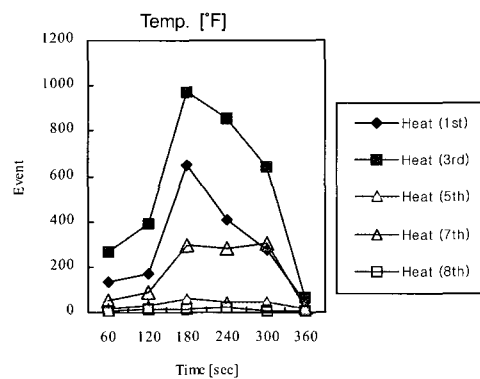
(a) specimen without repair

Fig. 20 AE events with heating cycles

Fig. 20 shows the relationship between the cumulative number of AE events and temperature gradient at each LHCLC stage. The number of AE events gradually increased at the first stage for both specimen without repair and repaired specimen due to the initial resistance in the laminates to mechanical load. The AE events in turn reached its peak at the third stage and drastically decreased over the latter stages. There

are also noticeable differences in AE events by heating between the repaired specimen and the specimen without repair. First, the number of AE events of the specimen without repair was substantially higher than repaired specimen's. Because the total number of events is a good indication of AE energy, the rate at which the events occur can be indicative of the extent of structural degradation. Consequently, it is speculated that the specimen lost its retained matrix ductility, hence its ability to resist delamination growth as AE energy releases from the specimen. Secondly, the occurrence of AE events from the repaired specimen was concentrated at the early stage while AE events from the specimen without repair were relatively distributed throughout the stages. After analysis of these results, it was concluded that such composite laminates repaired by cold-bonding technique could be weakened at a relatively early stage by the localized heating.
