Performance Evaluation of Sprayed Ductile Fiber-Reinforced Mortar as a Repairing Material

Abstract: Most of existing repair materials have some shortcomings such as brittle fracture, imperfect interface bonding and marked difference in modulus of elasticity compared with the structures. These problems make their repair inefficient. Some researches on using a fiber-reinforced mortar as an alternative to enhance the efficiency have been carried out recently. This paper presents the results of an experimental study on the performance of sprayed PVA fiber-reinforced mortar as a repair material. We evaluated its mechanical properties, durability and strengthening effect. This study shows that the sprayed PVA fiber-reinforced mortar is remarkably effective as a repair material.

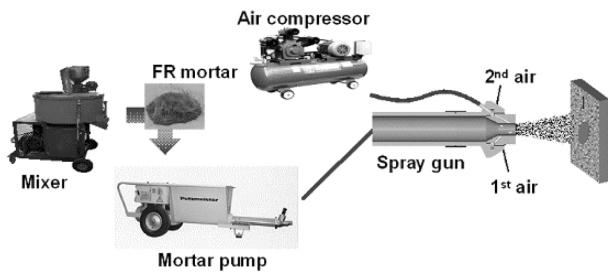
Fig. 1 Spraying system.

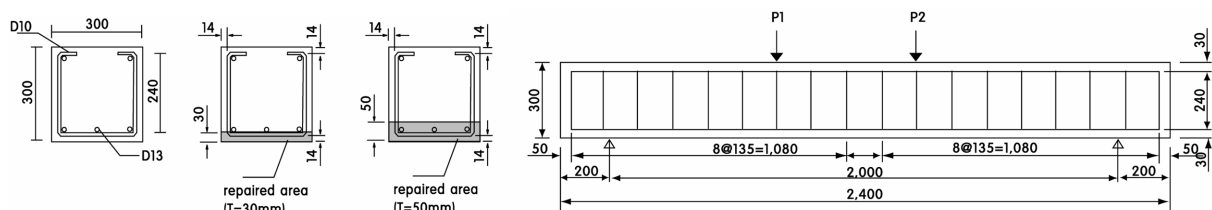
Fig. 2 Specimens for flexural tests

Specimens with dimensions of $300 \times 300 \times 2,400$ mm were manufactured as shown in Fig. 2 in order to examine the flexural

load bearing capacity of the repaired structure with the sprayed fiber-reinforced mortar. Repaired structures were made by applying the mortar after removing the area to be repaired. Table 4 summarizes the details of the specimens and the applied techniques. Two non-reinforced (plain) specimens were manufactured. Three specimens were fabricated with the sprayed fiber-reinforced mortar to possess a reinforcement thickness of 30 mm and 50 mm with proportions of PVA fiber set to 1.2% and 1.5%, respectively. Specimens with used polymer-type repair mortar and one layer of carbon fiber sheet, widely used for rehabilitation purpose, were also manufactured for the comparison with the specimen with sprayed fiber-reinforced mortar. Carbon fiber sheet has the depth of 0.11 mm, tensile strength of 3,550 MPa, and elastic modulus of 235 GPa. The concrete used for the specimens used coarse aggregates with the maximum dimension of 25 mm and exhibited design strength of 24 MPa. Steel rebars of 13 mm diameter with yield strength of 350 MPa were also used.

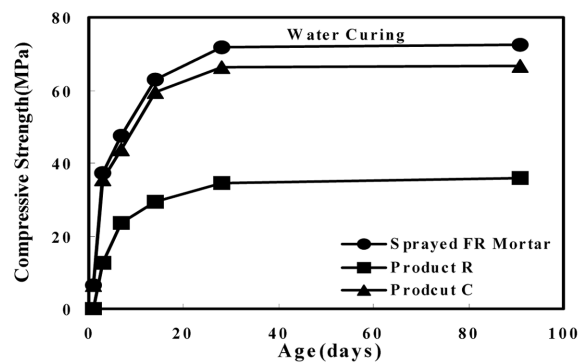
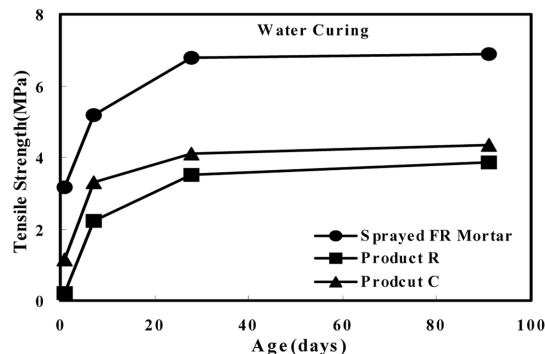
(a) Compressive strength

(b) Tensile strength

Fig. 3 Compressive and tensile strengths according to the type of repair material.

Fig. 3 plots the compressive strength according to the type of repair material. The sprayed fiber-reinforced mortar exhibits remarkably higher tensile strength than existing repair materials. This is due to the high strength of the repair mortar itself and to the use of PVA fiber, which increases the tensile strength significantly. Fig. 4 compares the elastic modulus of the sprayed fiber-reinforced mortar with those obtained by existing predictive formula. It can be seen that the elastic modulus of the material is underestimated compared to the values predicted by the formulae proposed by the Korean concrete structural design specifications and by the ACI Committee 363. However, this modulus is slightly larger than that obtained through the formula proposed in the design and construction guidelines for high-performance fiber reinforced cementitious composites (HPFRCC) of the Japanese Society of Civil Engineers under the condition of the same strength.¹ The elastic modulus of HPFRCC in these guidelines was 1/2 -2/3 of ordinary concrete. On the other hand, considering the fact that repair is unnecessary for high strength structures and assuming that structures requiring repair generally uses the concrete with strength below 30 MPa, it can be said that the elastic modulus of the sprayed fiber-reinforced mortar is similar to that of concrete structures requiring repair.

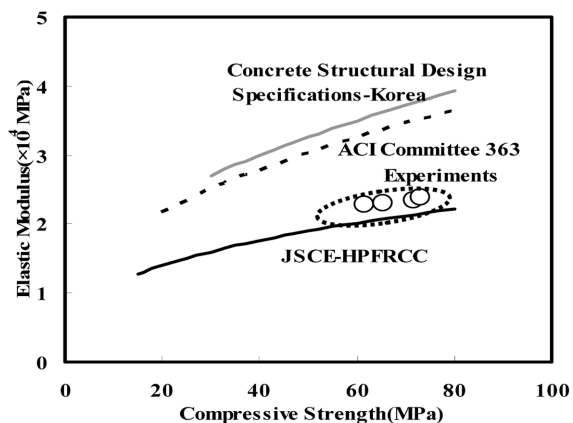
Fig. 4 Comparison of the elastic moduli of the sprayed fiber-reinforced mortar predicted by existing methods.

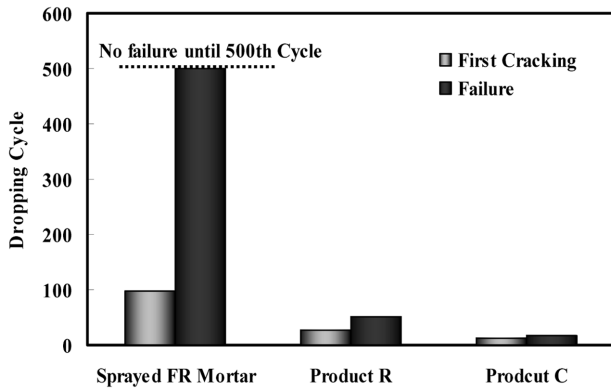
Fig. 5 Impact strength according to the type of repair material.

Fig. 5 presents the resistance to impact according to the type of repair material. All of the existing repair materials failed before 50th free dropping cycles, which reveals their brittle fracture mode. However, the first micro-crack appeared at the 97th free dropping

cycle for the sprayed fiber-reinforced mortar without the appearance of other cracks or failure up to the 500th cycle. Such remark-

able resistance to impact of the sprayed fiber-reinforced mortar can be explained by the improvement of the shock absorption performance due to the mixing of PVA fiber into the test specimen.

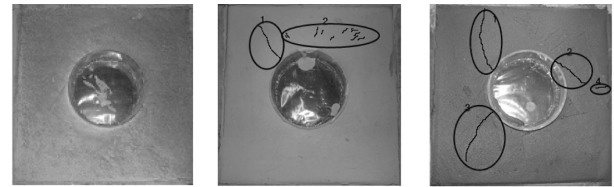
(a) Sprayed FR mortar (b) Existing product R (c) Existing product C

Fig. 6 Images of specimens after plastic shrinkage test.

Table 5 summarizes the results of the plastic shrinkage test and Fig. 6 shows images of specimens after plastic shrinkage. The existing products R and C developed cracks of about 56 and 715 mm², respectively, under plastic shrinkage, while the sprayed fiber-reinforced mortar did not manifest any crack.

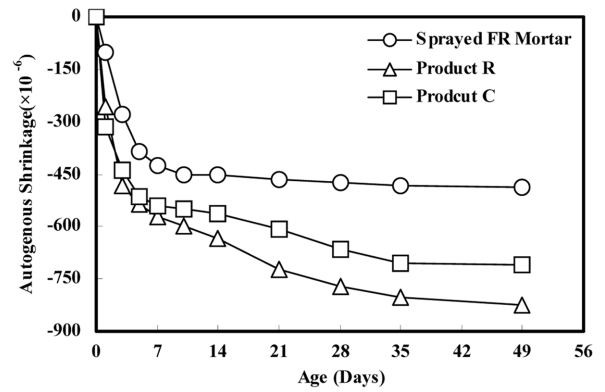
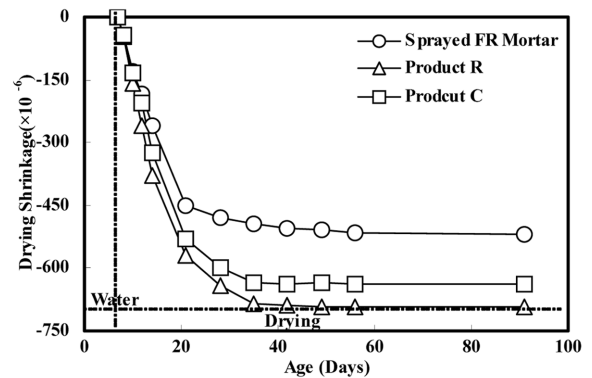
(a) Autogenous shrinkage

(b) Drying shrinkage

Fig. 7 Shrinkage characteristics according to the type of repair material.

Fig. 7 summarizes the results of the autogenous and drying shrinkage test. The autogenous and drying shrinkage strains, developed by the sprayed fiber-reinforced mortar, appear to be smaller by about 30~40% and 20%, respectively, compared to those of existing repair materials. The small shrinkage developed in the sprayed fiber-reinforced mortar is due to the use of shrinkage reducing agents and CSA-type expansion agents as well as the admixing of PVA fiber.

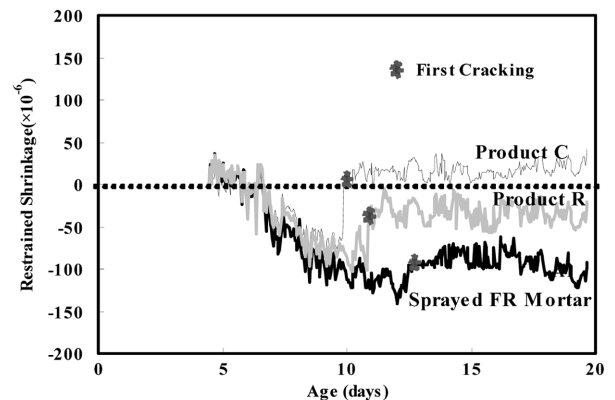
Fig. 8 Strains on the specimens due to confining shrinkages.

Fig. 8 arranges the result of the crack control performance according to the type of repair material. The products C and R developed cracks after approximately 10 days, and cracks appeared after 13 days for the sprayed fiber-reinforced mortar. The product R and C experienced cracks at first to present brittle cracking mode while the sprayed fiber-reinforced mortar exhibited ductile cracking mode without the large development of cracks even after first cracking owing to the bridging action of the PVA fiber.

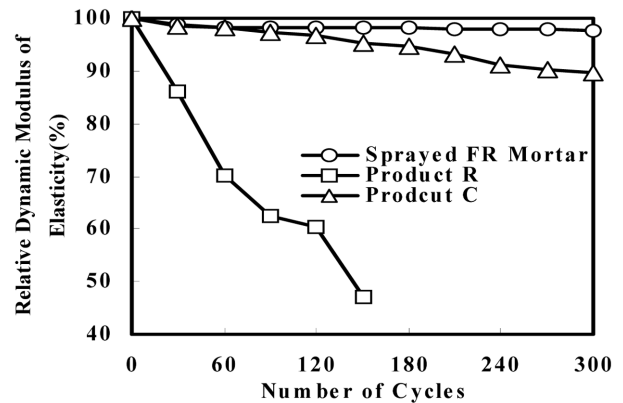
Fig. 11 Results of relative dynamic modulus of elasticity.

The results for the relative dynamic modulus of elasticity are summarized in Fig. 11. The product R exhibited degraded resistance to freezing and thawing after the first cycle, with a 60% decrease in relative dynamic modulus of elasticity at the failure state after 120 freezing-thawing cycles. On the other hand, the sprayed fiber-reinforced mortar and the product C presented a remarkable relative dynamic modulus of elasticity, exceeding 80% even after 300 cycles at the completion of freezing-thawing. Especially, the sprayed fiber-reinforced mortar exhibited superior resistance to freezing-thawing with a relative dynamic modulus of elasticity of 98%.

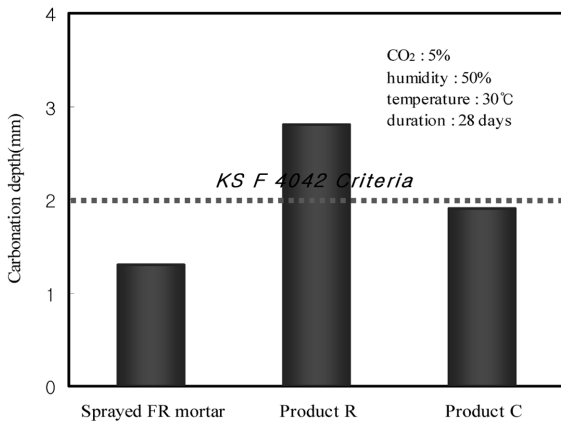
Fig. 9 Evaluation of the resistance to carbonation according to the type of repair material.

The resistance against carbonation was evaluated by the criteria set forth by KS F 4042. Fig. 9 shows the carbonation depth according to the type of repair material. The results show that the

sprayed fiber-reinforced mortar not only satisfy the criteria and but also is more resistant compared with product R and C.

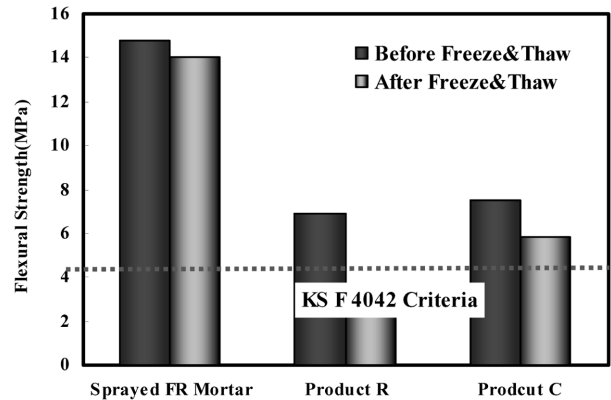
Fig. 12 Change in the flexural strength before and after freezing-thawing test.

Fig. 12 plots the variation of the flexural strength before and after the freezing-thawing test. Even if the existing products without the fiber reinforcement satisfied the criteria of KS F 4042 before the test, their flexural strength dropped below 6 MPa after the completion of the test. However, the sprayed fiber-reinforced

mortar showed an insignificant variation of the flexural strength before and after the freezing-thawing test, thus satisfying the KS standards. Consequently, the existing products exhibit degradation due to the action of freezing-thawing leading to the drop of the flexural strength below the KS criteria, which is likely to initiate cracking in the repair layer, while the sprayed fiber-reinforced mortar appears to be immune to the action of freezing and thawing.

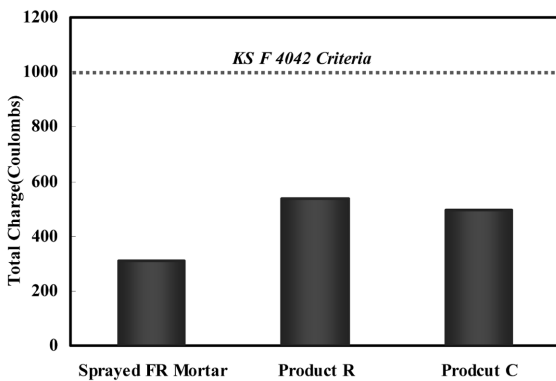
Fig. 10 Evaluation of the resistance to salt attack according to the type of repair material.

Fig. 10 presents the analysis results with respect to the resistance to salt attack. Regardless of the repair technique, all the results were evaluated as “very low” according to the criteria proposed by KS F 2711. Even though all the experimental values satisfied the KS F 4042 to be below the electric charge of 1,000 Coulombs, the sprayed fiber-reinforced mortar appears to exhibit the most resistance to salt attack among all the considered repair methods.

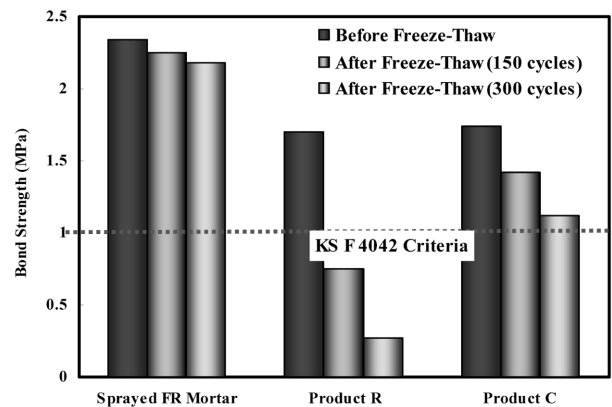
Fig. 13 Comparison of Bond Strength before and after freezing-thawing cycles.

Fig. 13 depicts the experimental results for the bond strength before and after freezing-thawing cycles. The test was repeated for 300 cycles. Before the start of freezing and thawing cycles, all the

materials satisfied the criteria of KS F 4042, which specifies that the repair material should be over than 1 MPa in bond strength. Especially, the sprayed fiber-reinforced mortar exhibited 1.35 times higher bond strength than that of compared materials. But after the freezing and thawing cycles, product R showed decreased bond strength to be below the criteria at 150 cycles and resulted in nearly zero bond strength at 300 cycles. Moreover, Product C showed a barely noticeable decrease in bond strength while satisfying the criteria both at 150 and 300 cycles. On the other hand, the sprayed fiber-reinforced mortar hardly showed a difference in the bond strength before and after the freezing-thawing cycles.

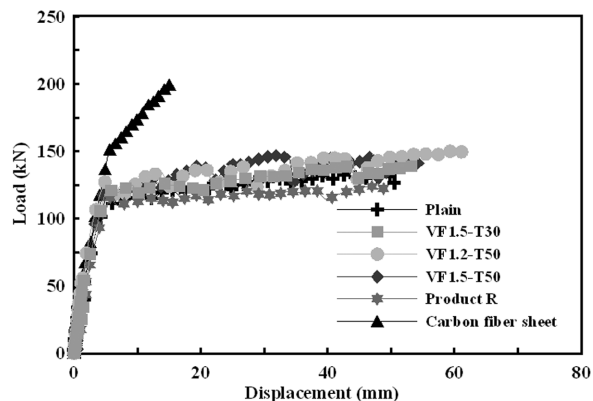
Fig. 14 Load-displacement relationships.

The compressive strength of normal concrete was 26.4 MPa. The sprayed fiber-reinforced mortar, product R and product C had compressive strength of 68.6 MPa, 31.2 MPa and 64.3 MPa, respectively. Table 6 summarizes the results of the load-displacement relationship of the beam specimen and the strain of the tension rebar. Figure 14 and Figure 15 plot the corresponding curves. Assuming the yield strength of $f_y = 350$ MPa for the main rebar of 13mm diameter, the yield load of the main rebar is defined as the load P_y for which the yield strain μ_e is equal to 1,750. In addition, the yield load of the reinforced specimen is expressed in terms of the ratio of the yield loads of the carbon reinforced specimen (P_y) to those of the specimen without the reinforcement.

Since both the strength and the stiffness of the specimens using existing repair materials are not exhibiting any increase compared to the reference non-reinforced specimen, it is likely that no reinforcement effect should be expected for the specimens using existing repair materials. The specimen bonded with one layer of carbon fiber sheet, which corresponds to the reinforcement methods widely selected recently, is showing a reinforcement effect with an increase of 50.7% in the maximum strength compared to the reference specimen. However, debonding of the sheet occurs suddenly at a displacement of 15.6 mm, which reveals a significant reduction in the ductility. Accordingly, even if the carbon fiber sheet reinforcement technique results in a reinforcement effect with respect to the load bearing capacity at early construction, a careful attention should be paid to the sudden failure at the interface between the sheet and concrete that eventually leads to a brittle fracture at failure.

The increase in the maximum strength and stiffness was verified for all of the 3 specimens using the sprayed fiber-reinforced

mortar. Among these specimens, the one with admixing of 1.5% fiber in the 50mm-thickness reinforcement manifested the largest increase in the maximum strength, corresponding to an augmentation of about 15% compared to the reference specimen as well as an approximately 17% increase in the yield strength. In addition, the yield strain increased by 1.2 times compared to the reference specimen regardless of the type of the specimens and the proportion of fiber and reinforcement thickness. Consequently, regarding the fact that the sprayed fiber-reinforced mortar also exhibits reinforcement effect and considering the durability and load bearing capacity globally, the sprayed fiber-reinforce mortar is evaluated to be sufficiently effective as a material combining both rehabilitation and reinforcement effects.
