# The safety behavior of agricultural reservoirs due to raising the embankment

**Abstract :** This study was carried out to investigate safety evaluation of agricultural reservoirs due to raising the embankment. The seepage analysis and large-scale model test were performed to compare and analyze the pore water pressure (PWP), leakage quantity, settlement and piping phenomenon in the inclined core type and the vertical core type embankments. The PWP after raising the embankment showed smaller than before raising the embankment and the stability for piping after raising the embankment. The allowable seepage quantity and the allowable leakage for the steady state and transient conditions is within the range of safe management standard. After raising the embankment in the inclined core, there was no infiltration by leakage. For the vertical core, the PWP showed a large change by faster infiltration of pore water than in the inclined core. In a rapid drawdown, inclined core was remained stable but the vertical core showed a large change in PWP. Settlement after raising the embankment showed larger amounts of settlement than before raising the embankment. The leakage quantity before ra

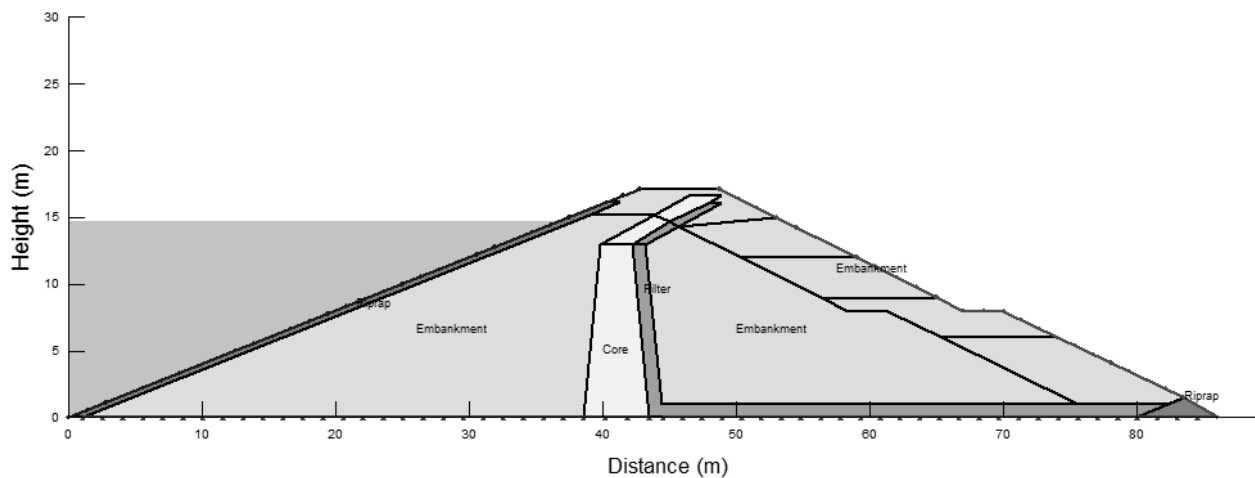
**Fig. 2.** A cross sections of the reservoir.

The field reservoir used for this study is shown in Table 1. A cross section of the reservoir before and after raising the embankment is shown as Fig. 2.

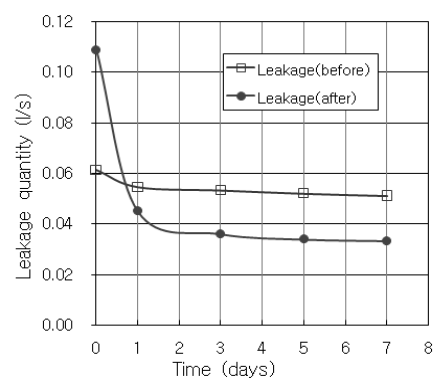
(a) Seepage quantity

(b) Leakage quantity

**Fig. 6.** Comparison of the steady state and the transient condition under rapid drawdown.

Fig. 6 (a), (b) shows the steady state before raising

the embankment with changes into the transient condition during rapid drawdown. The seepage quantity per day and the leakage quantity per 100 m decreases slightly in the beginning, but they decrease steadily without a great difference after one day. However, when the steady state after raising the embankment changed into the transient condition, the seepage quantity and the leakage quantity decreases greatly; approximately 2.4 times in the early stage, and after one day decreases steadily. The reason why there was no great difference in each time of rapid drawdown under the transient condition is judged to be because there was not enough time for dissipating the PWP with the water level falling too quickly.

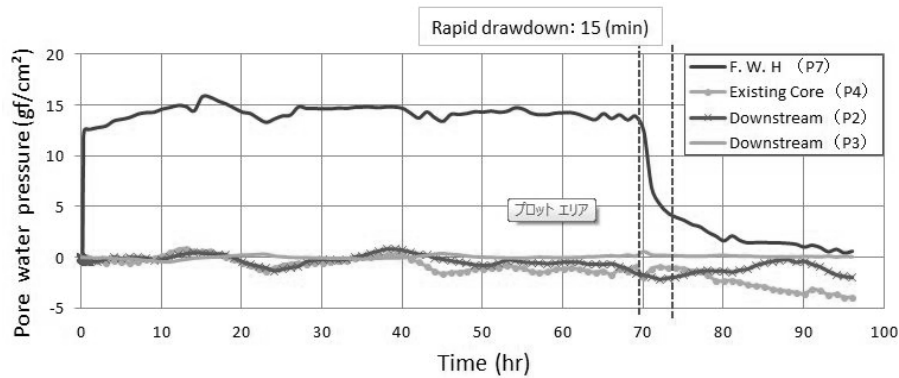
Fig. 7. Variation of PWP before raising the embankment.

Fig. 7 shows the variation of PWP in flood water level (60.8 cm) for 98 hours before the raising embankment. The PWP (P4) at the core showed itself nearly  $0 \text{ gf}/\text{cm}^2$

and it slowly decreased as time passed. The PWP in downstream slope was kept consistently at  $0 \text{ gf/cm}^2$ , which proved that there was no effect of water leak caused by infiltration.

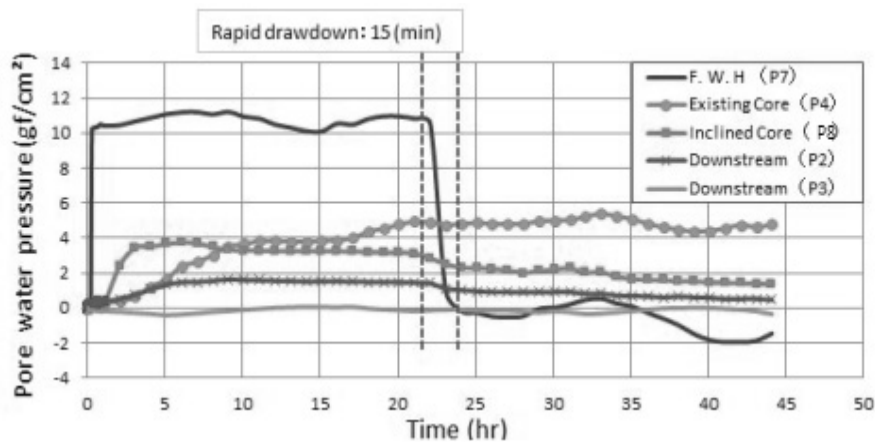
Fig. 8. Variation of PWP after raising the embankment in the inclined core.

Fig. 8 shows the variation of PWP for 44 hours after raising the embankment in the inclined core. In flood water level (75 cm), the PWP at the core (P4) didn't show substantial change in the early stage, but as time passed, the PWP slowly increased. The PWP at the core (P8) increased sharply in the beginning, and was gradually kept consistent; however, it showed a high PWP. In downstream, the PWP in the center (P2) slowly increased as time passed to show itself consistently within the range of  $1.5$  to  $1.8 \text{ gf/cm}^2$ . The PWP in the upper part (P3) was maintained at approximately  $0 \text{ gf/cm}^2$  at the time.

range of  $4$  to  $5 \text{ gf/cm}^2$ , and the PWP at the upper part (P2) and the core (P5) gradually decreased as time passed. The PWP in the upper part (P3) showed around  $0 \text{ gf/cm}^2$ . On the whole, when the core had been constructed as an incline core type, the pore water was infiltrated into the core; however in the downstream no infiltration by water leak took place to prove stability.

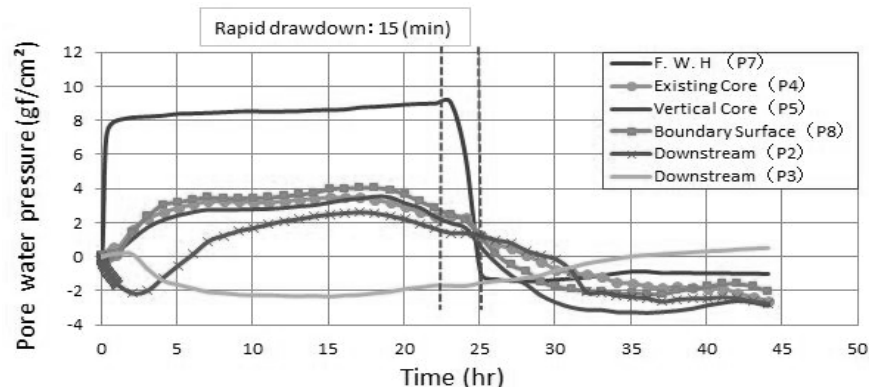
Fig. 9. Variation of PWP after raising the embankment in the vertical core.

Fig. 9 shows the variation of PWP for 44 hours after raising the embankment in the vertical core. In flood water level (77 cm), the PWP at the existing core (P4), upper core (P8) and the boundary surface (P5) increased sharply in the early stage, and was maintained consistently within the range of  $3$  to  $4 \text{ gf/cm}^2$ . In the downstream, the PWP at the center (P2) showed (-) PWP in the beginning; however as time passed, it suddenly increased and was consistently maintained within the range of  $2$  to  $3 \text{ gf/cm}^2$ . The PWP at the

upper part (P3) showed kept at  $-2 \text{ gf/cm}^2$ .
